<b>Facility</b>	<b>Federal Structure ID</b>	<b>Inspector Name</b>	<b>Agency/Consultant</b>	<b>Inspection Date</b>	<b>Legend</b> 9 New 7-8 Good 5-6 Fair 3-4 Poor 2 or Less Critical		
MICH AVE	13200030000B010	Lindsey Renner	Alfred Benesch & Co.	09/05/2012			
<b>Feature</b>	<b>Latitude</b>	<b>Longitude</b>	<b>Struc Num</b>	<b>Insp Freq</b>		<b>Insp Key</b>	
RICE CREEK	42 16' 34."	84 55' 50.25"	1310	12		WXJT	
<b>Location</b>	<b>Length</b>	<b>Width</b>	<b>Year Built</b>	<b>Year Recon</b>		<b>Br Type</b>	<b>Scour Eval</b>
MARENGO TWP SEC 19	49.9	30.51	1923		1	25	U

**NBI INSPECTION**

CALHOUN COUNTY BRIDGE # 15P  
STRUCTURE #1310  
MARENGO TOWNSHIP  
9/5/2012

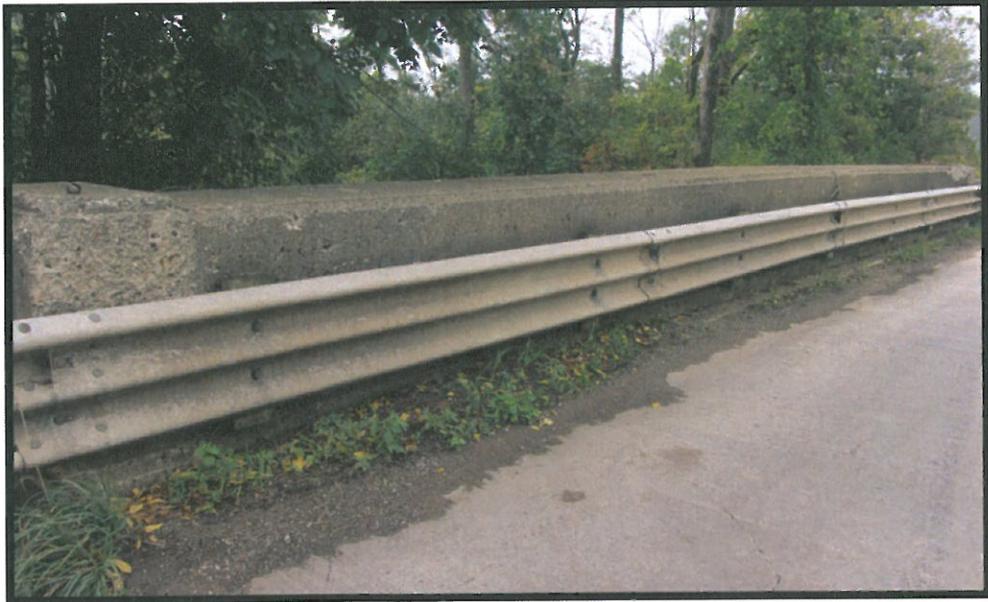
South railing

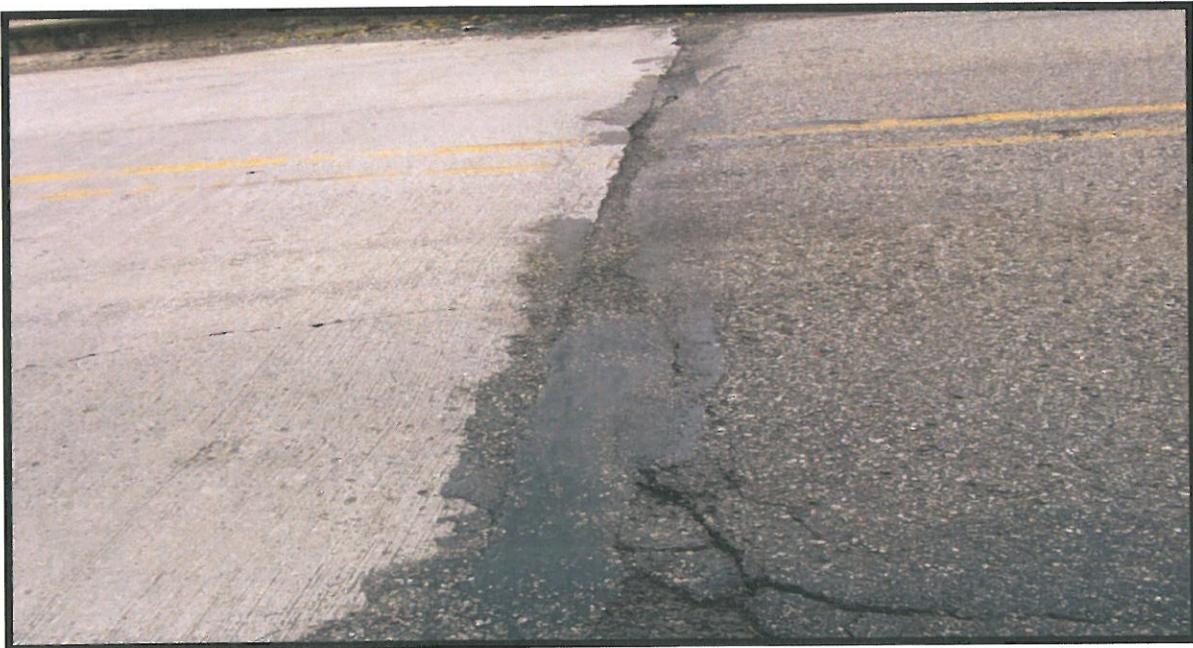
East end joint

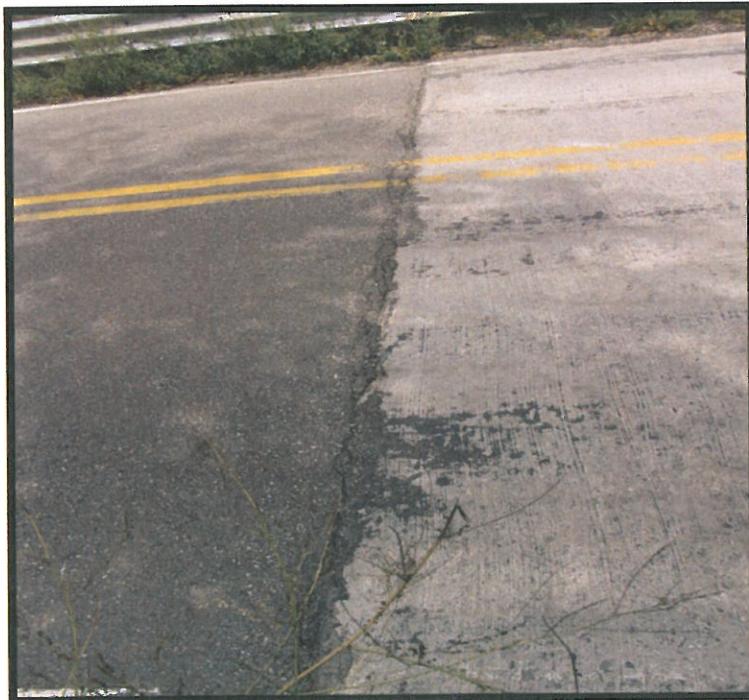
West end joint.

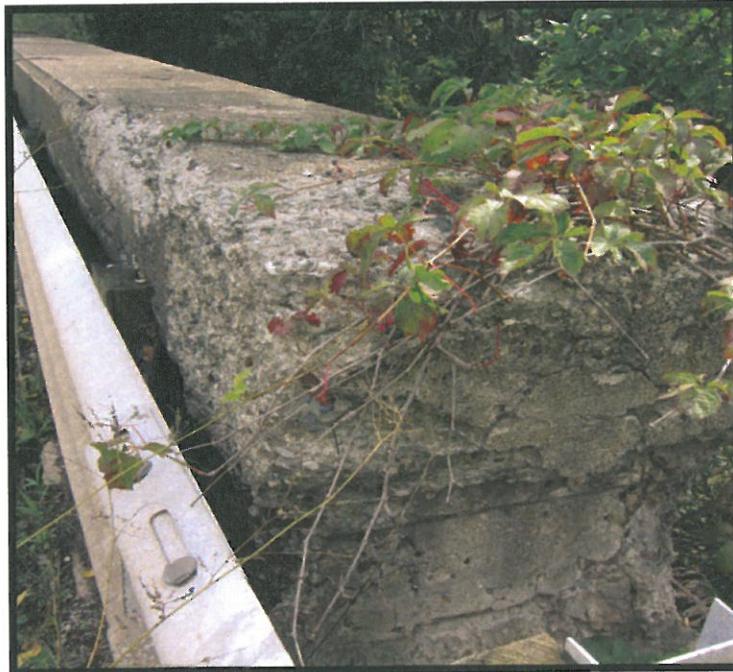
Deterioration in south railing, west end.

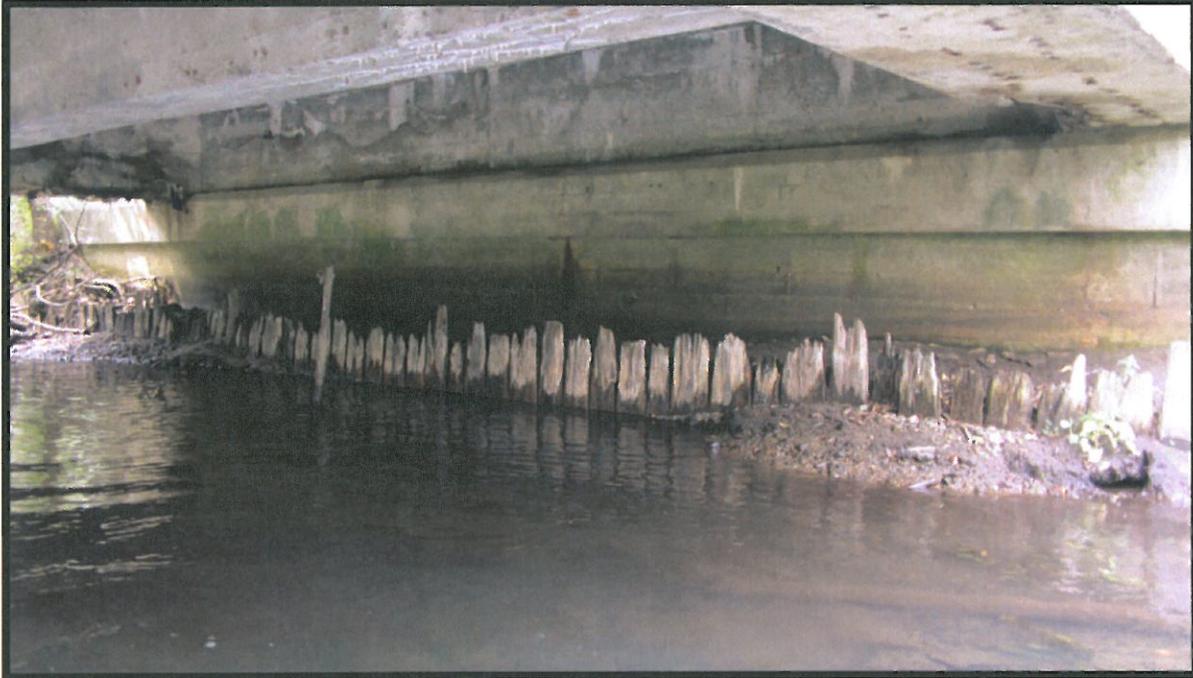
West Abutment.

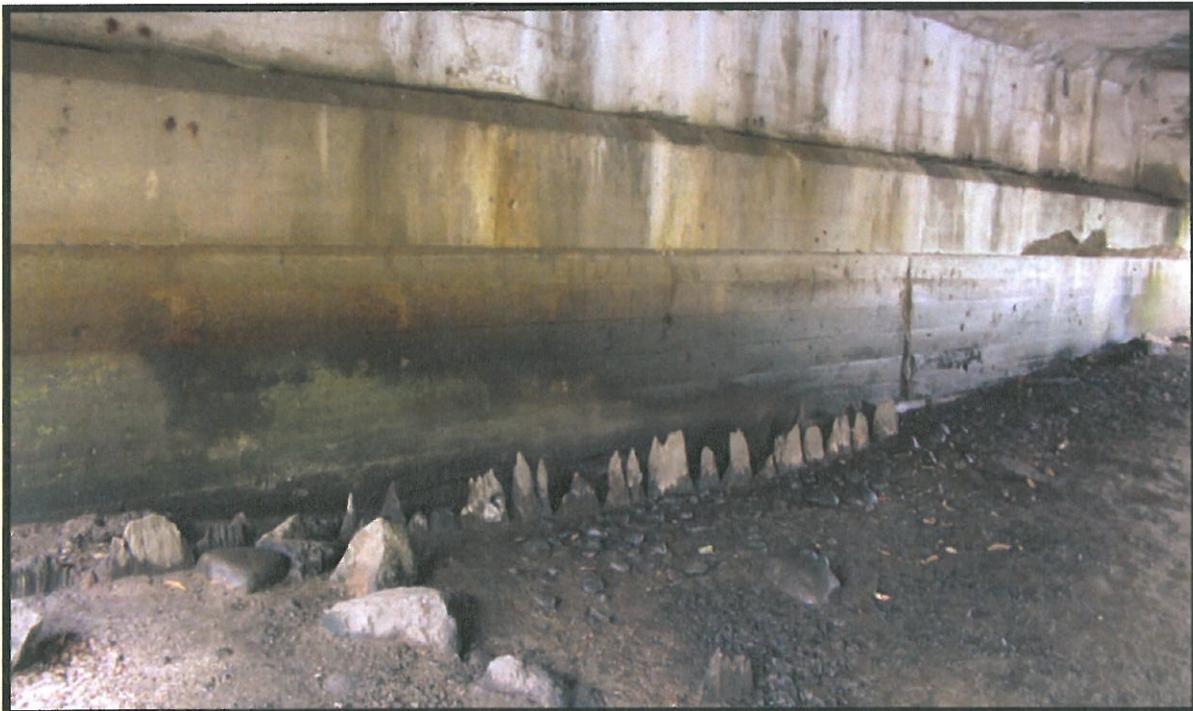
East abutment

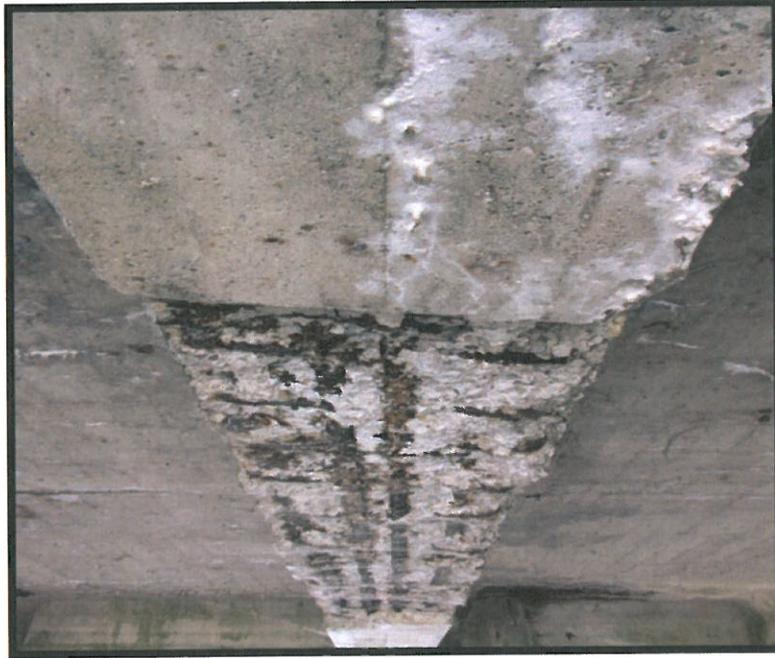
Deteriorated concrete beam 2 West.

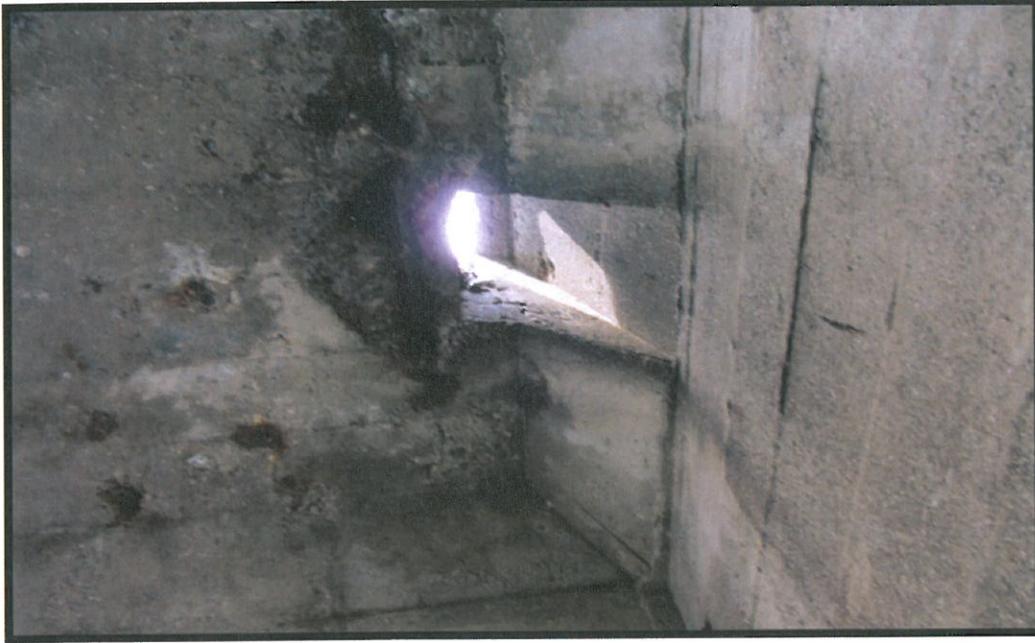
Deck bottom at northeast deck drain.

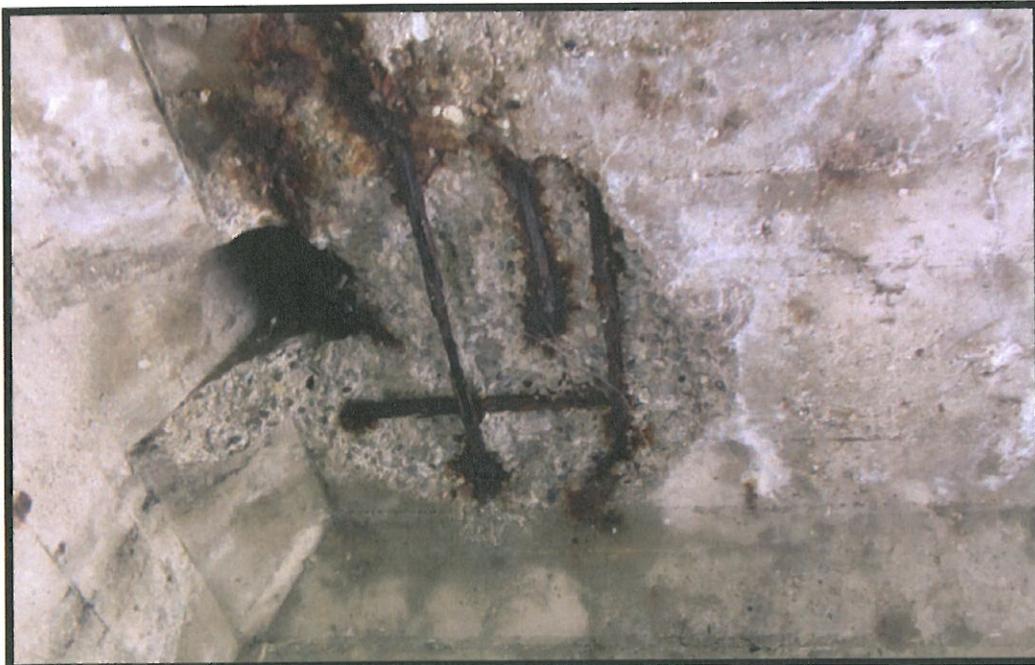
Deck bottom at southeast deck drain

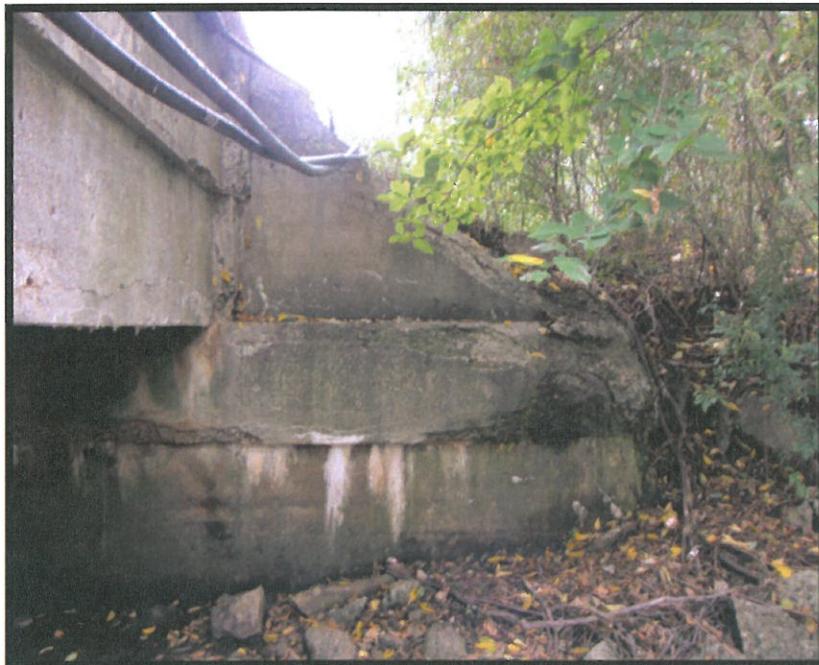
South East return wall (typ.)

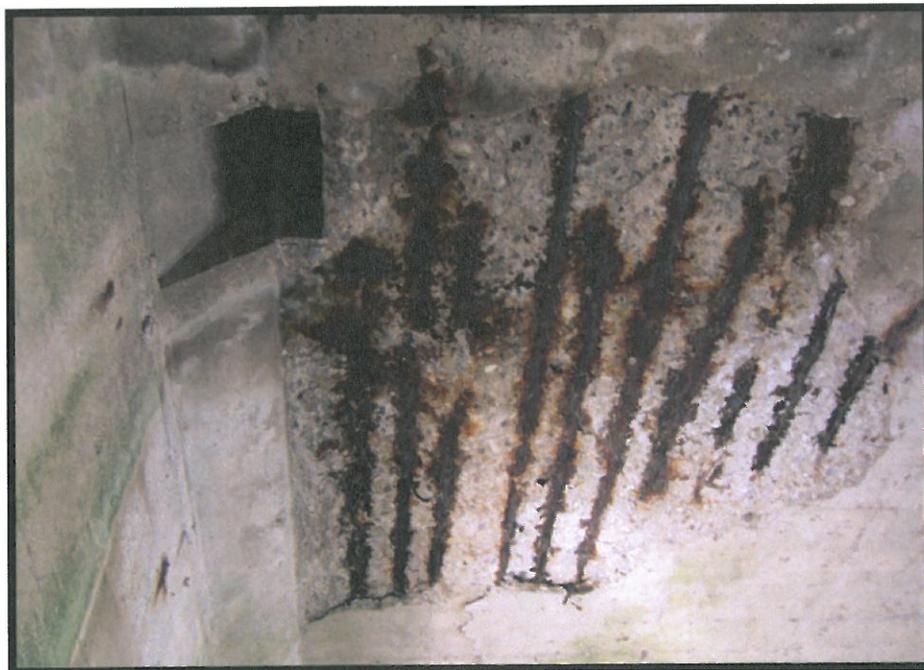
Spalling at southwest

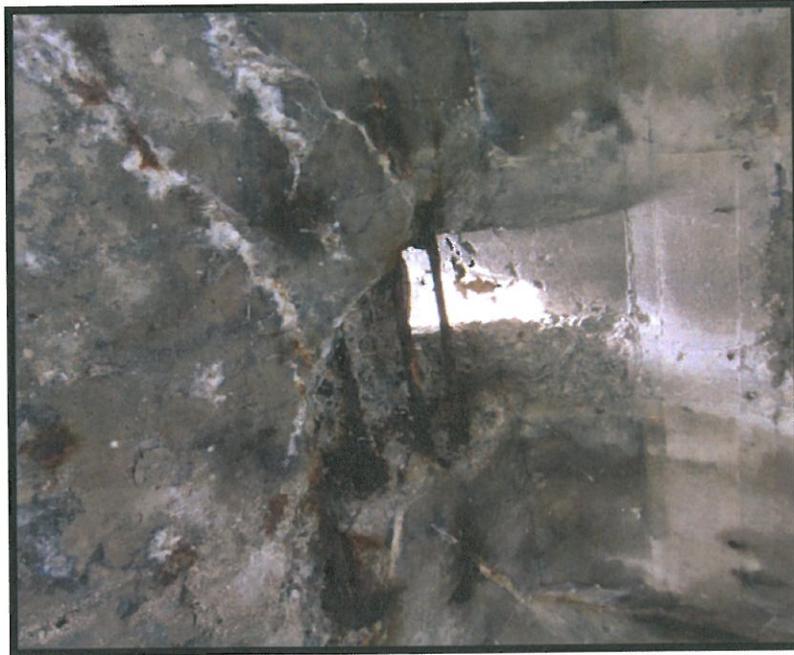
Northwest deck drain
