**NESHAP RENOVATION / DEMOLITION INSPECTION OF
ASBESTOS CONTAINING MATERIALS
AND OTHER HAZARDOUS WASTE MATERIALS**

68-70 Frelinghuysen Avenue
Battle Creek, MI 49017

City of Battle Creek
10 North Division Street - Rm 117
Battle Creek, MI 49017
269-966-3323

07/16/19
Date of Report

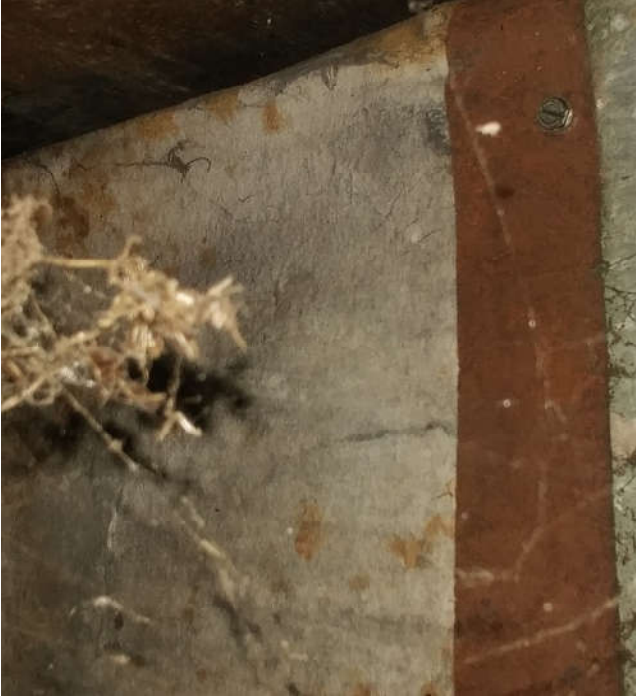
Duct Wrap - Grey

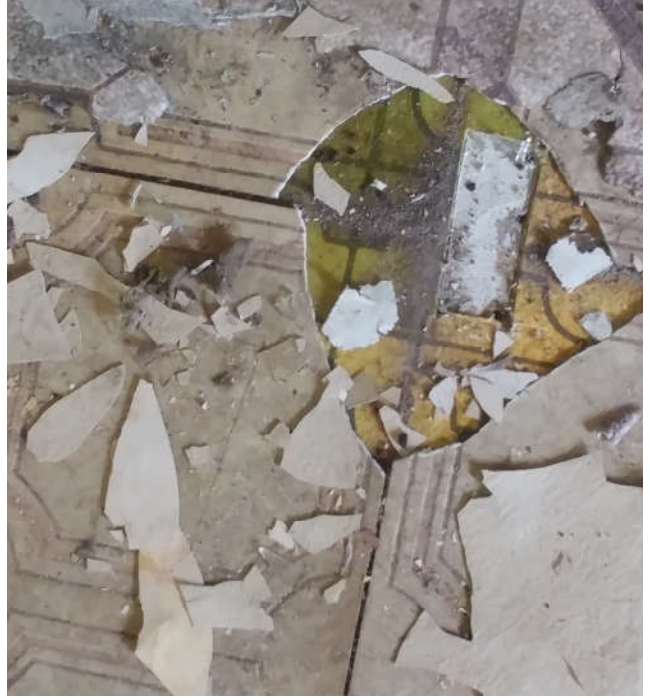
Peel & Stick - Green/Yellow
