**MULTI-FAMILY COMBINATION LEAD BASED PAINT  
INSPECTION AND  
RISK ASSESSMENT SURVEY**

Frelinghuysen Duplex  
68-70 Frelinghuysen Avenue  
Battle Creek, MI 49017  
Owner's phone #: 269-966-3323  
Date of Construction: 1910

ETC Job#: 223531

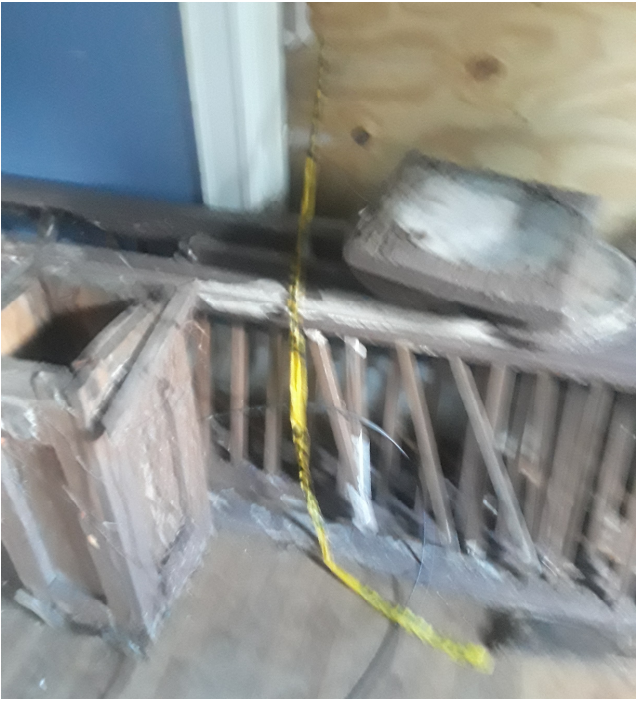
Positive Debris - Living Room 22

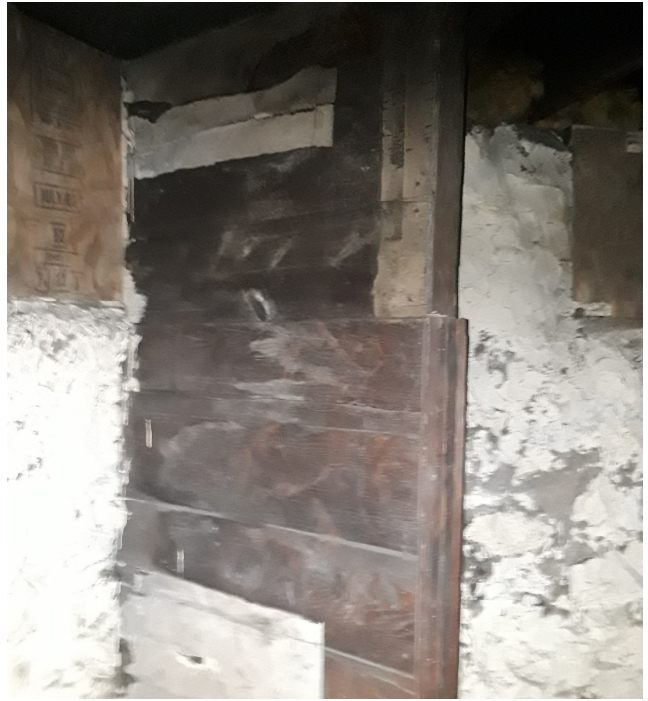
<b>Basement 14</b>				
<b>Wall (Side D)</b> represents deteriorated lead paint surface hazard(s)	Low	Low	1) Enclose with drywall or other suitable wallboard material or 2) wet scrape/sand all surfaces, make necessary repairs, stabilize surfaces and encapsulate with a Michigan approved encapsulant.	Wet scrape / sand all surfaces, make necessary repairs, stabilize all surfaces and repaint.

Basement 14 - Positive wood wall

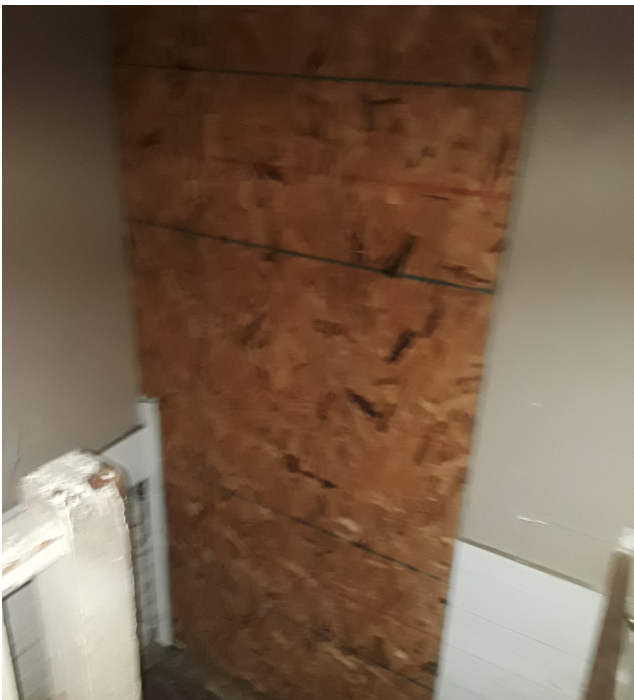
<b>Base. Stairs 13</b>				
<b>Wall (Side B, C, D), Lower Wall (Side D), and Ceiling (Ceiling)</b> represents deteriorated lead paint surface hazard(s)	Low	Low	1) Enclose with drywall or other suitable wallboard material or 2) wet scrape/sand all surfaces, make necessary repairs, stabilize surfaces and encapsulate with a Michigan approved encapsulant.	Wet scrape / sand all surfaces, make necessary repairs, stabilize all surfaces and repaint.
<b>Chair Rail (All)</b> represents deteriorated lead paint surface hazard(s)	High	Low	1) Remove and replace with new components or 2) wet scrape/sand all surfaces, make necessary repairs, stabilize surfaces and encapsulate with a Michigan approved encapsulant, install stops at all contact points with other building components (I.E. doors, etc...) or 3) strip all surfaces bare to the substrate, make necessary repairs and recoat.	Wet scrape / sand all surfaces, make necessary repairs, stabilize all surfaces and repaint.

Base Stair 13, Side C - Boarded shut
