STRUCTURAL REVIEW

501 Berrien Street Albion, Michigan

Calhoun County Land Bank Authority

ADM Engineering Project # 180004

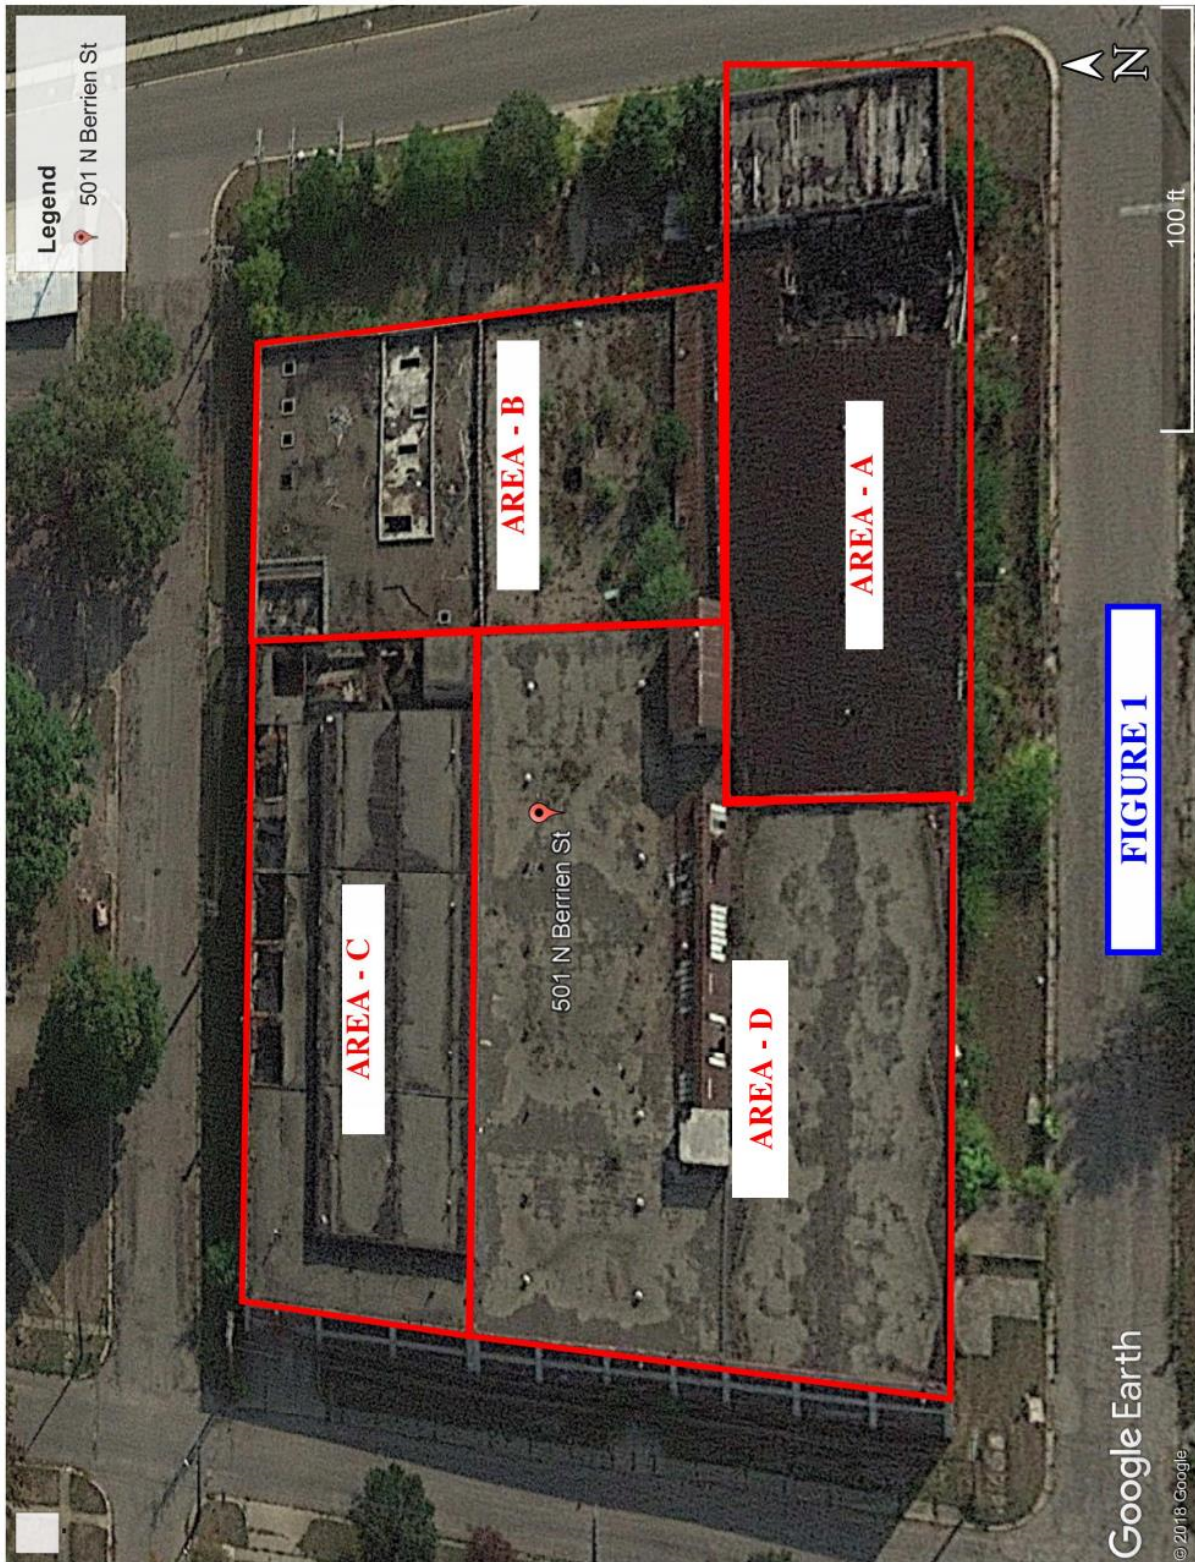
Figure 1 Overall Aerial of Property

Figure 1 shows an area view of the building and labels the various areas of construction. This will be used as a reference in this report to define what area is being discussed.

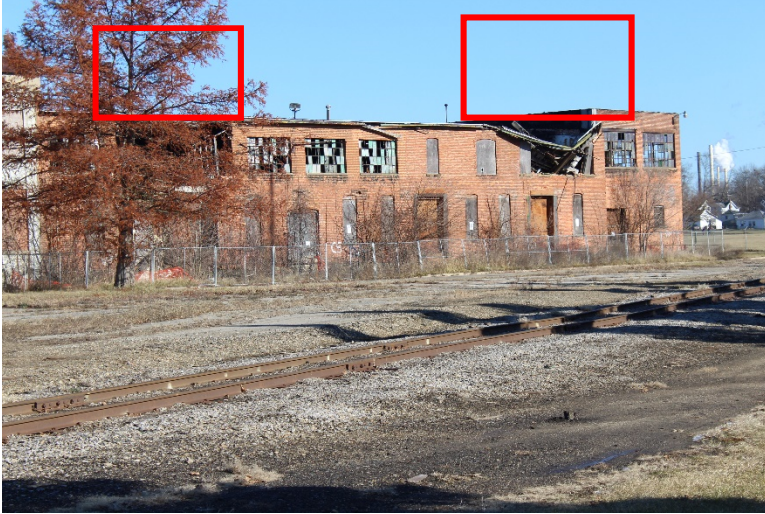
As this photo shows that in area-A part of the roof and two sections of the South wall have collapsed.

Photo 1 – Area-A South Wall

Based on our review of the structure ADM Engineering recommends the oldest section of the building area-A should be demolished without question. From a risk management standpoint, it is an accident waiting to happen, not to mention the open area provide access to the building (although not easy) for trespassers to enter and do more damage or become injured themselves.

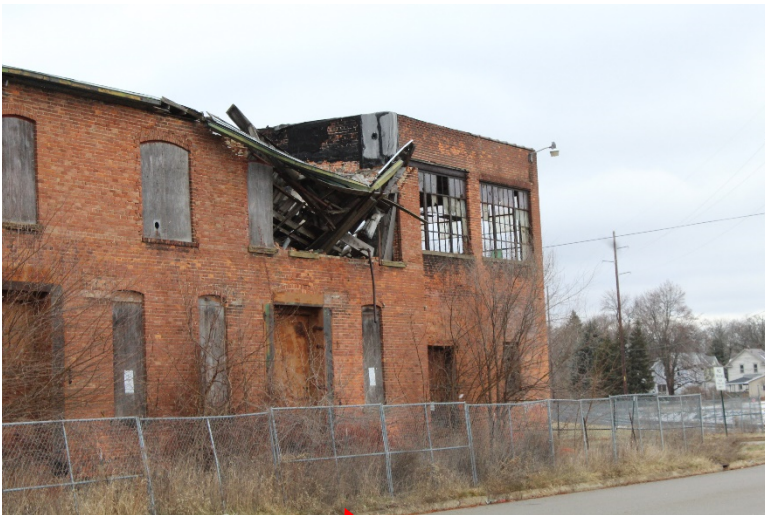
A close-up of the roof and wall collapse in area-A.

Photo 2 Area-A South Wall Roof & Wall Collapse

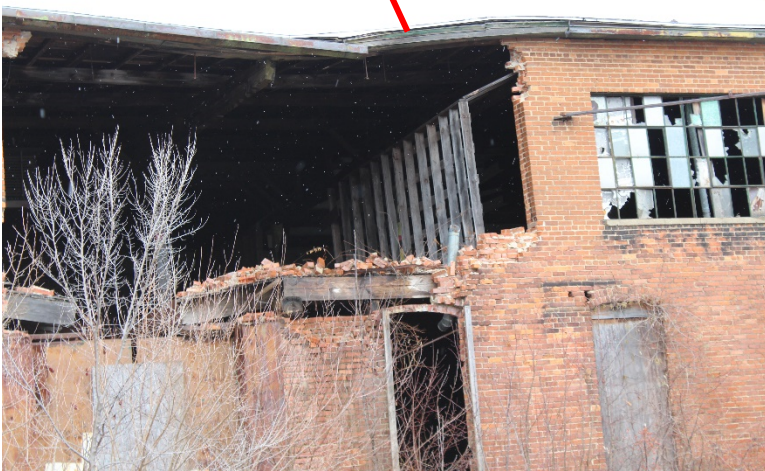
A close-up of the wall collapse in area-A. Notice the roof is starting to show signs of collapsing as well.

Photo 3 Area-A South Wall Collapse

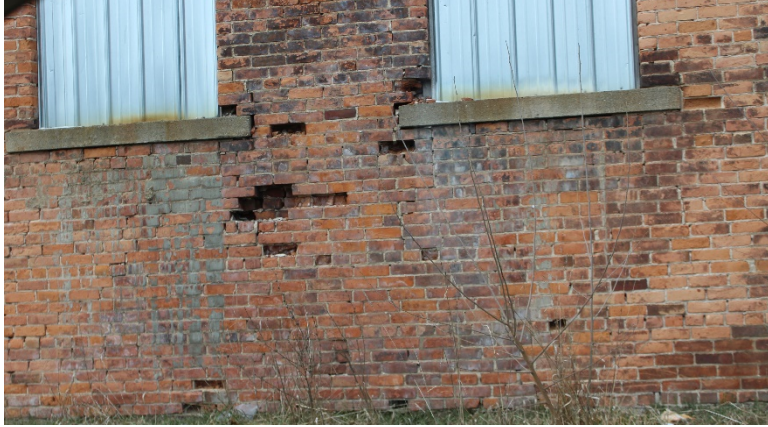
Part of area-A East wall showing the deteriorated brick.

Photo 6 Area-A East Wall Brick Work

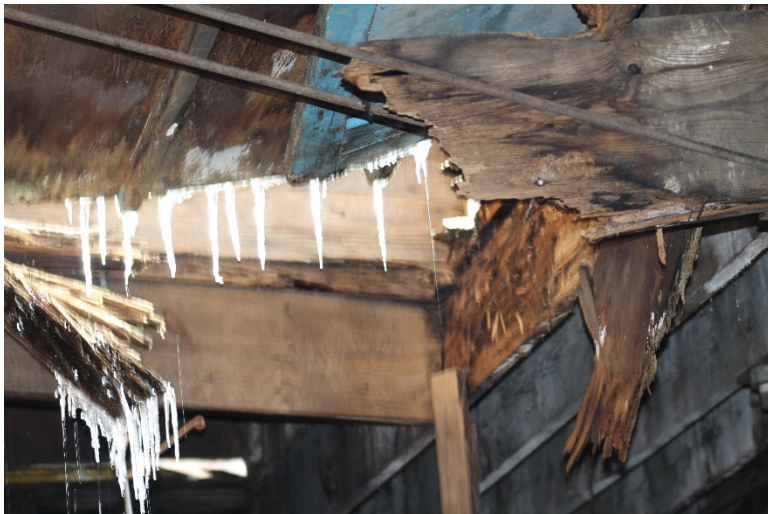
Close-up of roof collapse in area-A.

Photo 4 Area-A Roof Section

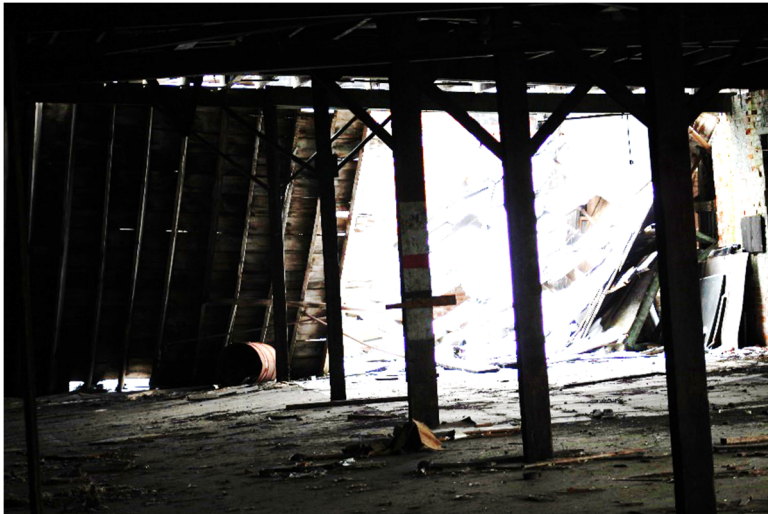
A view of the roof and wall collapse from the second floor in area-A.

Photo 5 Area-A Roof Collapse

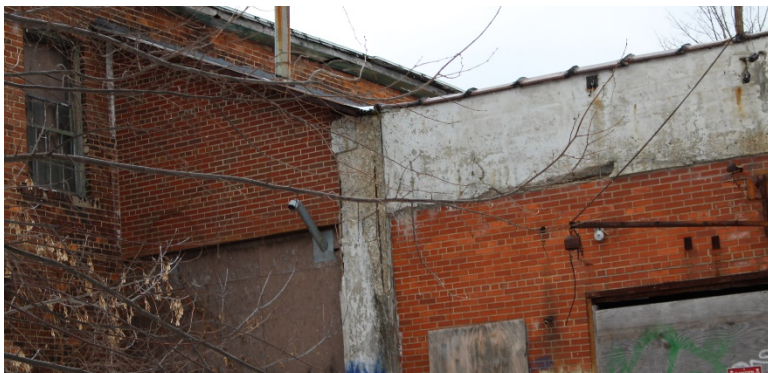
Outside of area-B along the East wall.

Photo 8 Area-B East Wall Close-up

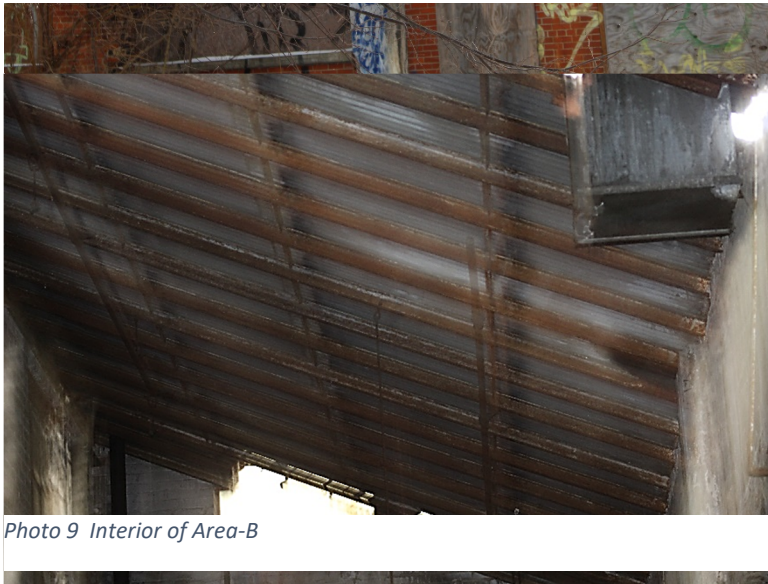
Close-up of the East wall of area-B.

Photo 9 Interior of Area-B

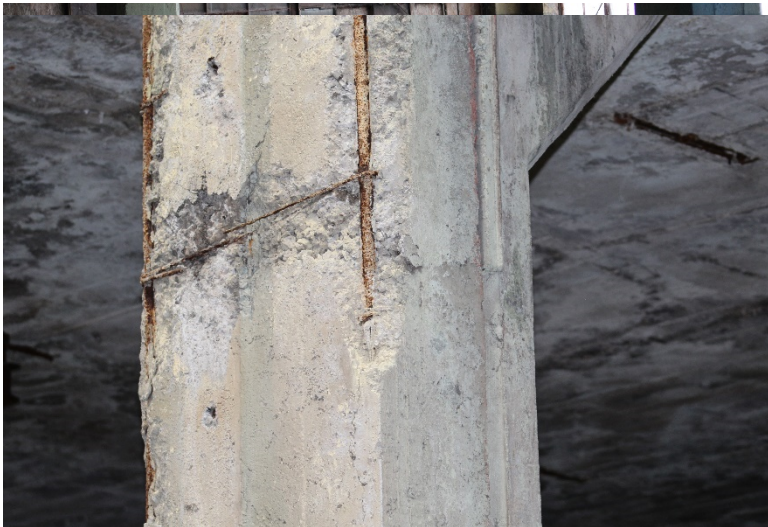
The second worst area and the largest section of the building is Area-D. This is a two-story full concrete framed structure that clearly shows signs of potential structural deficiencies. There are several areas that have column reinforcing exposed, photo 16 or sign of spalling from concrete or reinforcing deterioration, photos 22, 29 & 30. The floor and roof beams are damaged, photo 19 or show signs of concrete and/or reinforcing deterioration, photos 18, 24, 26, 32 & 33. The beam to column connections around the perimeter and where visible on the interior lead ADM Engineering that they are not structural adequate for future use presently, photos 22,30 & 31. The roof and floor slab are questionable with the amount of water intrusion from a lone term reliability of strength, even some of the floor slab reinforcing is exposed and deteriorating, photo 20.

Photo 16 Exposed Column Reinforcing

The strength and durability would be a major concern with this structure moving forward. From a life safety point of view the framing is high questionable and would require major repairs and potentially replacement. A large-scale engineering review of the framing system and a in depth testing of the concrete and reinforcing should be done to gage the full scope of repairs and reinforcing required before consideration of moving forward with repurposing of this area of the property.

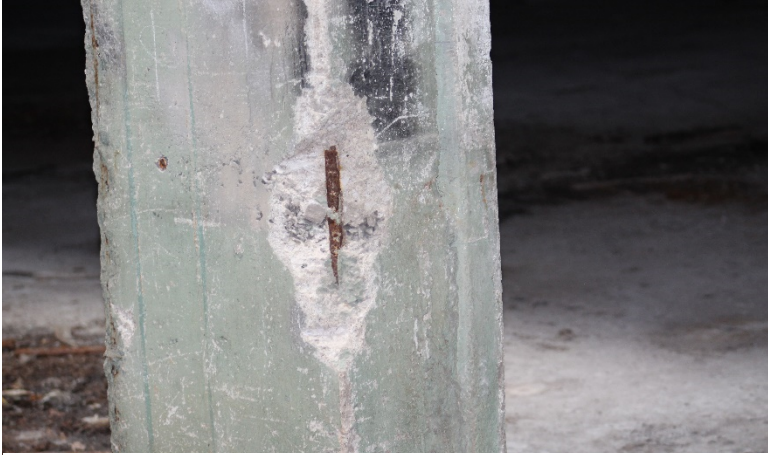
Photo 21 Exposed Column Reinforcing

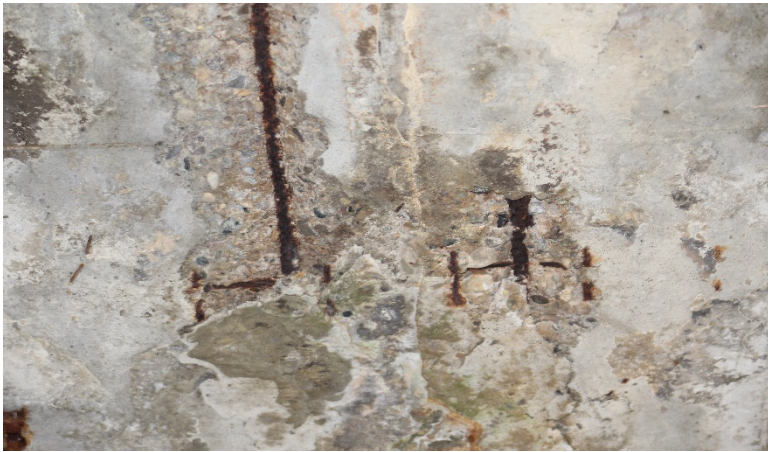
Photo 20 Exposed Floor Slab Reinforcing Steel

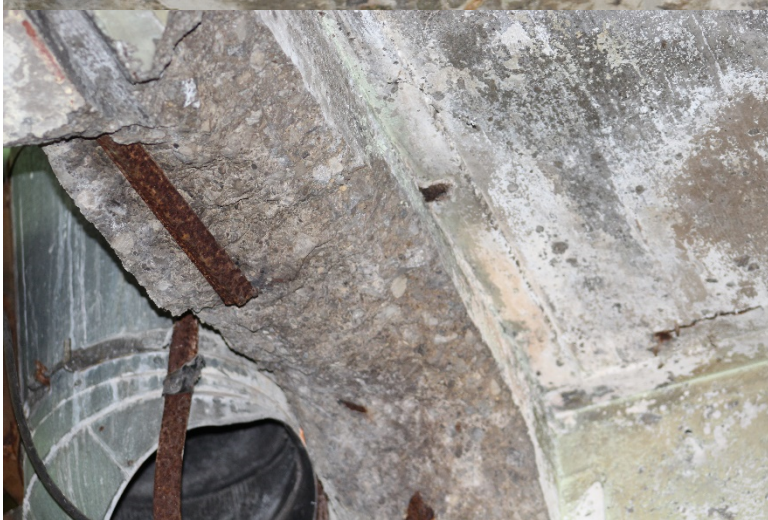
Photo 19 Damaged Floor Beam Area-C & D

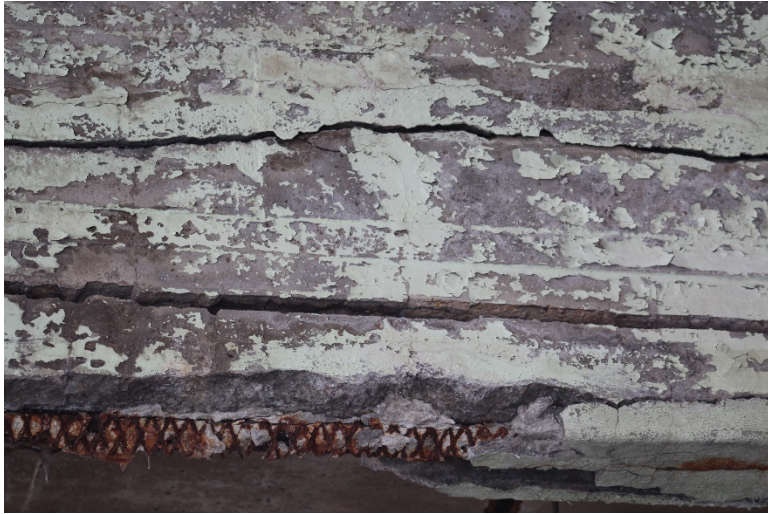
Photo 24 Several Cracked Roof Beam Area-D

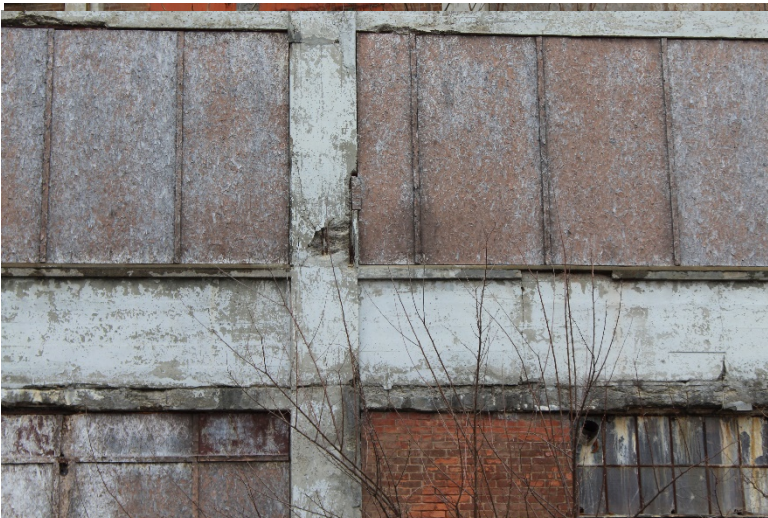
Photo 22 South Wall Deteriorated Column

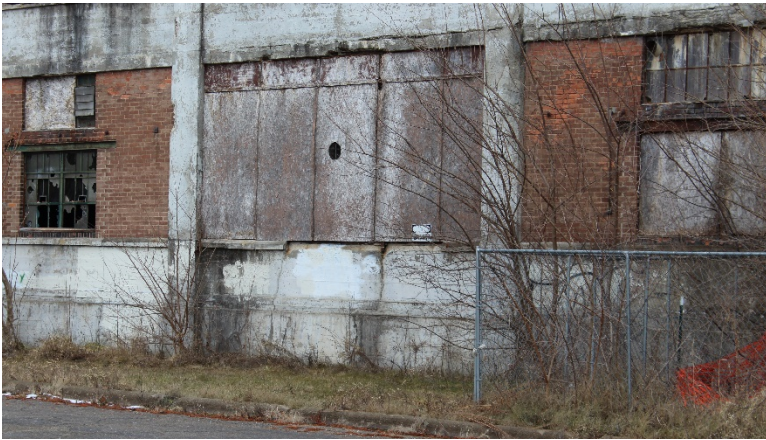
Photo 26 Exterior South Wall Ground Floor Cracked Beams

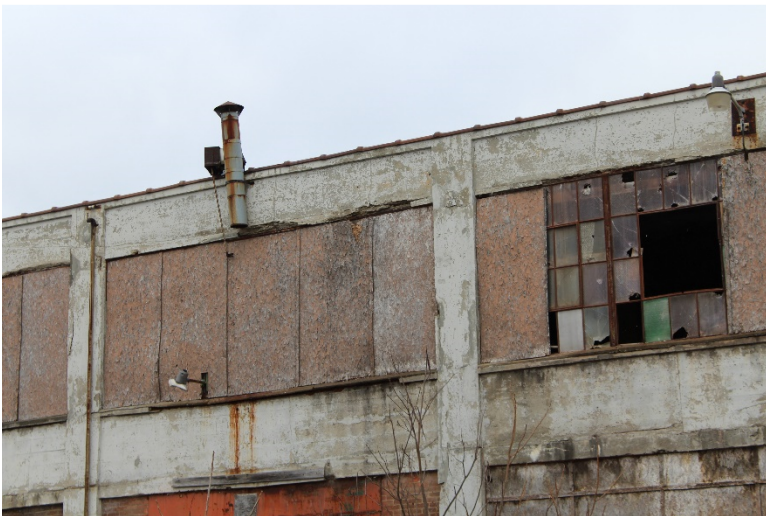
Photo 27 South Wall Area-D Structural Beam Cracking

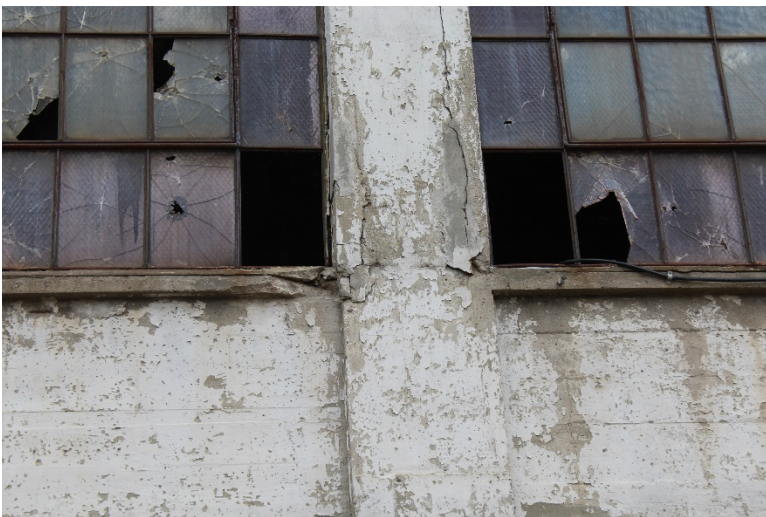
Photo 30 Column Deterioration - West Wall

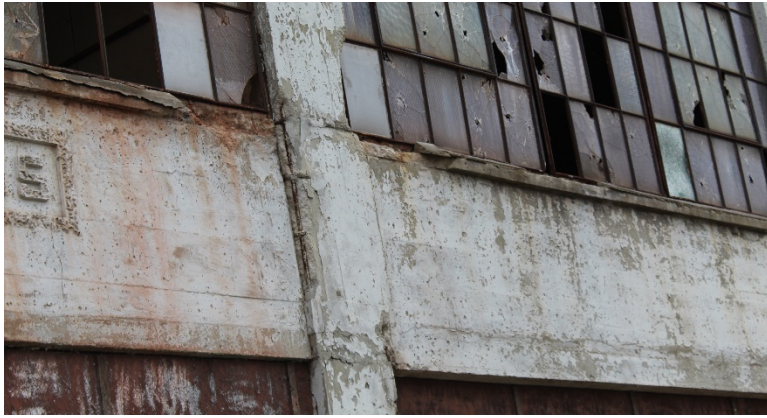
Photo 31 Column & Beam Connection Deterioration

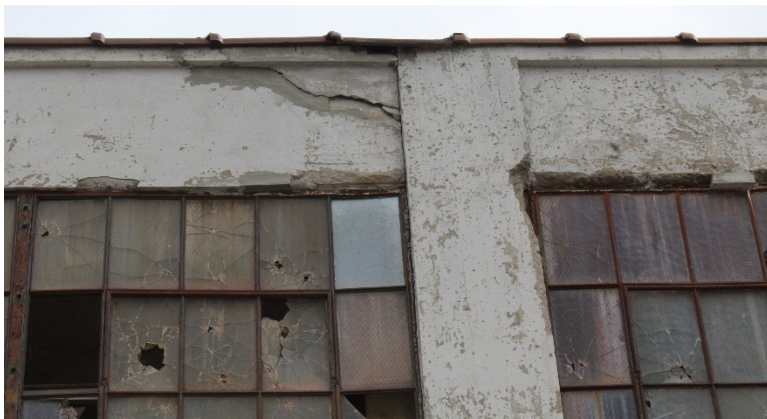
Photo 32 Roof Beam Damage w/ Failed Repair

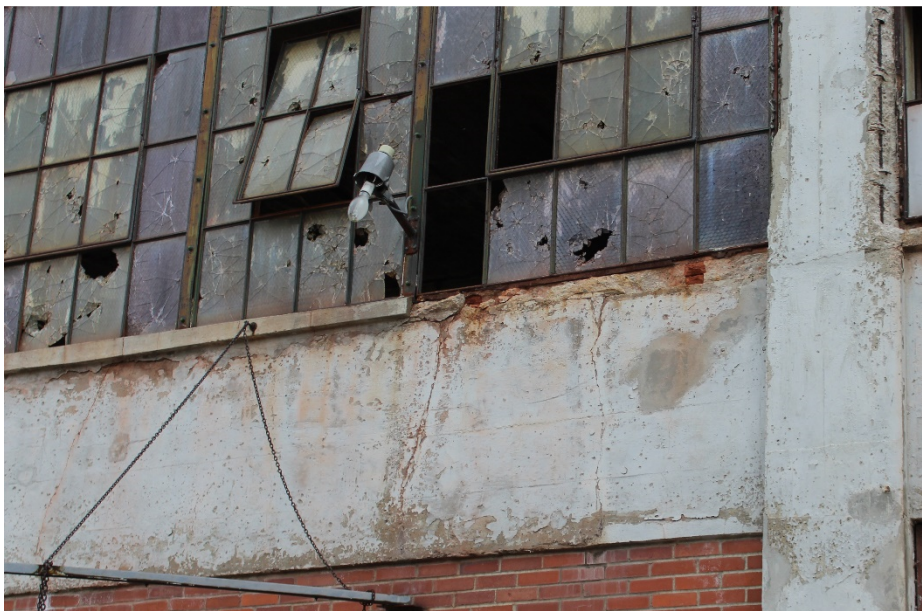
Photo 33 West Wall Floor Beam Cracking
