## ***Hazardous/Regulated Materials Survey and Inspection Report***

**Calhoun County Land Bank Authority**  
 315 W. Green Street  
 Marshall, MI 49068  
 ETC Job Number: 269-781-0744\*

<b>Parcel:</b>	269-781-0744
<b>House No:</b>	501 N. Berrien Street, Albion, MI 49224
<b>Date Inspected:</b>	05/01/2019
<b>Inspected By:</b>	Heather Broome
<b>Inspector's State Card #:</b>	A-48908

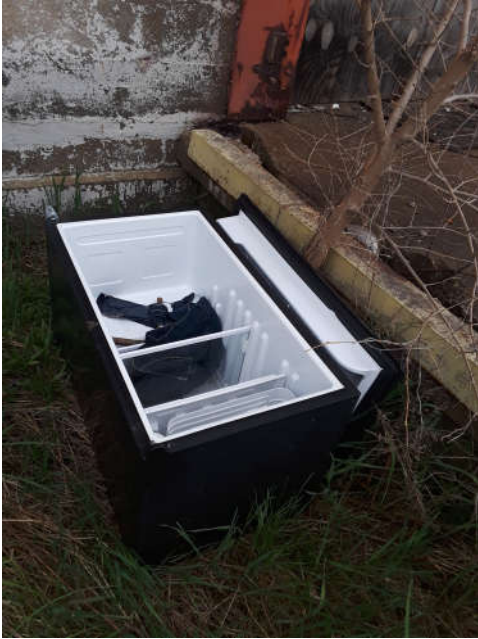
Refrigerator	1 ea	Exterior
Biohazard (Bird Feces)	20 SF	Room 28
55 Gallon Drum	1 ea	Room 18

Refrigerator

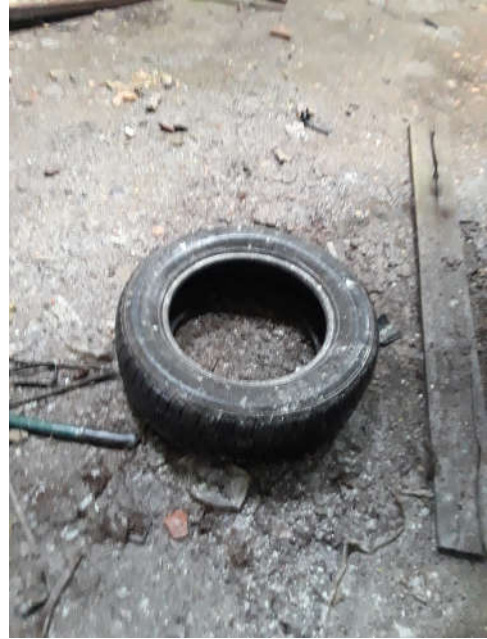
Tires	1 ea	Room 1
-------	------	--------

Tire

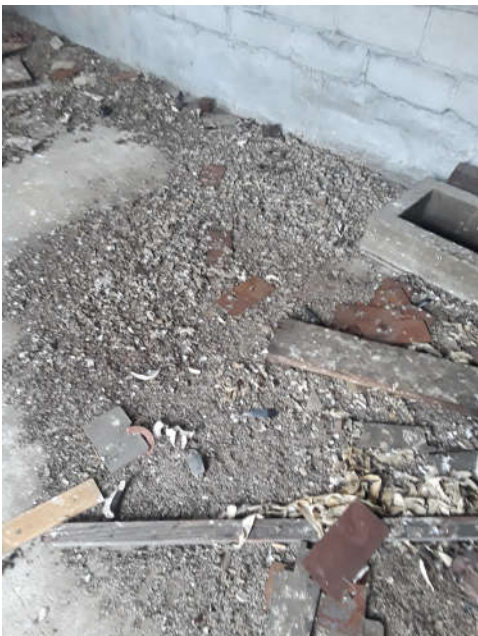
Biohazard (Bird Feces)

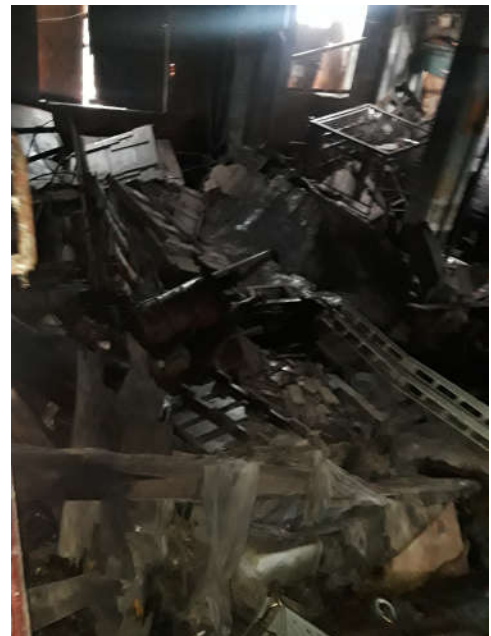
55 Gallon Drum

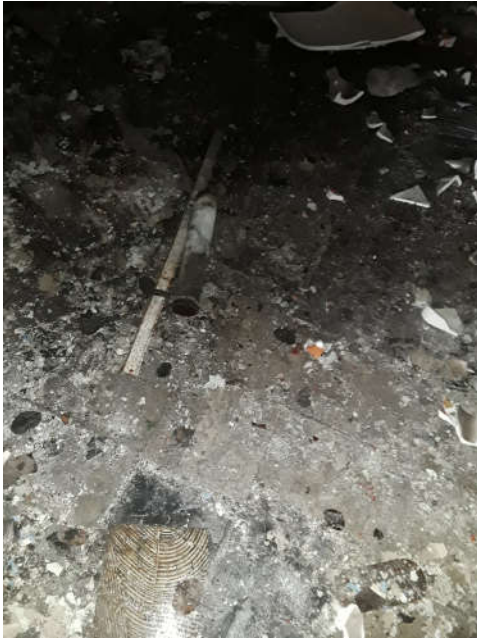
9 x 9 Floor Tile

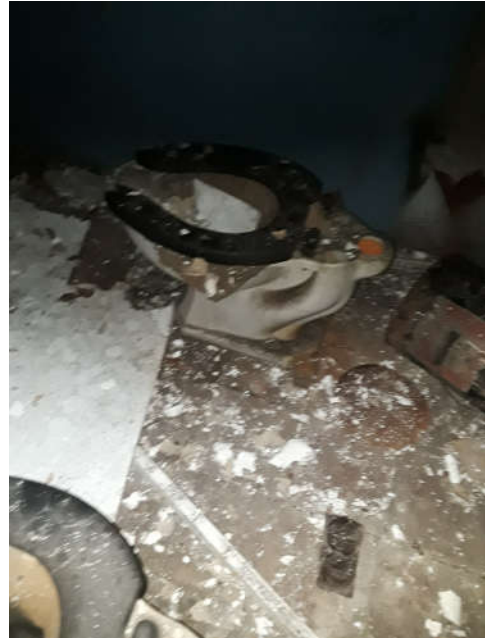
Interior Caulk

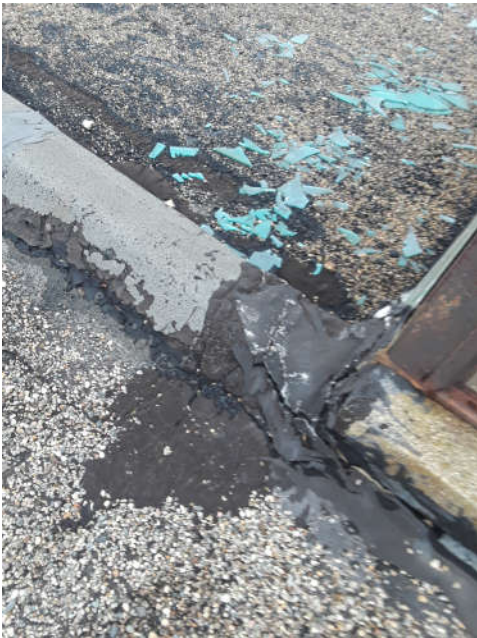
Material #	Friable (F) / Non-Friable (NF)	Material Description	Material Location	Estimated Quantity	ACM Present %
1	NF	Window Glaze (Barrier Side) - Grey	Throughout	150 Units	ND
2	NF	Window Glaze (Monroe Side) - Grey	Throughout	88 Units	ND
3	NF	Poured Concrete - Grey	Throughout	120,000 SF	ND
4	NF	Red Brick - Red	Throughout	50,400 SF	ND
5	NF	Red Brick Mortar - Grey	Throughout	50,400 SF	ND
6	NF	Ceiling Tile - White	Room 24	120 SF	ND
7	<b>NF</b>	<b>9 x 9 Floor Tile - Beige</b>	<b>Room 24</b>	<b>120 SF</b>	<b>2%</b>
8	NF	Mastic - Black	Room 24	120 SF	ND
9	NF	Paper Backing - White	Room 6, 24	240 SF	ND
<b>10</b>	<b>NF</b>	<b>Window Caulk - White</b>	<b>Throughout</b>	<b>7200 LF</b>	<b>2%</b>
<b>11</b>	<b>NF</b>	<b>Interior Caulk - White</b>	<b>Room 24</b>	<b>240 LF</b>	<b>15%</b>
12	NF	Roofing Material - Brown	Exterior Roof	60,000 SF	ND
<b>13</b>	<b>NF</b>	<b>Tar - Dark Black (On Edges)</b>	<b>Exterior Roof</b>	<b>60,000 SF</b>	<b>2%</b>

Tar, on Ledges

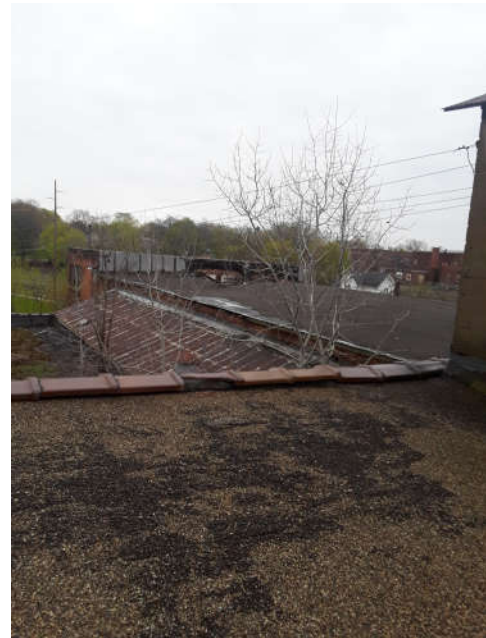
<b>14</b>	<b>NF</b>	<b>Tar - Dark Grey</b>	<b>Exterior Roof</b>	<b>60,000 SF</b>	<b>4%</b>
15	NF	Shingle - Grey	Room 29 (Step)	10 SF	ND
16	F	Roofing Insulation - Black/Tan	Exterior Roof	60,000 SF	ND
17	NF	Fiberboard - Tan (Under Steel Panels)	Room 22	60 SF	ND
18	NF	Cloth Vibration Damper - Grey (Under Steel Panels)	Room 26	10 SF	ND
19	NF	12 x 12 Floor Tile - Grey	Room 1	30 SF	ND
20	F	Machine Insulation - Tan/Orange	Room 17	15 SF	ND
21	NF	Caulk - Tan (On Machine)	Room 17	180 LF	ND

Tar

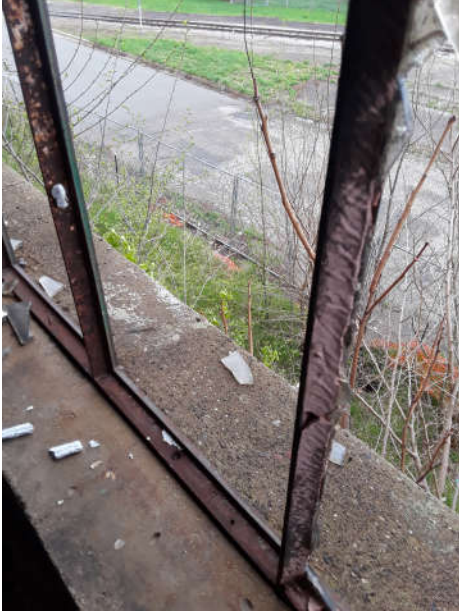
Window Caulk
