Gang of Lakes Intercounty Drain Assessment Report

Calhoun and Jackson Counties, Michigan

August 19, 2015

GEI Project No. 1509010

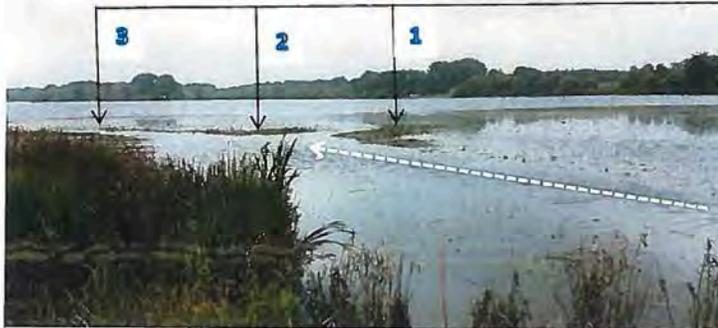
Shows three(3) spots where sediment deposit have been deposited in Prairie Lake. Also the flow of the Gang of Lakes drain is shown with a broken arrow line

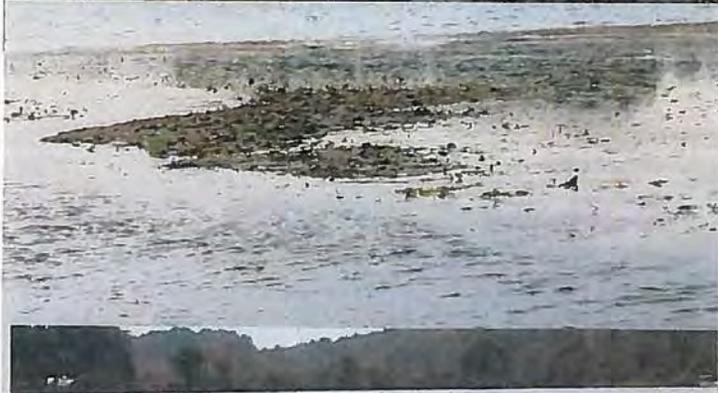
Spot One(1)
Close-up of sediment deposit.

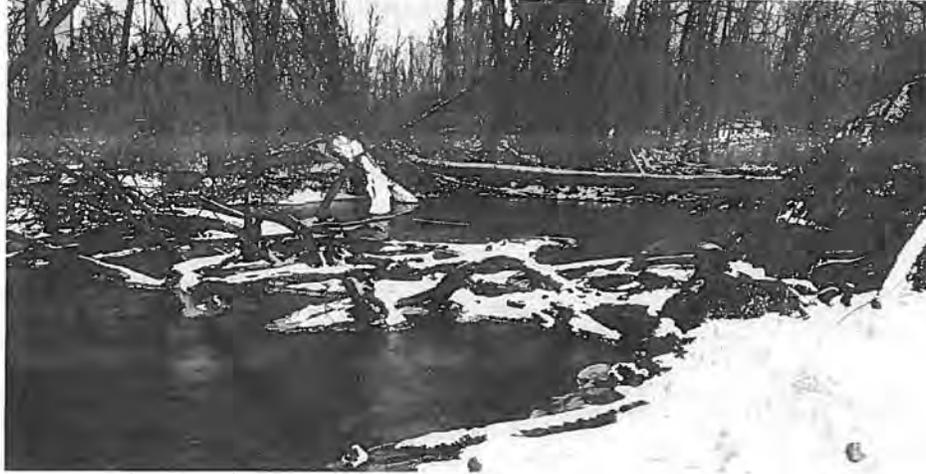
These series of pictures were taken along the drain between 22 1/2 Mile Road and the Deforest & Chittenden County Drain. This section of drain is approx. 1550 feet long. The stretch of drain West of this section was looked at during the summer of 2013. The land owner at that time had been keeping the dead falls out of the drain. The water at this time was too deep to determine if any sediment needs to be removed.
