ENVIRONMENTAL ASSESSMENT
(HUD recommended format per 24 CFR 58.36)

**100 AND 101 WINDING WAY
BATTLE CREEK, MICHIGAN 49014**

TEC REPORT 52083-2

**ASBESTOS CONTAINING MATERIAL SURVEY
DECEMBER 7-8, 2011**

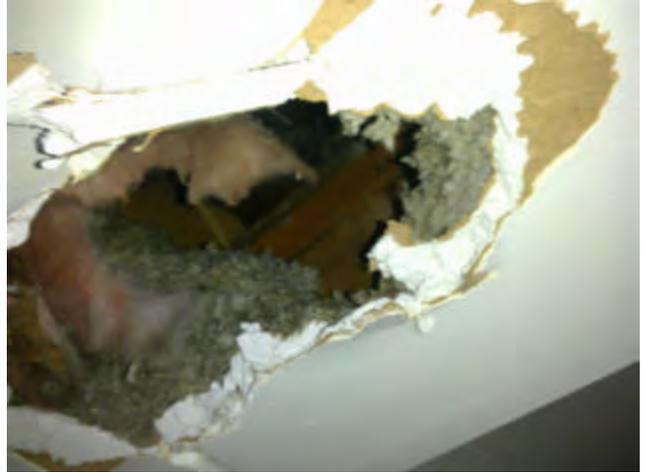
Attic blown in insulation

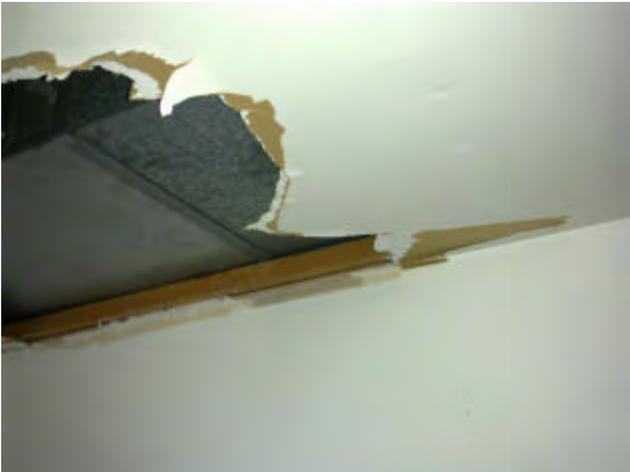
Drywall, drywall mud, drywall tape

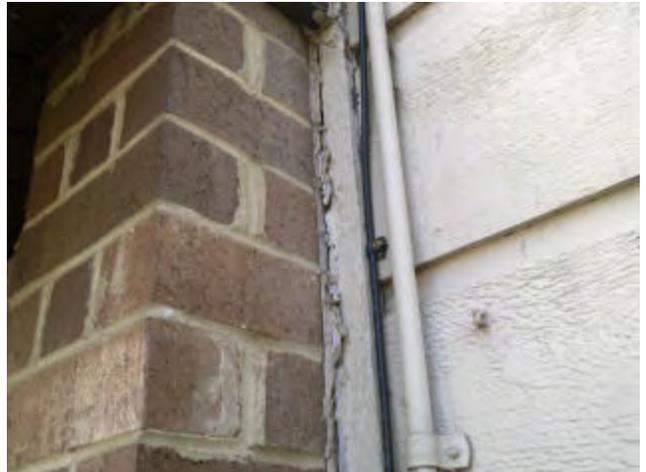
Exterior caulk

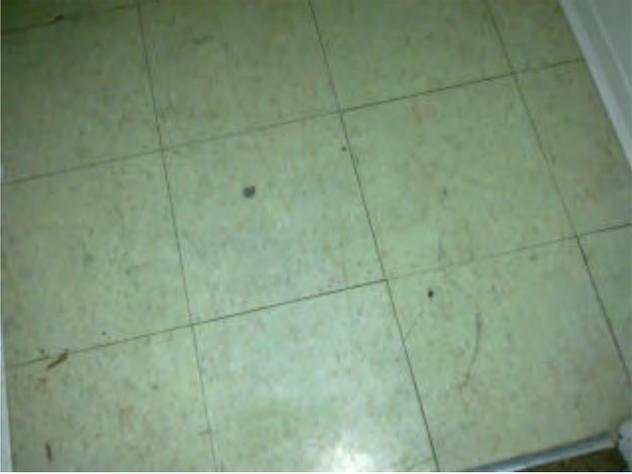
Floor tile

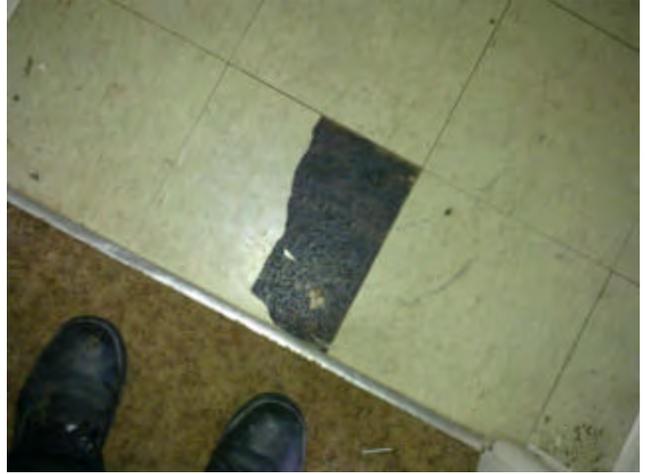
Floor tile mastic

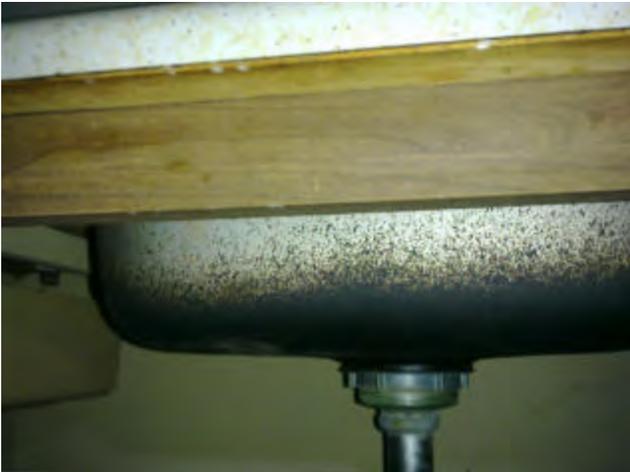
Kitchen sink undercoating

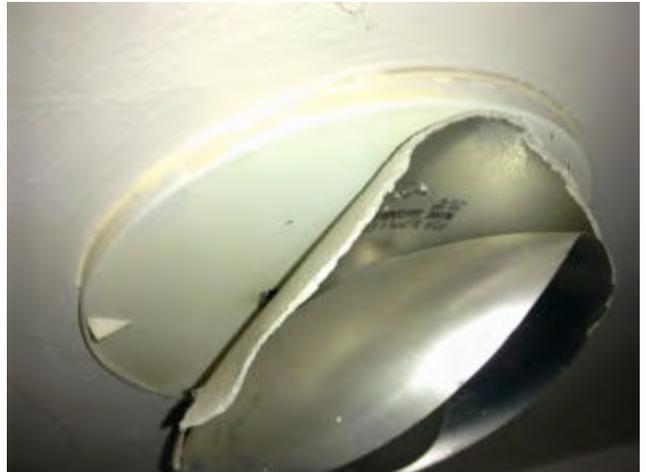
Light heat shield

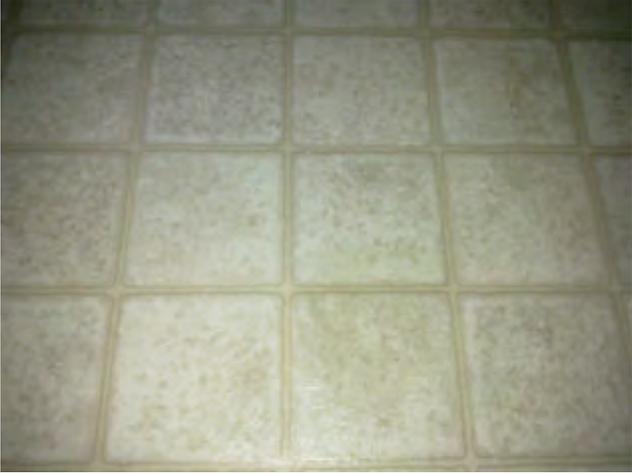
Linoleum

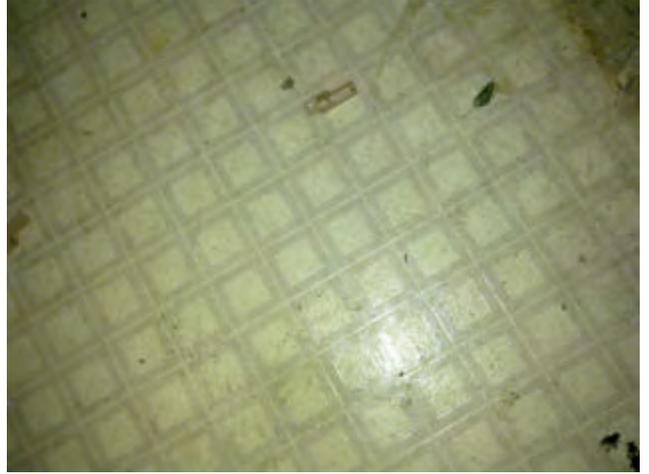
Linoleum

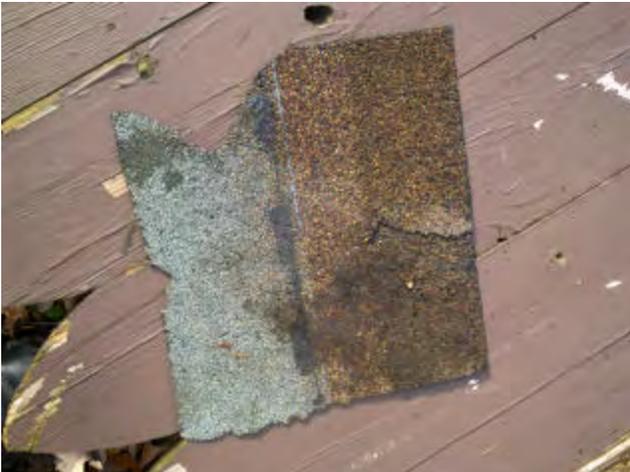
Roofing shingle
