Gang of Lakes Intercounty Drain Assessment Report

Calhoun and Jackson Counties, Michigan

August 19, 2015

GEI Project No. 1509010

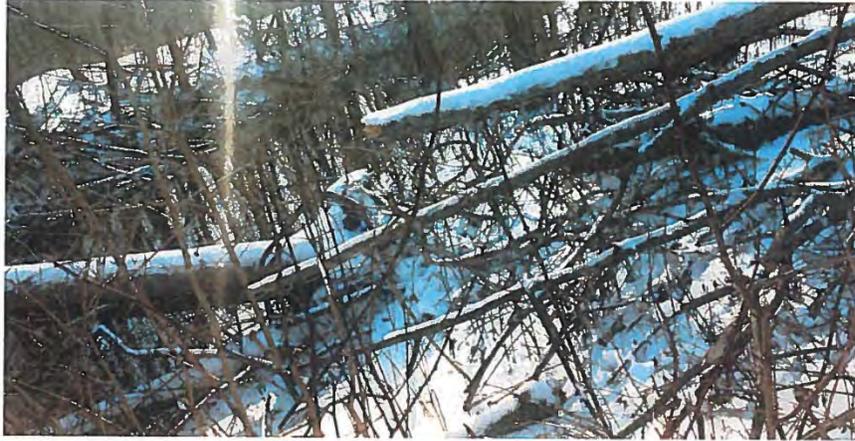
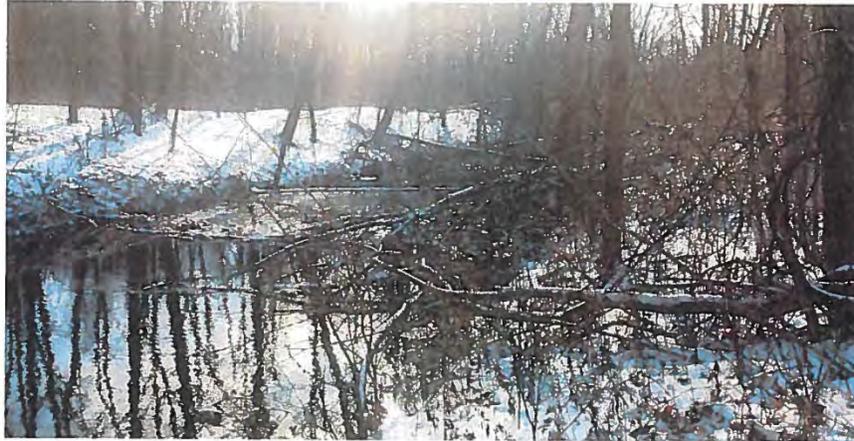
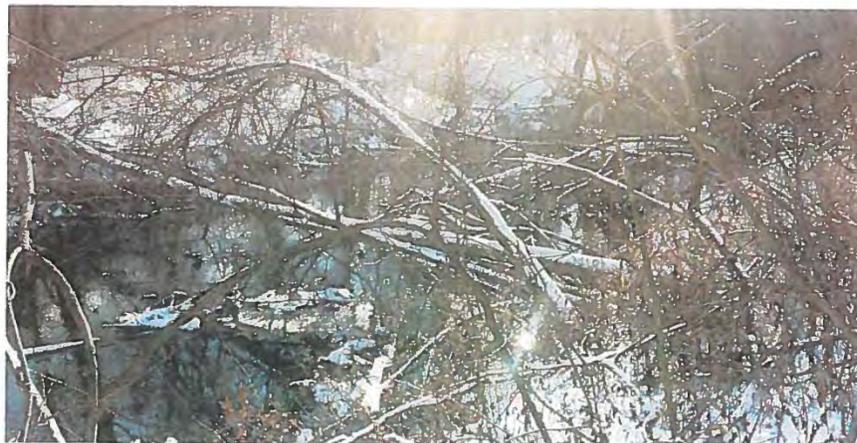
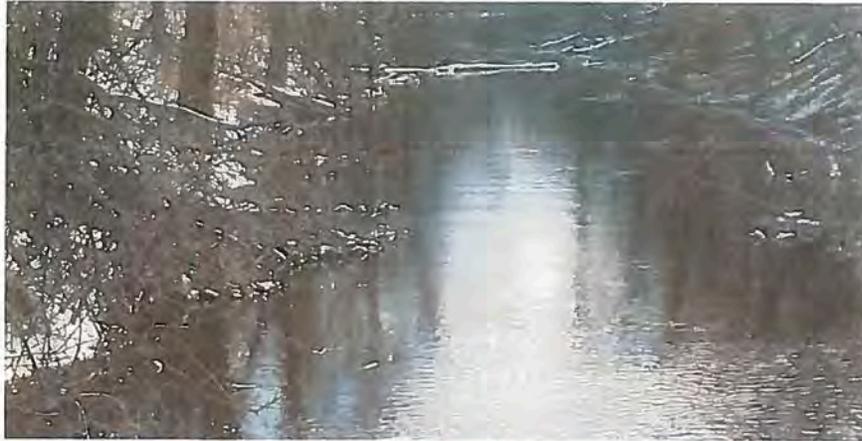
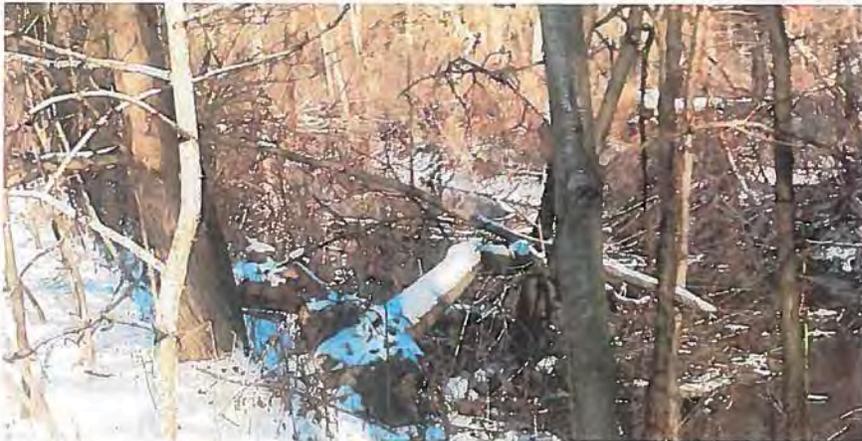
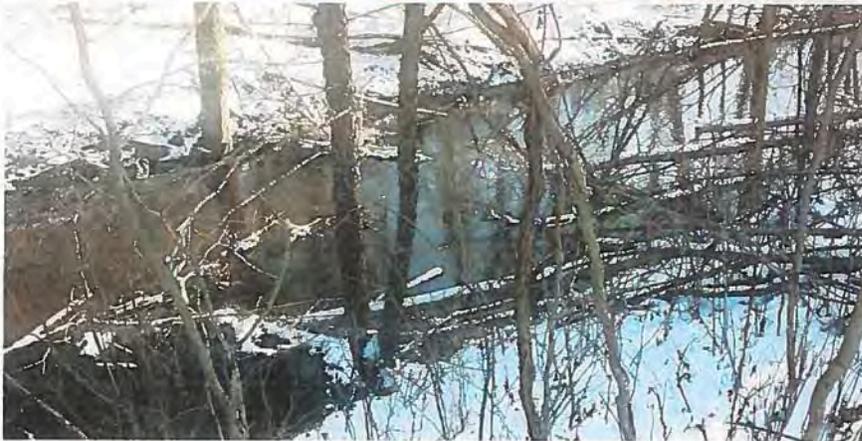
2400 feet of the drain, South of L Drive North was inspected and the following pictures represent that area. No specific picture was referenced to a location on the drain.

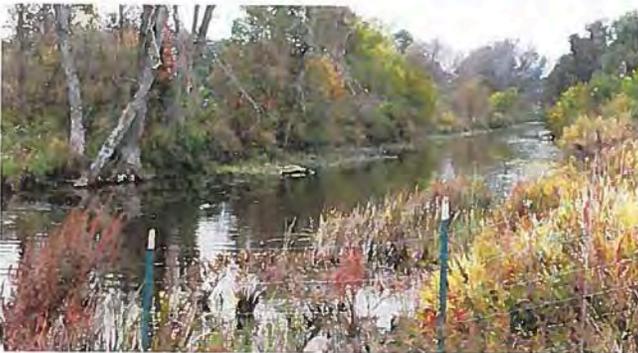
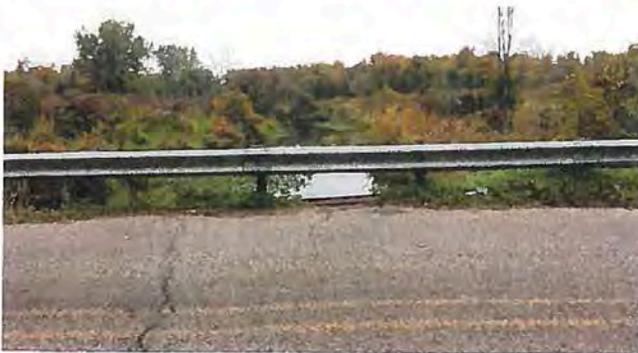
Picture of drain South of 26 Mile Road showing some of the sediment deposit just South of the Road Culverts

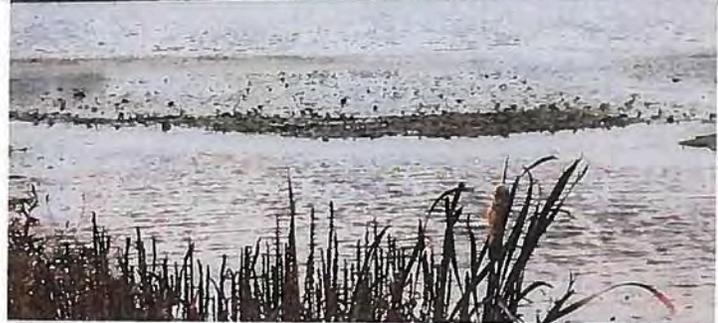
Spot two (2)
Close-up of sediment deposit.

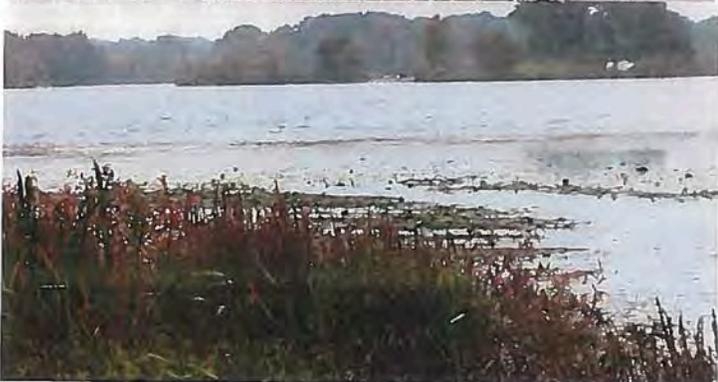
Spot three (3)
Close-up of sediment deposit.

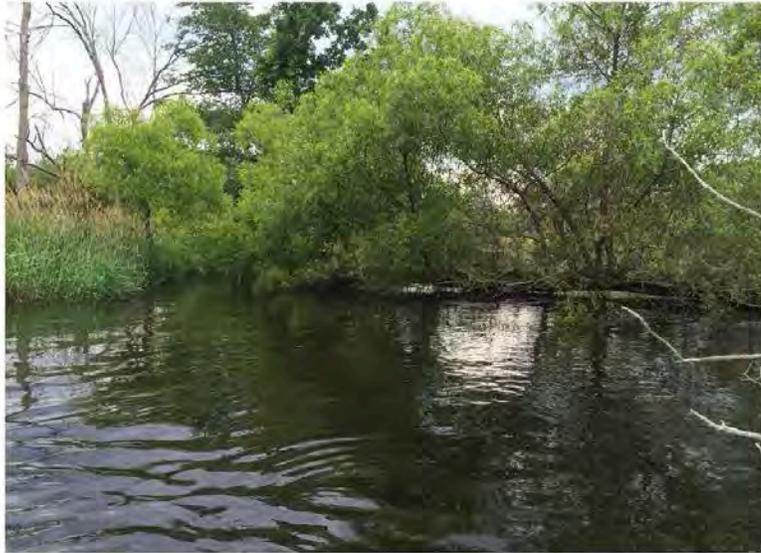
Photo 1. View downstream of site #1

Site No. #	Bank or Channel	Description	Cubic Yards	Recommendations	Priority	Field Photographs
1	LDB RDB MC	Large woody debris, consisting of submerged branches and overhanging trees, obstructing natural flow	3	Remove, Relocate to LDB/RDB, and cut back vegetation from mid channel	H	1 - View d/s
2	LDB MC	Large woody debris, consisting of submerged branches and trees, obstructing natural flow	1/4	Remove to upland; Cut back vegetation from mid channel	L	2 - View u/s
3		Confluence of north branch of Rice Creek (Gang of Lakes Drain)				NP
4	LDB RDB MC	Large woody debris, consisting of submerged branches, obstructing natural flow	1/4	Remove to upland	L	3 - View d/s
Photograph Point A		Photograph Point A - Open reach of drain showing no apparent signs of obstruction to flow or erosion; mid channel approximately 6 ft. deep; center of drain channel is silt and detrital bottom; no action recommended				4 - View u/s 5 - View d/s

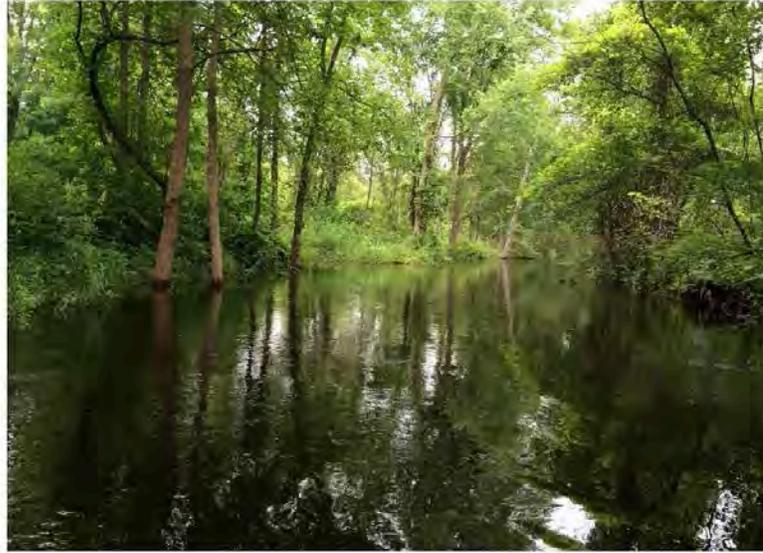
Photo 65. View upstream of Photograph Point D

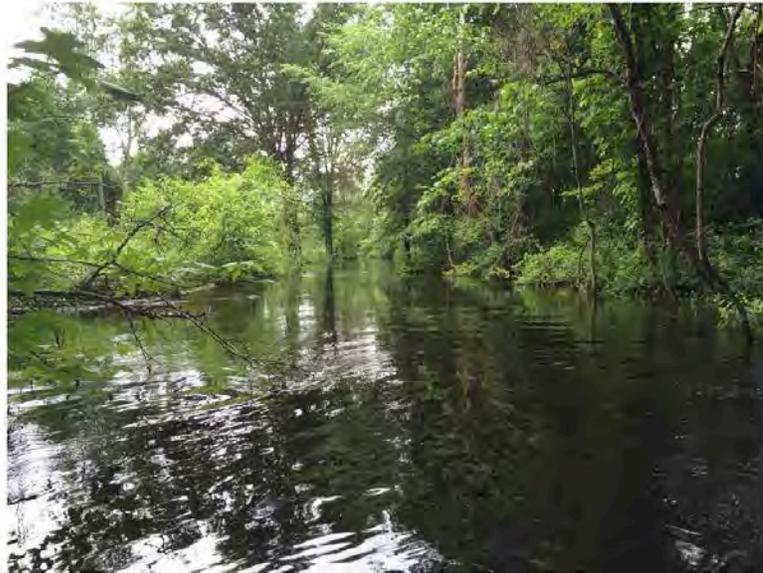
Photo 66. View downstream of Photograph Point D

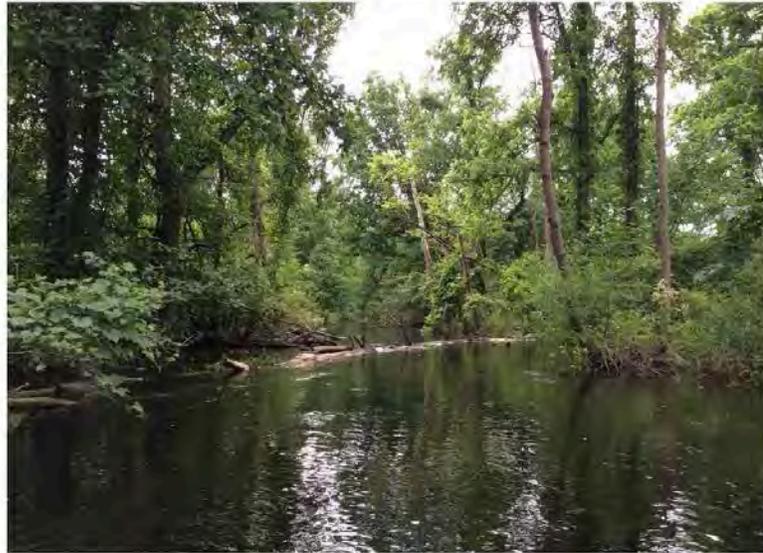
Photo 67. View downstream of site #44

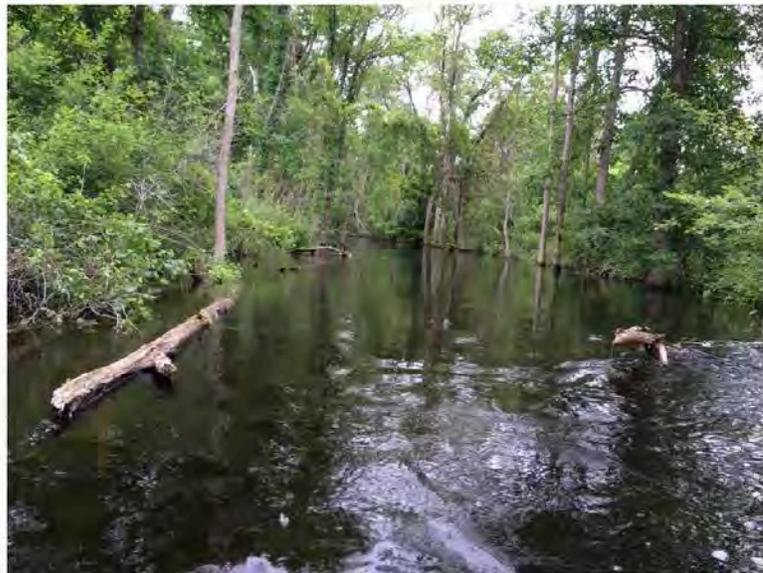
Photo 68. View upstream of site #45

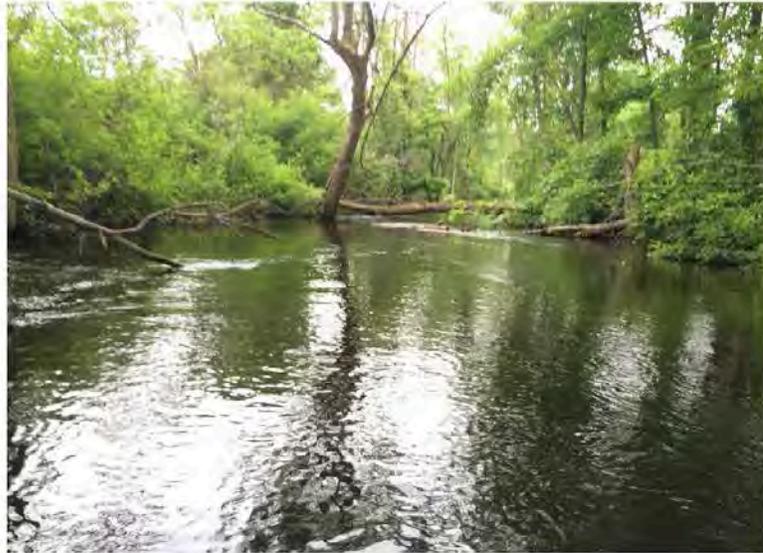
Photo 69. View downstream of site #46

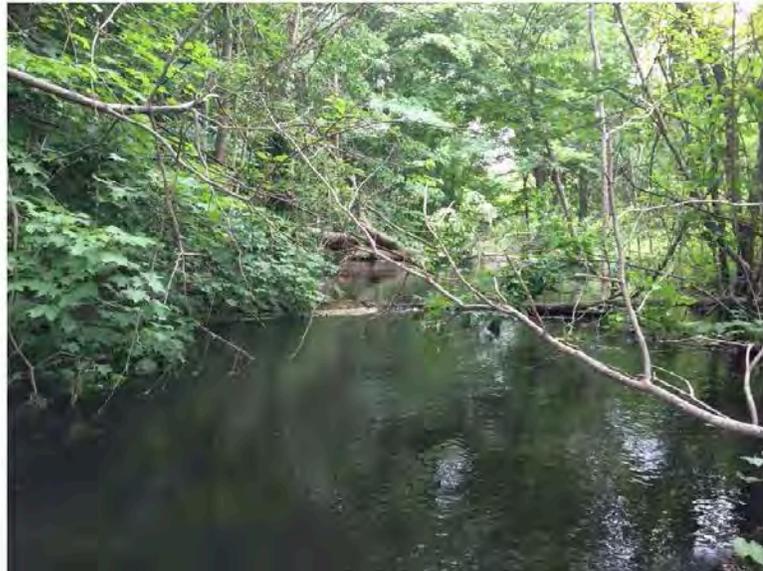
Photo 70. View upstream of site #47

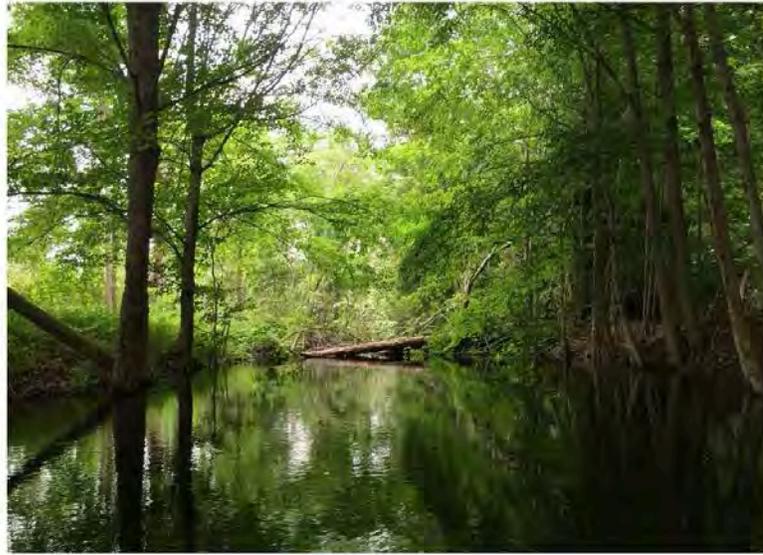
Photo 71. View downstream of site #48

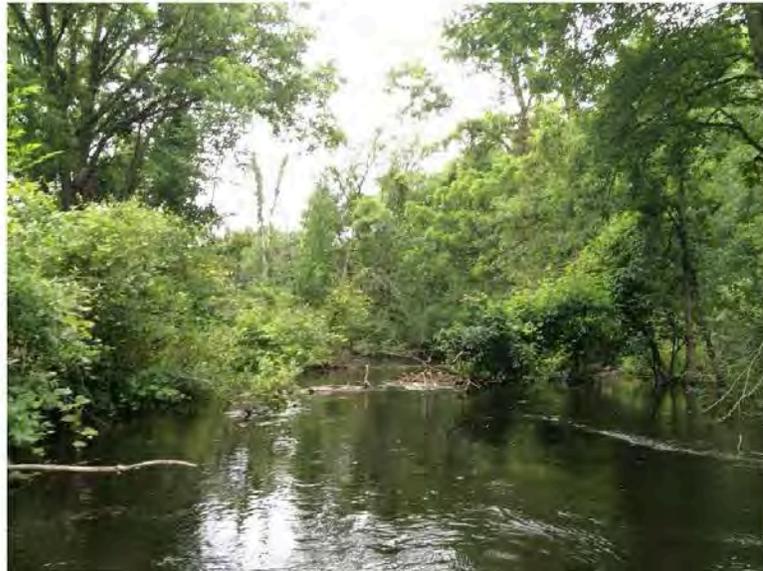
Photo 72. View downstream from site #49

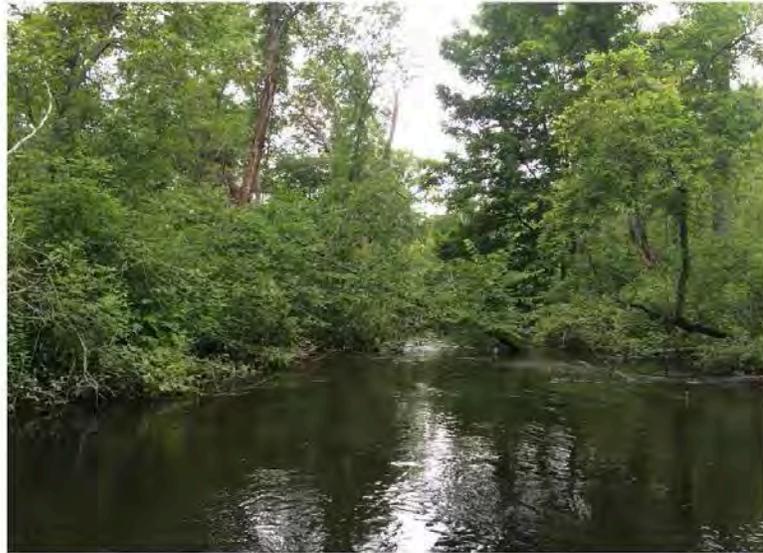
Photo 73. View downstream of site #50

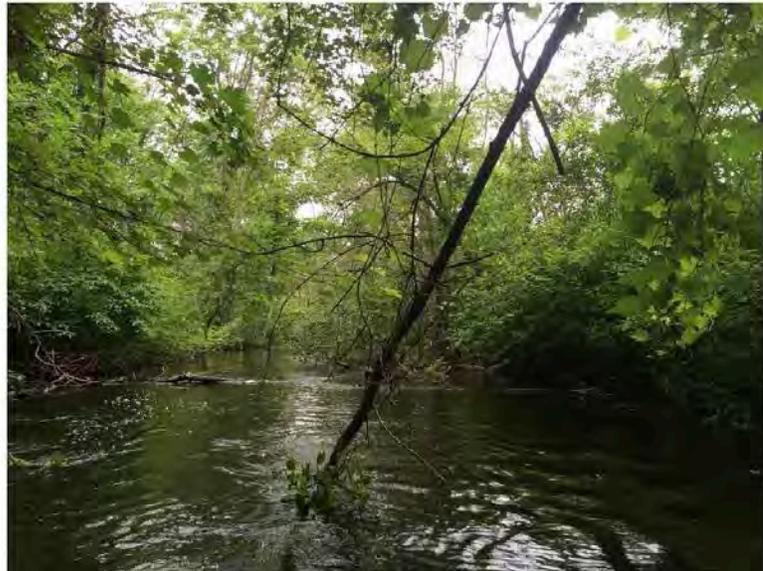
Photo 74. View upstream from site #51

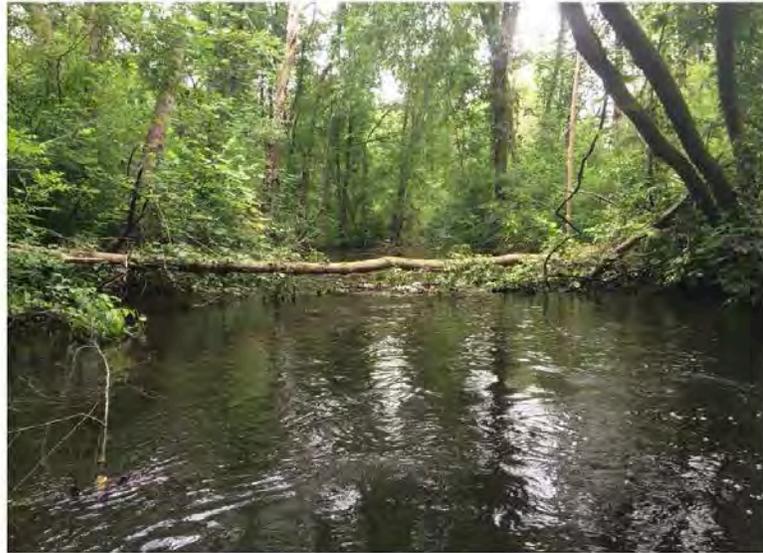
Photo 75. View downstream from site #52

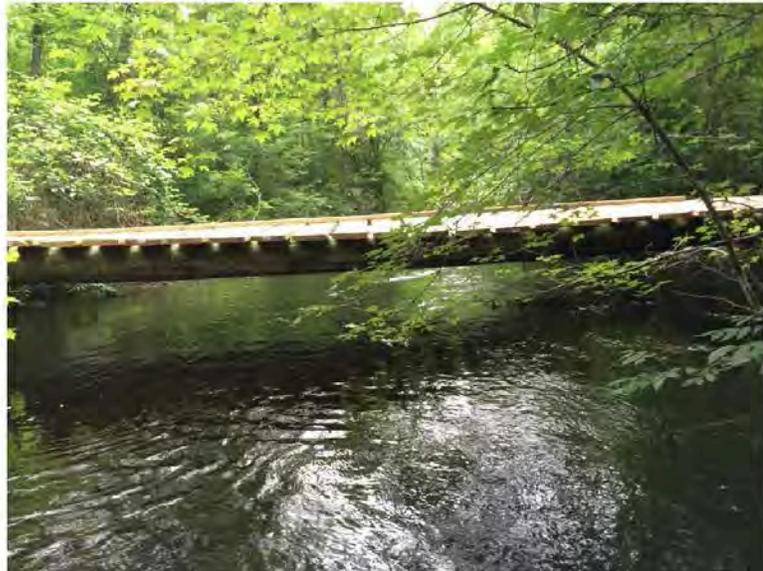
Photo 76. View downstream from site #53

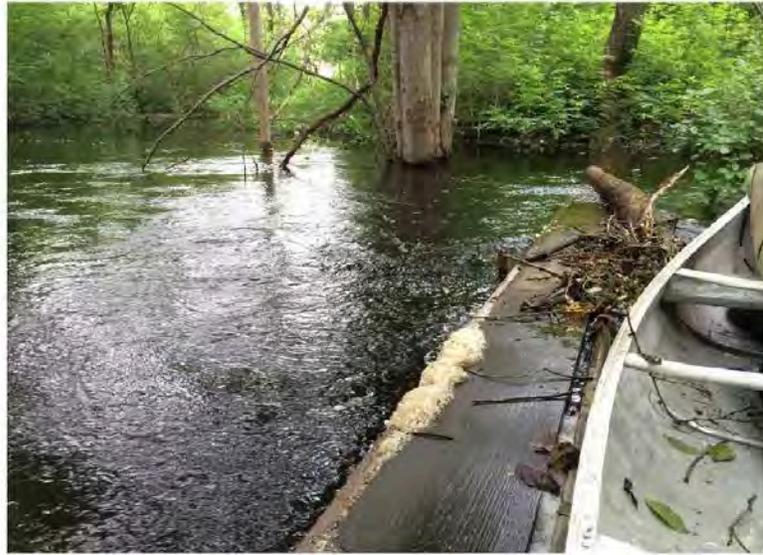
Photo 77. View upstream from site #54

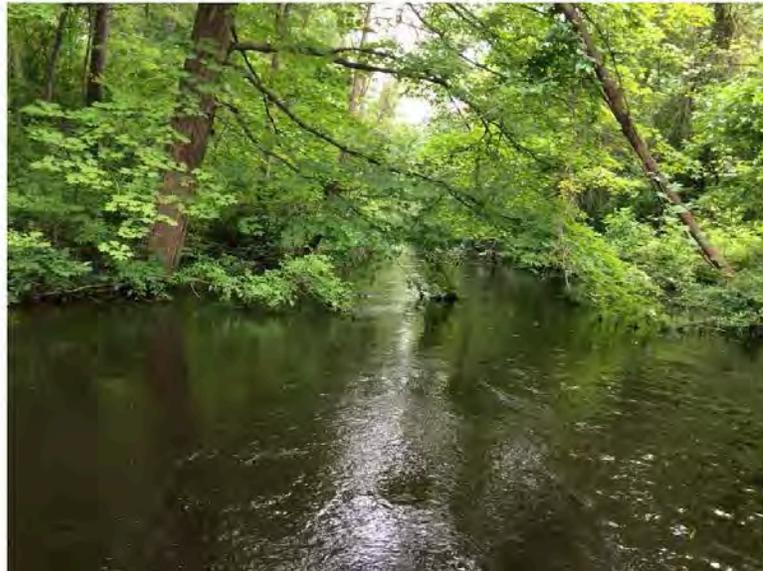
Photo 78. View downstream from site #55

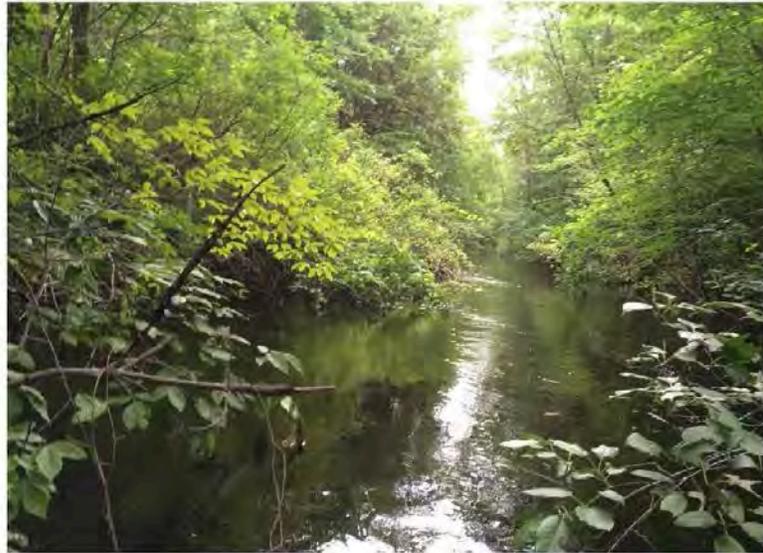
Photo 79. View upstream from site #55

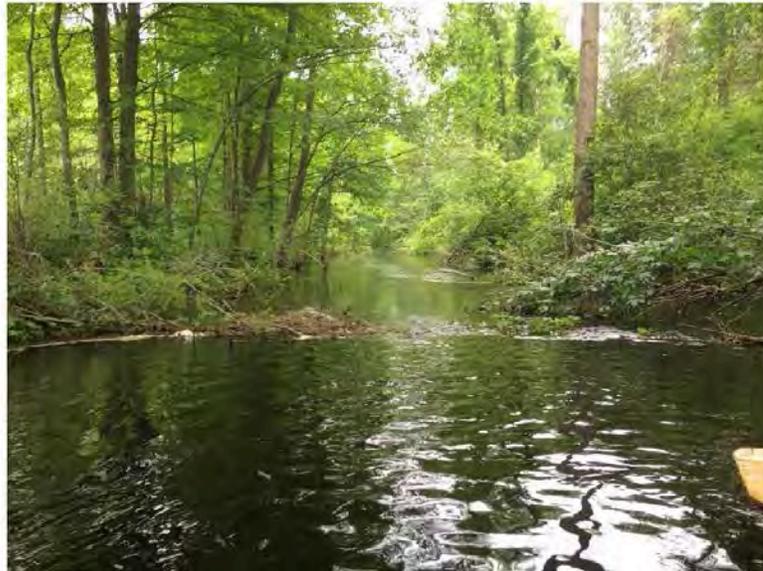
Photo 80. View downstream from site #56

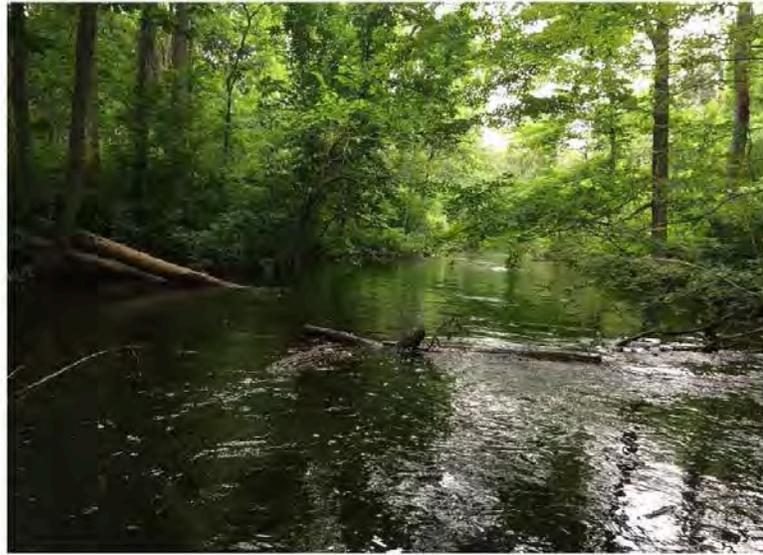
Site No. #	Bank or Channel	Description	Cubic Yards	Recommendations	Priority	Field Photographs	
57	LDB RDB MC	Large woody debris, consisting of submerged logs, obstructing natural flow; approximately 75 LF	2	Relocate to LDB/RDB	M	82 - View u/s	
58	LDB RDB MC	Large woody debris and vines obstructing natural flow; approximately 50 LF	1	Remove if small - Relocate larger LWD RDB or LDB	H	83 - View d/s	
Photograph Point E		Photograph Point E - Gravel sand bottom substrates, 5-6 foot water depths					84 - View u/s 85 - View d/s
59	LDB RDB MC	Large woody debris obstructing natural flow	1/4	Relocate to LDB/RDB	H	86 - View u/s	
60	LDB RDB MC	Large woody debris and vines obstructing natural flow	1/2	Relocate to LDB/RDB	M	87 - View d/s	
61	LDB RDB MC	Large woody debris obstructing natural flow	1/2	Relocate to LDB/RDB	M	88 - View d/s	
62	LDB RDB MC	Large woody debris and shrubs obstructing natural flow	1/2	Relocate to LDB/RDB	M	89 - View d/s

Photo 81. View upstream from site #57

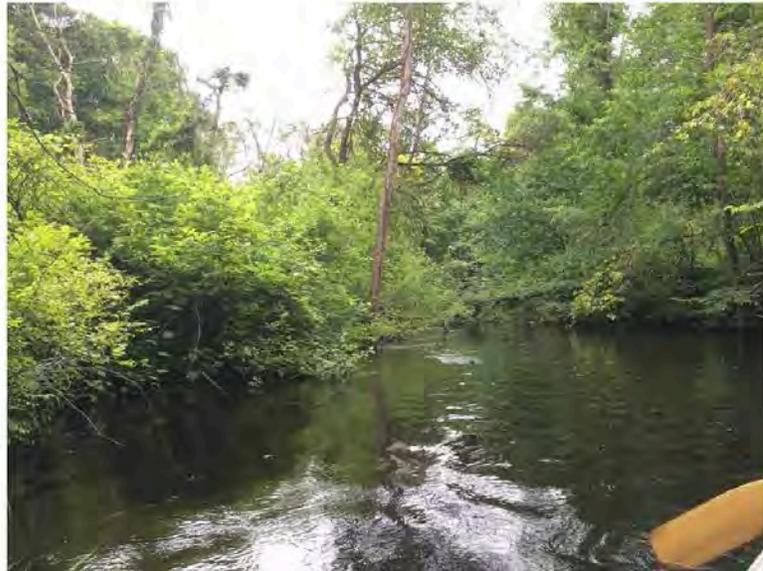
Photo 82. View downstream from site #58

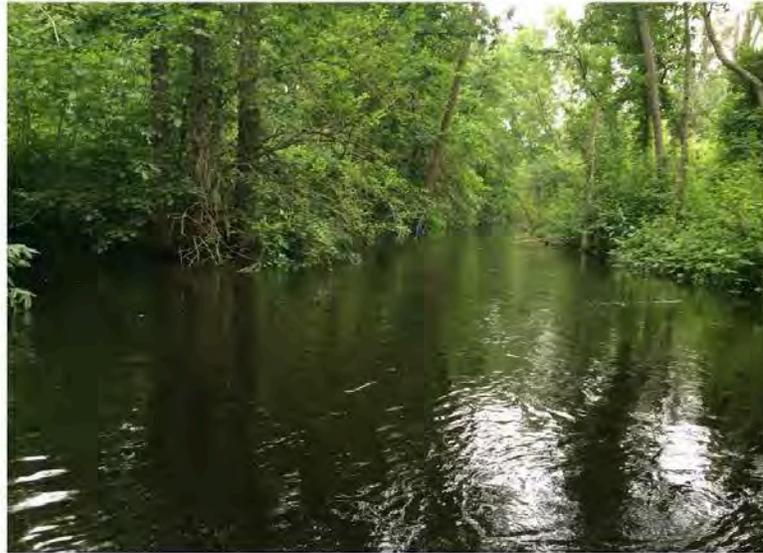
Photo 83. View upstream of Photograph Point E

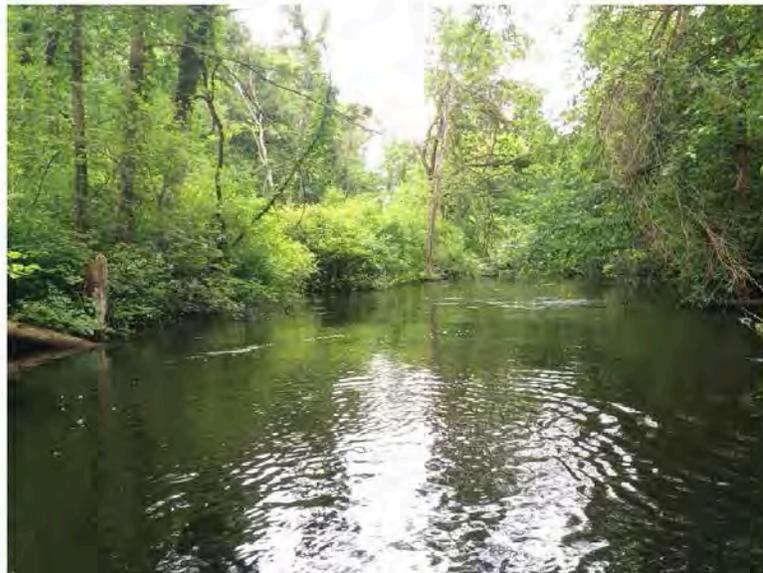
Photo 84. View downstream of Photograph Point E

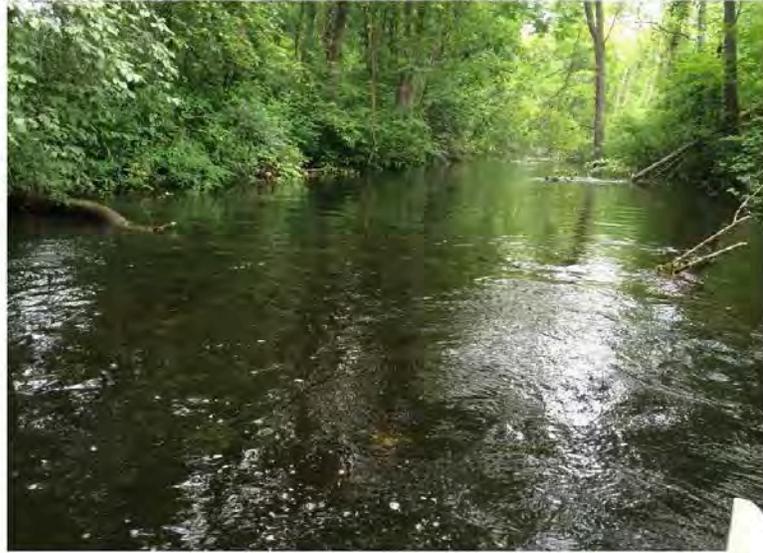
Photo 85. View upstream of site #59

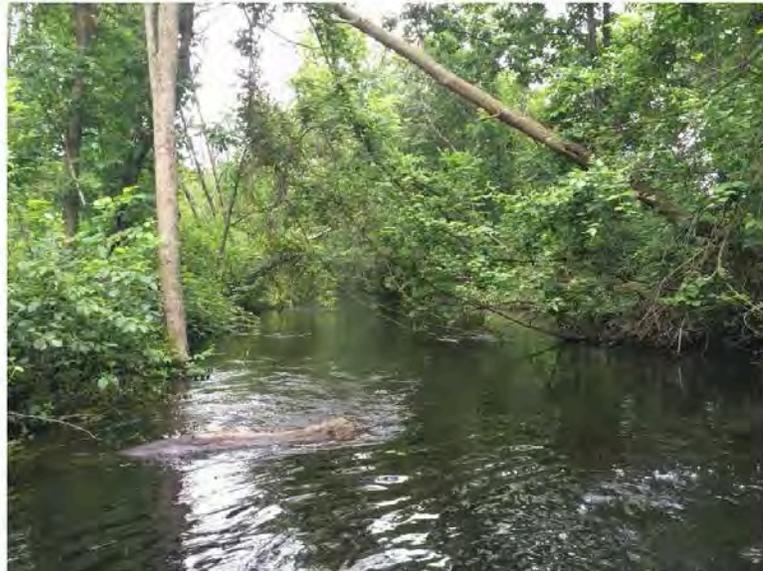
Photo 86. View downstream of site #60

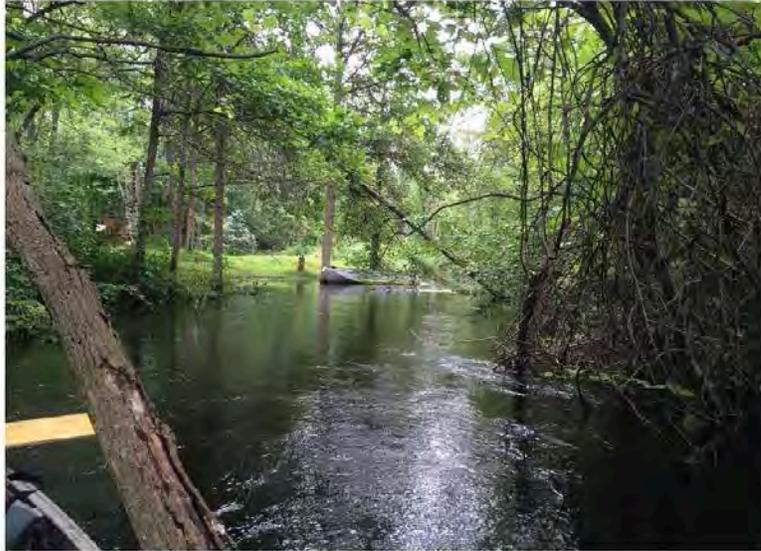
Photo 87. View downstream of site #61

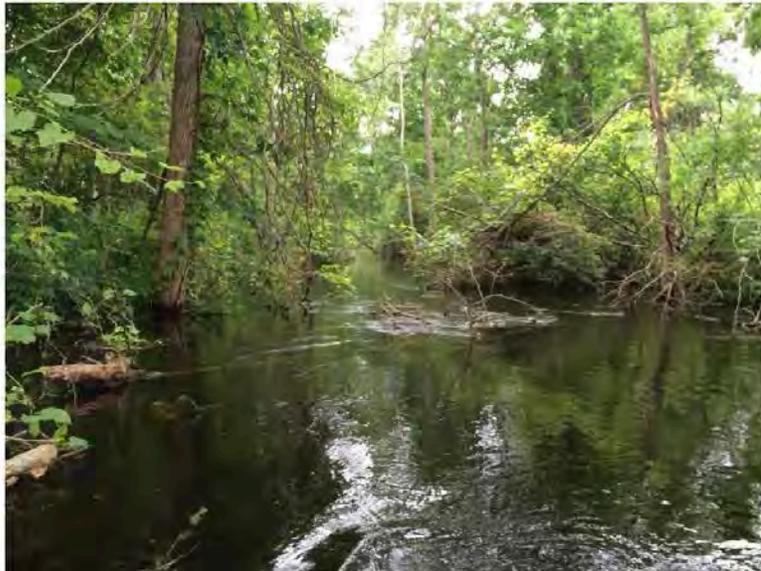
Photo 88. View downstream of site #62

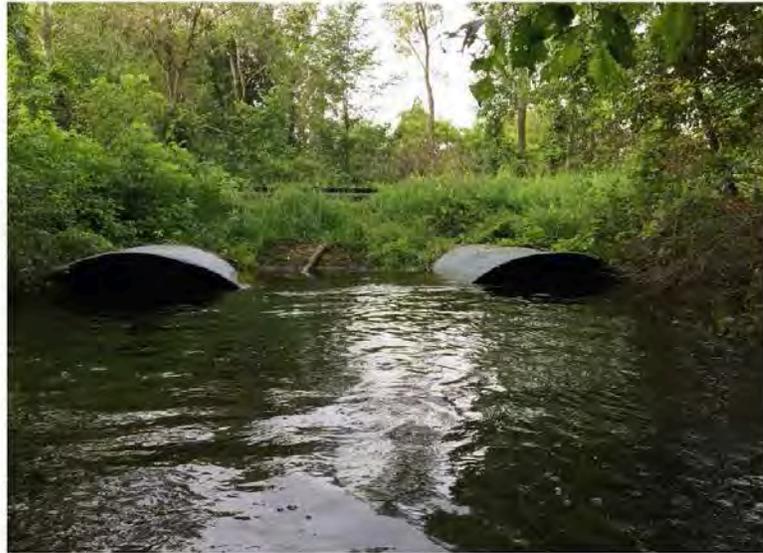
63	MC	L Drive Road Crossing - Two elliptical culverts; upstream end of west culvert: 5'10" water depth, ~3'10" sediment depth, 14" space between top of culvert and water surface; upstream end of east culvert: 4'8" water depth, 3' sediment depth, 16" space between top of culvert and water surface; showing no apparent signs of erosion around the upstream or downstream ends; no action recommended.		Stable. No action recommended	NA	80 - View u/s 81 - View d/s 92 - View u/s	
64	MC	Large woody debris, consisting of submerged logs, obstructing natural flow	1/2	Relocate to LDB/RDB	H	93 - View u/s	
65	MC	Large woody debris, consisting of overhanging trees, shrubs, branches, and vines, obstructing natural flow		Cut back and remove overhanging trees, shrubs, branches, and vines from mid channel	M	94 - View u/s

Photo 89. View upstream of site #63

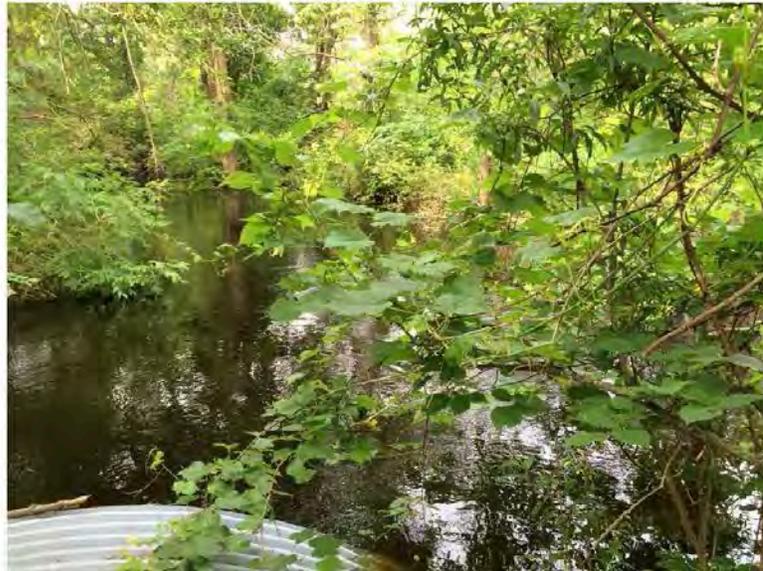
Photo 90. View downstream from site #63

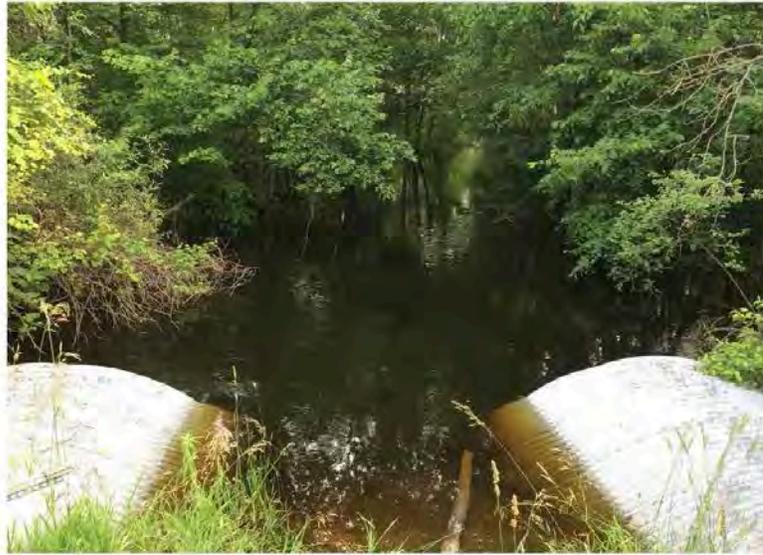
Photo 91. View upstream of site #63

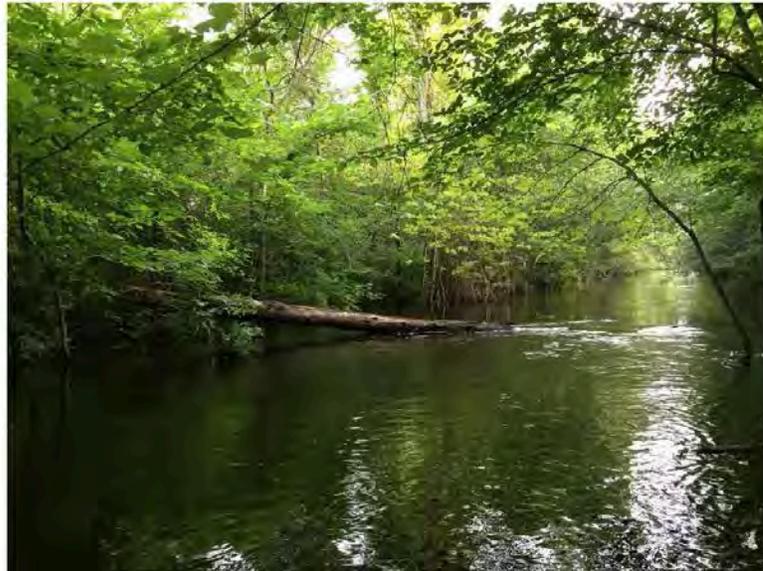
Photo 92. View upstream of site #64

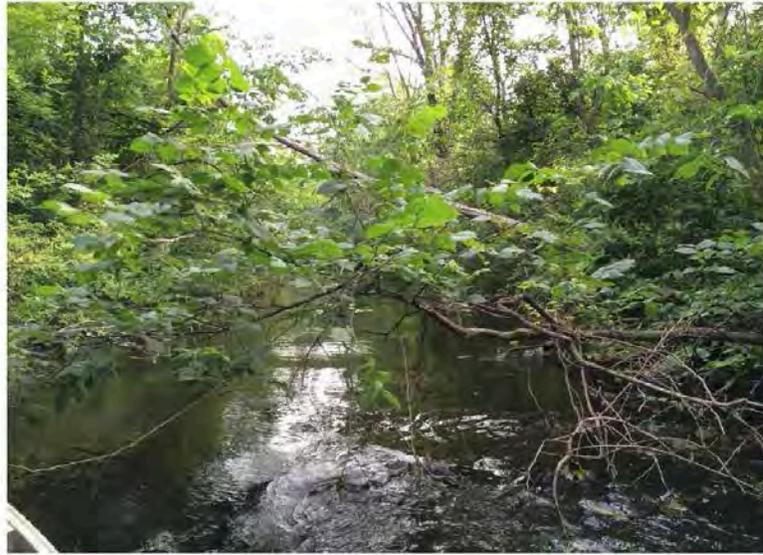
Photo 93. View upstream of site #65

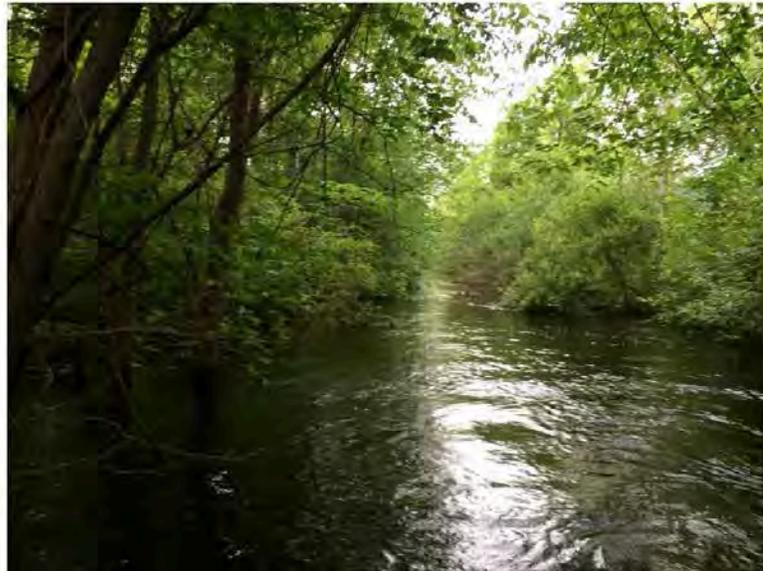
65.5		Photograph Point F - Open reach of drain showing no apparent signs of obstruction to flow or erosion; mid channel approximately 5 ft. deep; center of drain channel is gravel; no action recommended					95 - View d/s 96 - View u/s
66	MC	Large woody debris, consisting of overhanging branches, obstructing natural flow	1/4	Cut back and remove overhanging branches from mid channel	L	97 - View u/s	
67	LDB RDB MC	Large woody debris, consisting of submerged logs and overhanging trees and branches, obstructing natural flow; approximately 250 LF	3 to 5	Relocate to LDB/RDB	H	98 - View u/s 99 - View d/s	
68	LDB RDB MC	Large woody debris, consisting of submerged logs and overhanging branches, obstructing natural flow and catching pondweeds; approximately 100 LF	1	Relocate to RDB	M	100 - View u/s	
69	LDB RDB MC	Large woody debris, consisting of submerged logs and overhanging branches, obstructing natural flow and catching pondweeds; approximately 200 LF	1 - 1/2	Relocate to RDB	H	101 - View d/s

Photo 94. View downstream of Photograph Point F

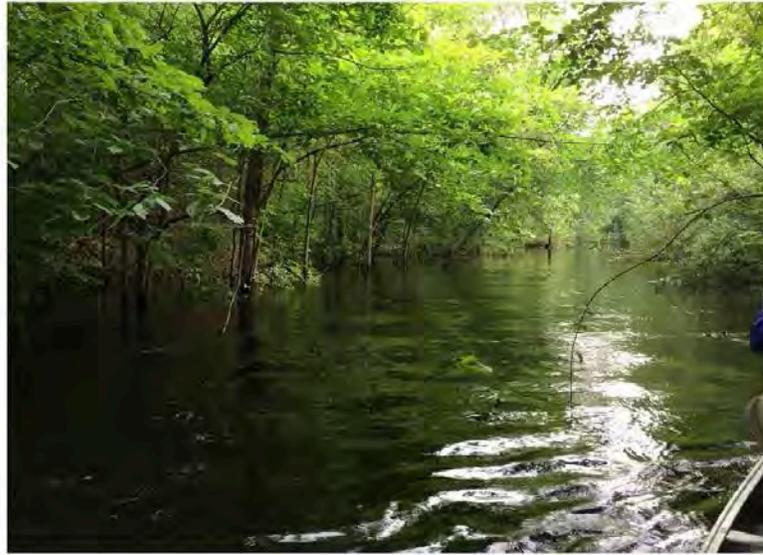
Photo 95. View upstream of Photograph Point F

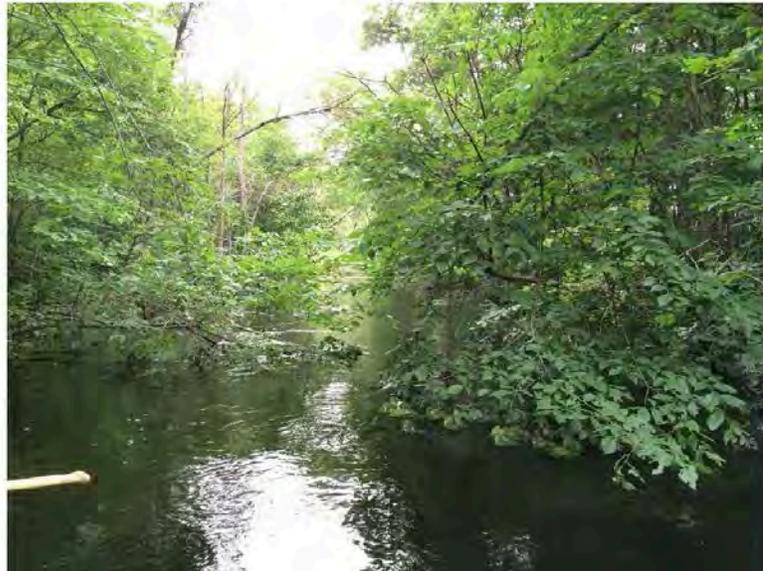
Photo 96. View upstream of site #66

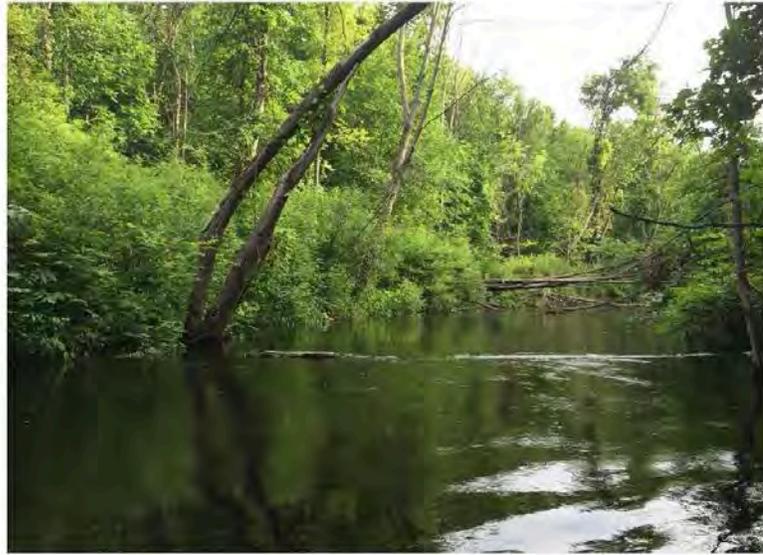
Photo 97. view upstream of site #67

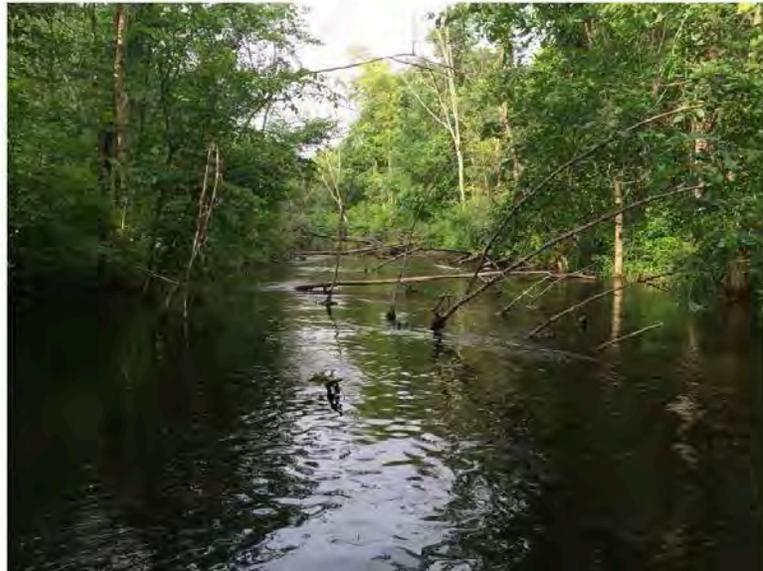
Photo 98. View downstream of site #67

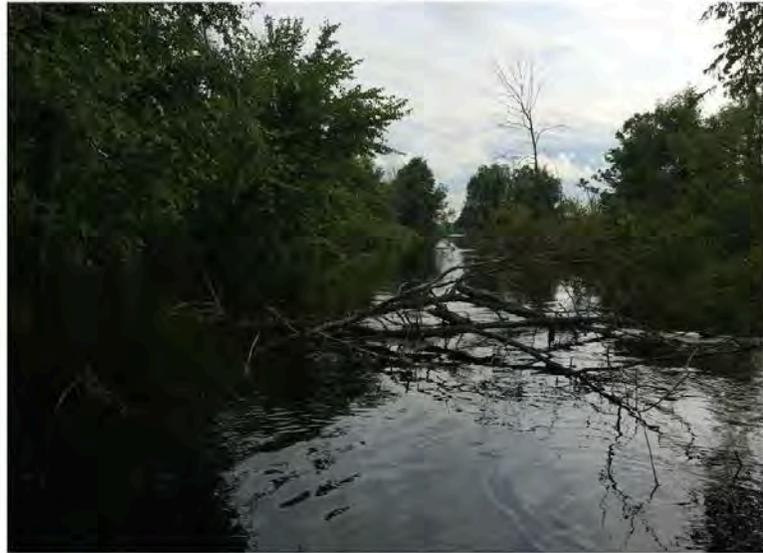
Photo 99. View upstream of site #68

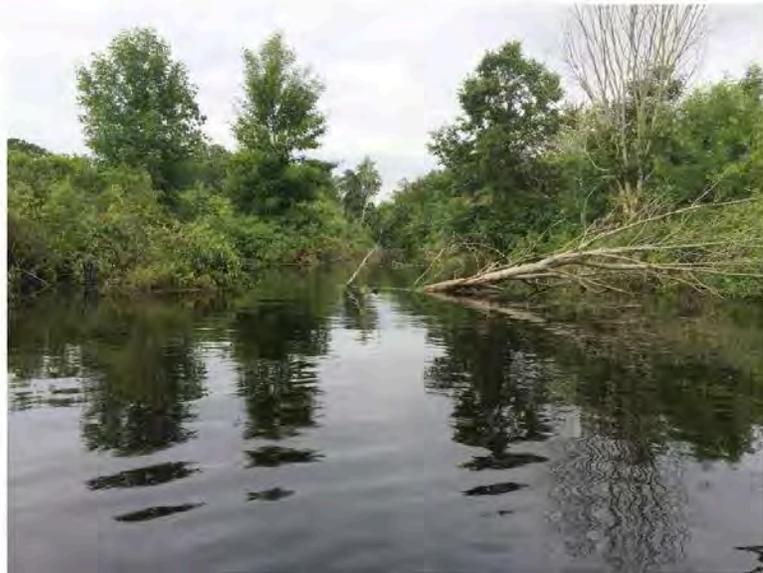
Photo 100. View downstream of site #69

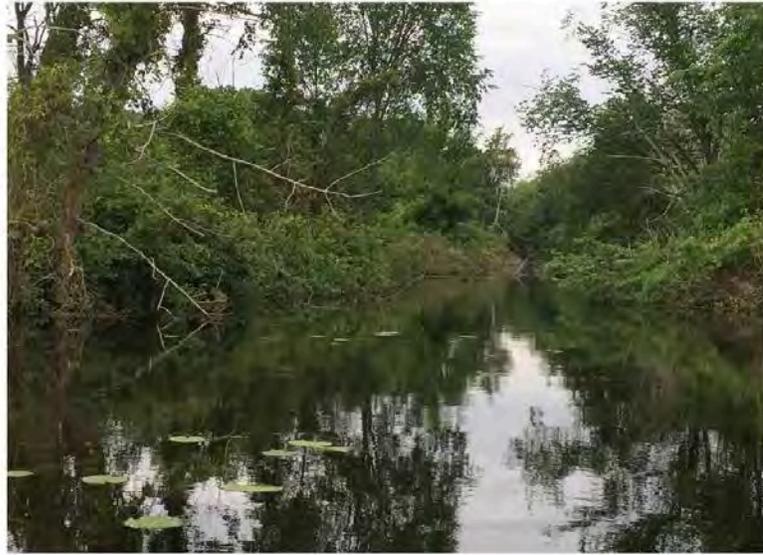
Photo 101. View downstream of Photograph Point G

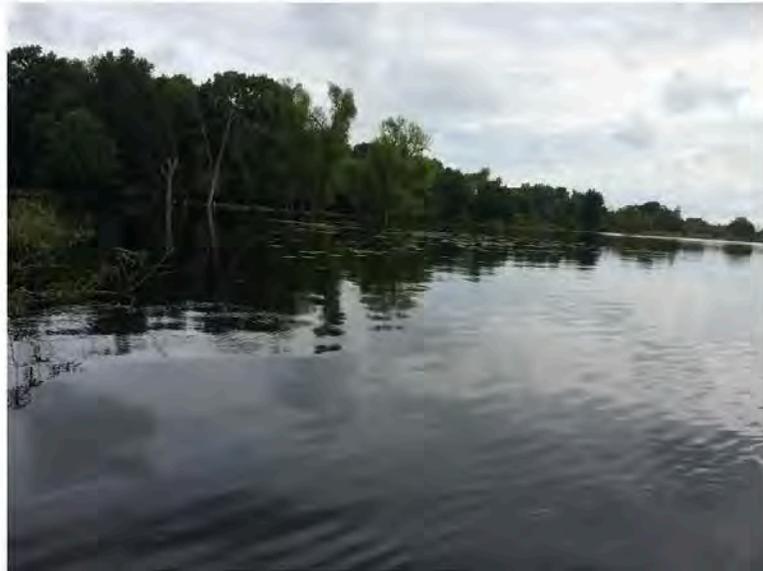
Photo 102. View of Prairie Lake

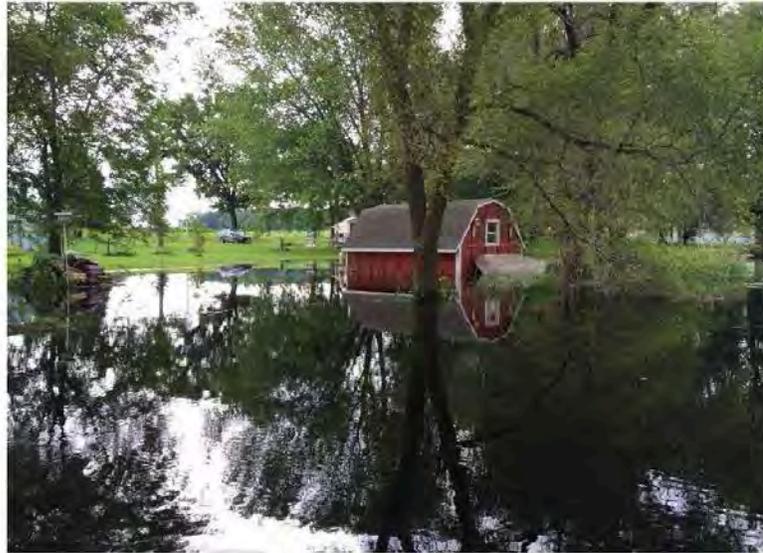
Photo 103. View upstream of Photograph Point H

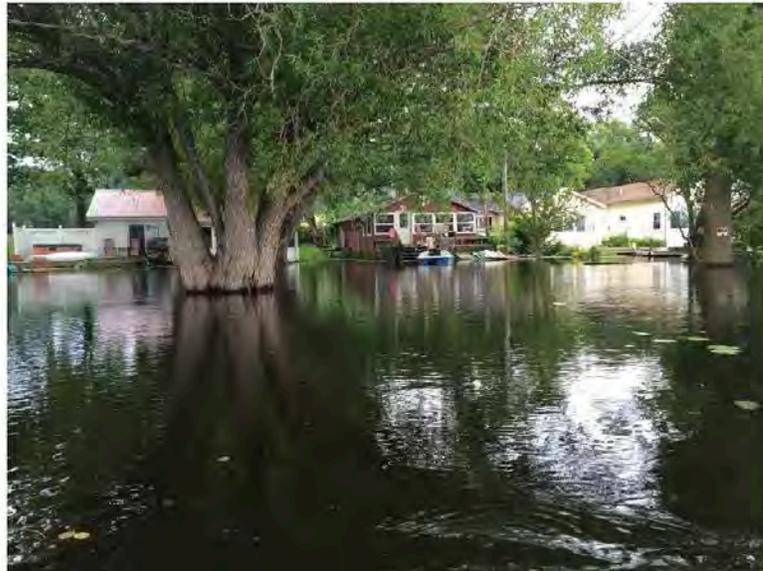
Photo 104. View downstream of Photograph Point H

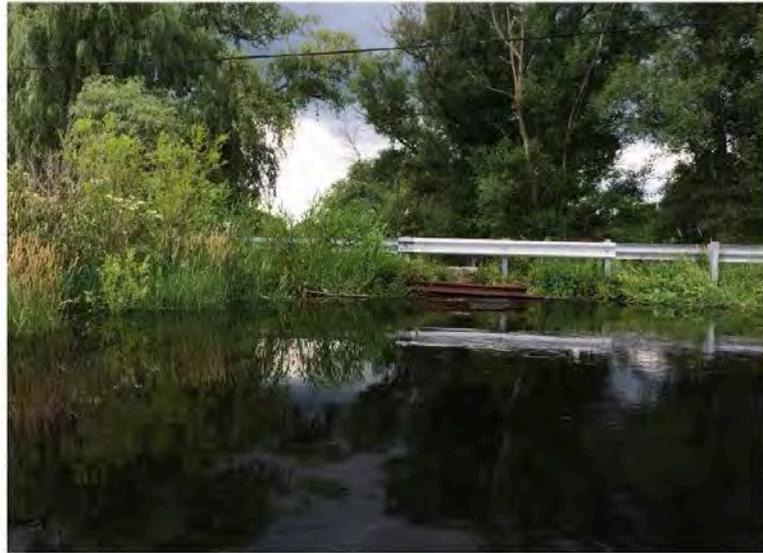
Photo 105. View downstream of site #70

- At 26 ½ Road (Site 70) the existing culvert was completely full of water and was forming a whirlpool affect at the upstream end.
 - Upstream of 27 Road the drain channel was approximately 30 feet wide however there was only a 9 foot wide culvert under the roadway to pass the flow of the drain (Site 84, photographs 125 and 126 of Appendix B).
