Gang of Lakes Intercounty Drain Assessment Report

Calhoun and Jackson Counties, Michigan

August 19, 2015

GEI Project No. 1509010

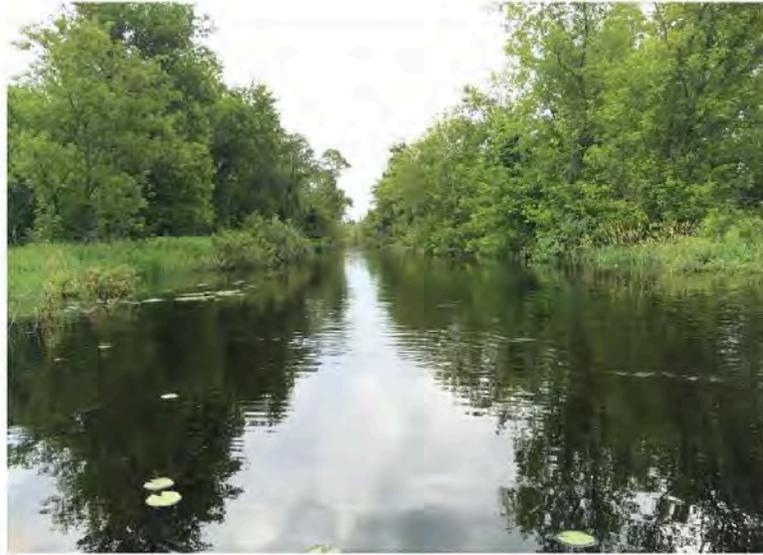
Photo 109. View upstream of Photograph Point I

71.5		Photograph Point I - Open reach of drain acting as a depositional area above 26 mile road; showing no apparent signs of obstruction to flow or erosion; mid channel approximately 7 ft. deep; center of drain channel is silt; no action recommended					110 - View u/s 111 - View d/s
72	MC	Large woody debris, consisting of overhanging branches and shrubs, obstructing natural flow	1/2	Relocate to LDB	M-H	112 - View d/s	
73	LDB	Large woody debris, consisting of overhanging trees and branches, obstructing natural flow; approximately 50 LF	1	Relocate to LDB	H	113 - View u/s	
74		Large woody debris, consisting of overhanging trees, obstructing natural flow and catching pondweeds	1/2	Relocate to LDB	H	114 - View d/s	
75		Large woody debris, consisting of overhanging trees and branches, obstructing natural flow and catching pondweeds	1	Relocate to LDB	H	115 - View d/s	
76		Large woody debris, consisting of overhanging branches, obstructing natural flow and catching pondweeds; apparent tributary/drain entering along RDB	1/2	Relocate to LDB - HSB	H	116 - View u/s

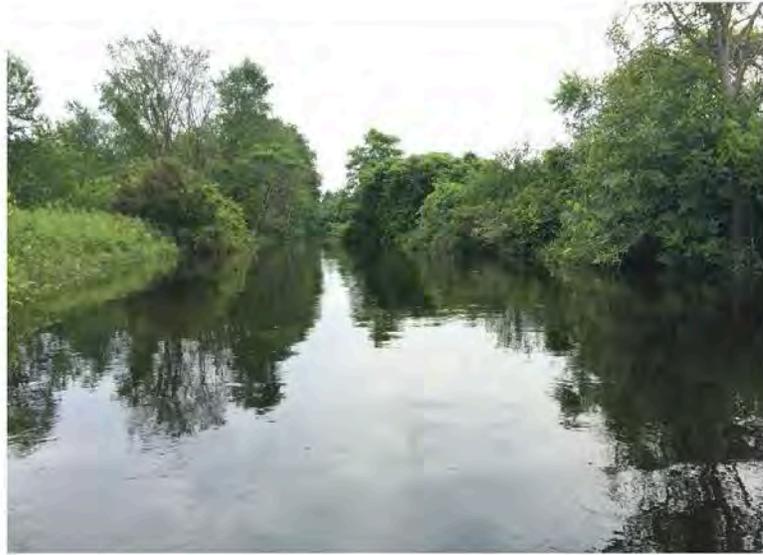
Photo 121. View upstream of Photograph Point J

81.5		Photograph Point J - Open reach of drain showing no apparent signs of obstruction to flow or erosion; mid channel approximately 6.5 ft. deep; center of drain channel is silt; no action recommended					122 - View u/s 123 - View d/s
82	MC	Large woody debris, consisting of overhanging trees and vines, obstructing natural flow	1/4	Remove to upland (too small)	M	124 - View d/s	
83	LDB	Large woody debris, consisting of overhanging branches, obstructing natural flow	1/4	Remove to upland (too small)	M	125 - View d/s	
84	MC	27 Road Crossing - 9' CMP; upstream end of culvert: 6'2" water depth, ~2' sediment depth, 10" space between top of culvert and water surface; downstream end of culvert: 5'6" water depth, ~3' sediment depth, 6" space between top of culvert and water surface; showing no apparent signs of erosion around the upstream or downstream ends; no action recommended			NA	126 - View d/s 127 - View u/s

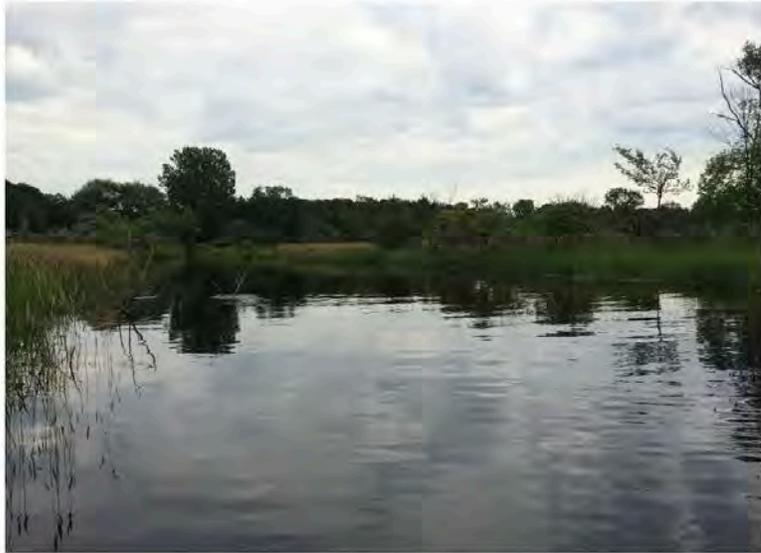
Photo 133. View upstream of Photograph Point K

90.5		Photograph Point K - Open reach of drain acting as a depositional area; showing no apparent signs of obstruction to flow or erosion; mid channel approximately 5 ft. deep; center of drain channel is silt and detrital material; no action recommended					134 - View u/s 135 - View d/s
91		Large woody debris, consisting of submerged logs and overhanging branches, obstructing natural flow	2	Relocate to LDB	H	136 - View d/s

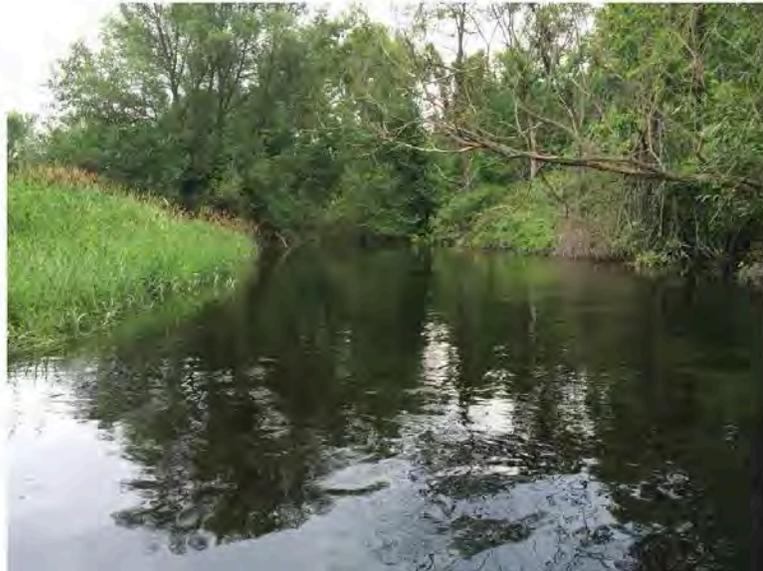
Photo 136. View upstream of Photograph Point L

91.5		Photograph Point L - Open reach of drain showing no apparent signs of obstruction to flow or erosion; mid channel approximately 5.5 ft. deep; center of drain channel is sand and gravel; historic spoil berm present on the RDB; no action recommended					137 - View u/s 138 - View d/s
92		Large woody debris, consisting of overhanging trees and vines, obstructing natural flow	1/2	Relocate to RDB	H	139 - View d/s	
93		Large woody debris, consisting of submerged logs and overhanging shrubs and vines, obstructing natural flow	1/2	Remove to upland (too small)	H	140 - View d/s	
94		Large woody debris, consisting of submerged logs and overhanging vines, obstructing natural flow	1/2	Remove to upland (too small)	H	141 - View d/s	
95		Large woody debris, consisting of submerged logs and overhanging shrubs and vines, obstructing natural flow	1/4	Remove to upland (too small)	H	142 - View d/s

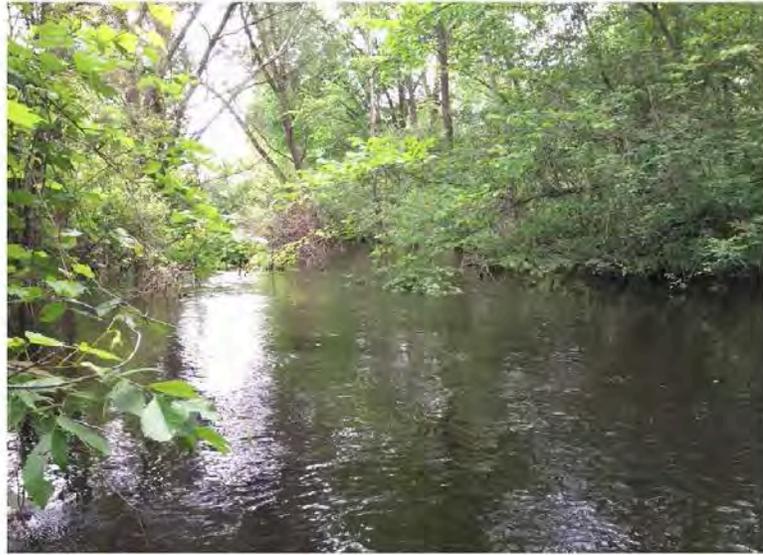
Photo 143. View upstream of Photograph Point M

97.5		Photograph Point M - Open reach of drain showing no apparent signs of obstruction to flow or erosion; mid channel approximately 5.5 ft. deep; center of drain channel is sand; trees and shrubs along RDB and LDB; no action recommended					145 - View u/s 146 - View d/s
98		Large woody debris obstructing natural flow	1/4	Relocate to RDB	H	147 - View u/s	
99		Large woody debris obstructing natural flow	1/2	Relocate to RDB	H	148 - View d/s	
100	MC	28 Road Crossing; 72" CMP (maybe elliptical)		Stable - No action recommended	NA	149 - View u/s from d/s end of crossing	
101	MC	Large woody debris, consisting of overhanging branches and vines, obstructing natural flow	1/4	Remove to upland (too small)	M	150 - View d/s	
102	MC	Large woody debris, consisting of submerged logs, obstructing natural flow; approximately 30 LF	1 1/2	Remove to upland (too small)	M	151 - View d/s	
103	LDB RDB MC	Large woody debris, consisting of overhanging shrubs, obstructing natural flow and catching pondweeds; approximately 200 LF	1	Remove to upland (too small)	M	152 - View d/s

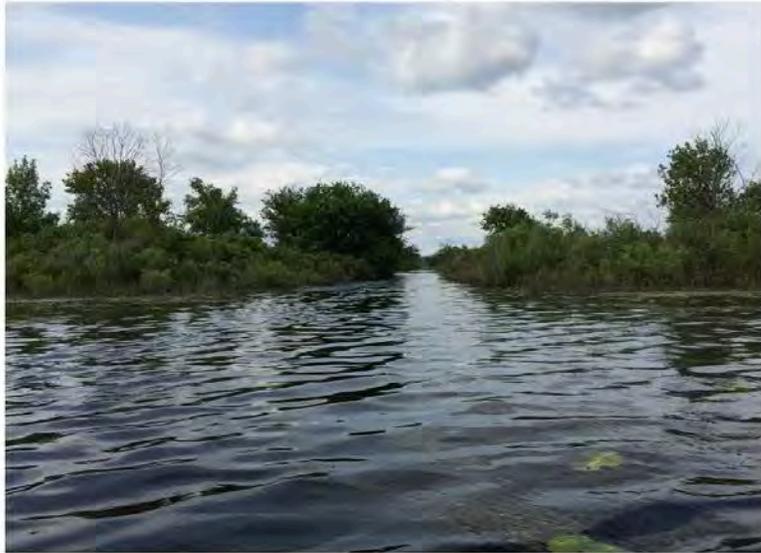
Photo 155. View of drain outlet into Bell Lake, Photograph Point O

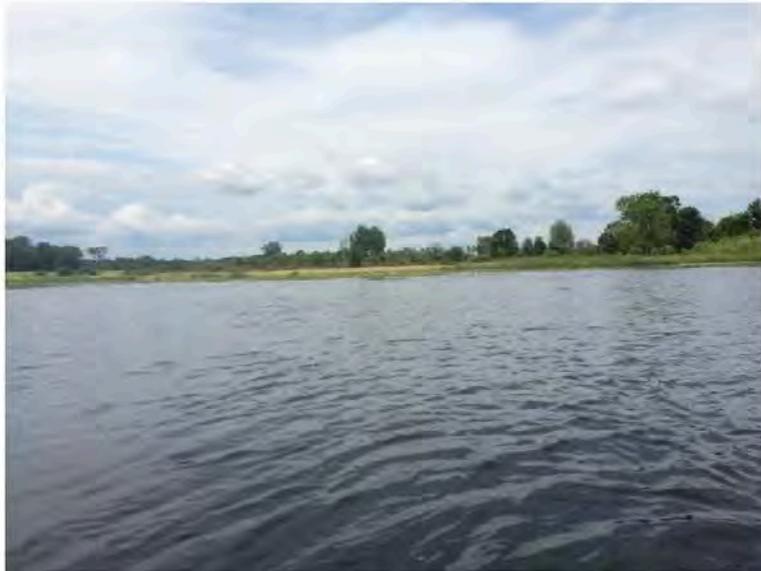
Photo 156. View of north end of Bell Lake, Photograph Point O

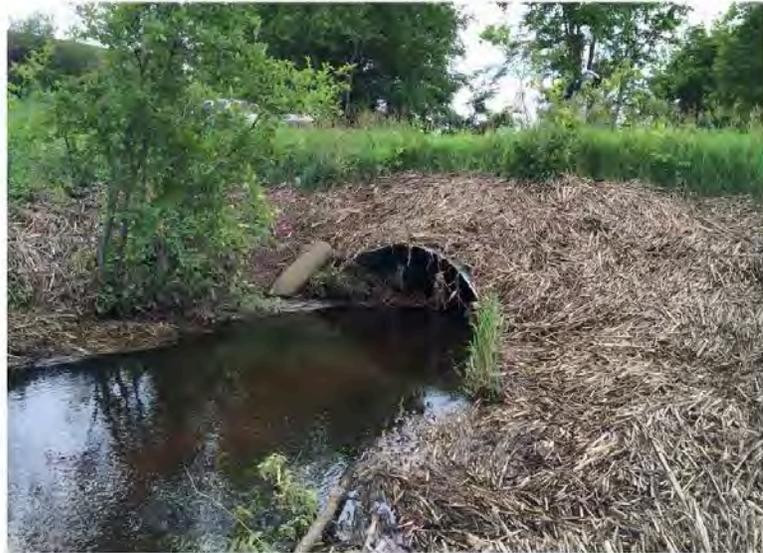
Photo 173. View upstream of site #112

Site No. #	Bank or Channel	Description	Cubic Yards	Recommendations	Priority	Field Photographs
112	MC	29 1/2 Road Crossing - 80' RCP culvert; upstream end of culvert: 48" water depth, 0 sediment depth, 32" space between top of culvert and water surface; downstream end of culvert: 2'3" water depth, 0 sediment depth, 2'7" space between top of culvert and water surface; showing no apparent signs of erosion around the upstream or downstream ends; no action recommended		Check hydraulics of crossing	NA	175 - View u/s 176 - View u/s 177 - View d/s 178 - View d/s
113	LDB RDB MC	Large woody debris obstructing natural flow and catching material (i.e. corn stalks)	1/4	Remove to upland (too small)	H	179 - View u/s
114	RDB MC	Large woody debris obstructing natural flow	1/2	Remove to upland (if too small); Relocate to LDB	M	180 - View u/s
115	LDB RDB MC	Large woody debris, consisting of overhanging shrubs and vines, obstructing natural flow	1/4	Remove and cut back vegetation from mid channel	M	181 - View u/s

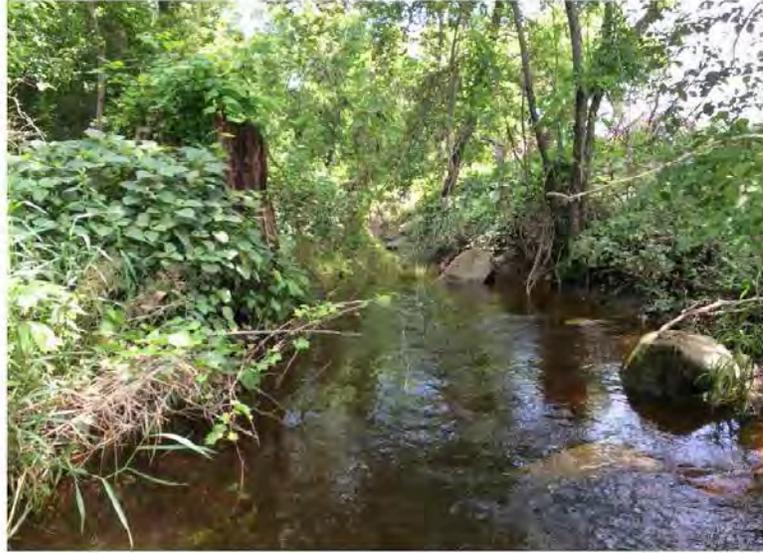
Photo 187. View upstream of Photograph Point T

Photograph Point T		Photograph Point T - Open reach of drain showing no apparent signs of obstruction to flow or erosion; mid channel approximately 15" deep; 12 to 13' stream width; center of drain channel is cobble, gravel, and sand (10%,40%,50% respectively); no action recommended				189 - View u/s 190 - View d/s
121	LDB RDB MC	Large woody debris obstructing natural flow and catching pondweeds	10	Relocate to RDB	H	191 - View u/s 192 - View u/s 193 - View d/s
122	LDB RDB MC	Large woody debris, consisting of overhanging shrubs, obstructing natural flow; approximately 100 LF	1/2	Remove to upland	L-M	194 - View u/s
123	MC	Wooden pallets dumped into the drain are obstructing natural flow	42038	Remove to upland	H	195 - View across reach
124	LDB RDB MC	Large woody debris, consisting of overhanging trees and branches, obstructing natural flow		Remove small debris - Relocate medium to large LWD to RDB	H	196 - View u/s 197 - View u/s

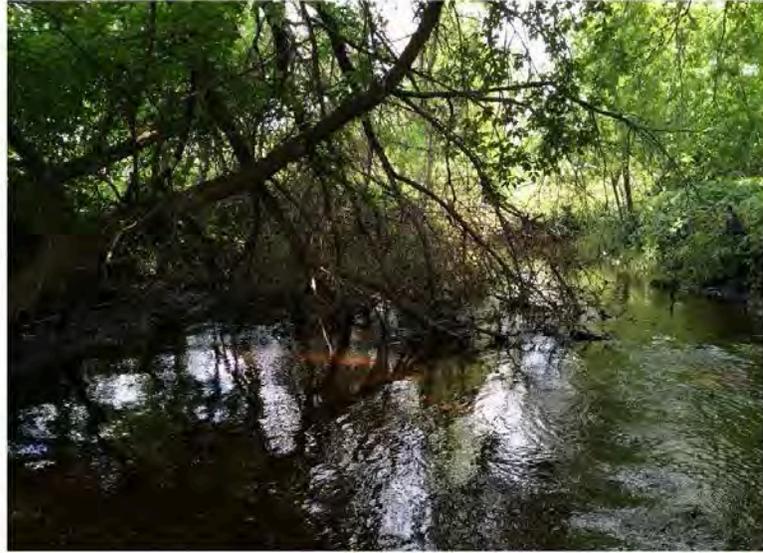
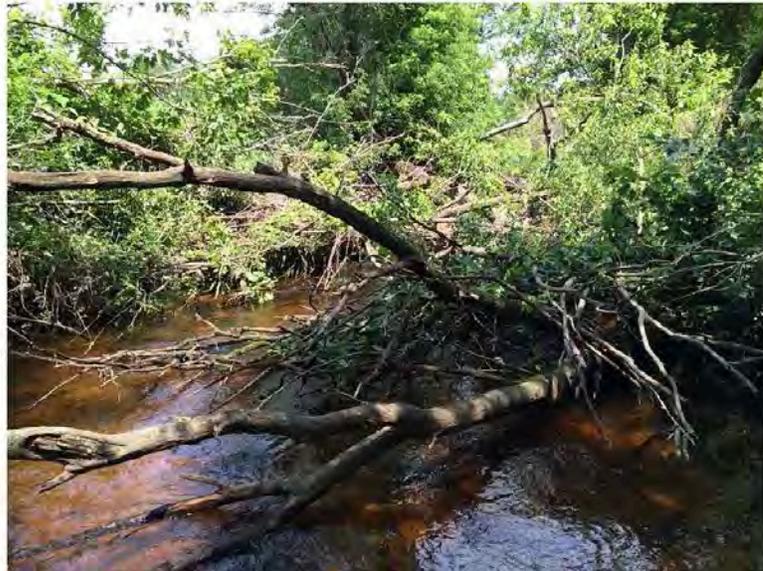
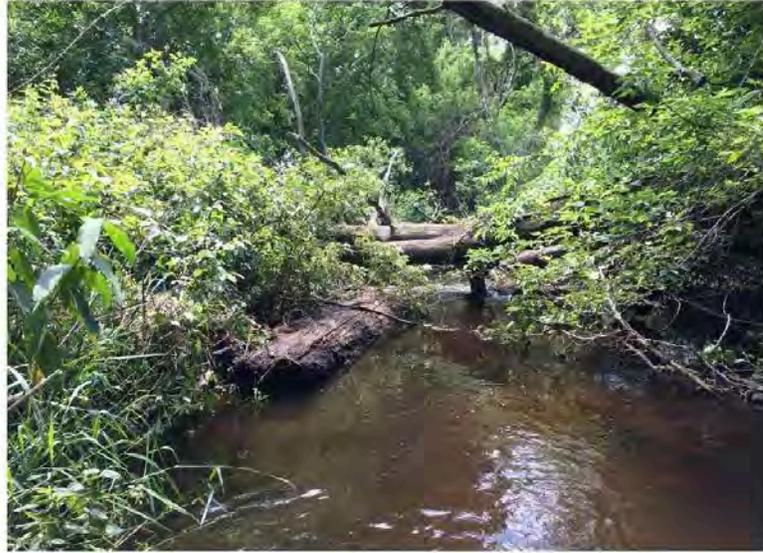
Photo 189. View upstream of site #121

Photo 190. View upstream of site #121

Photo 191. View downstream of site #121

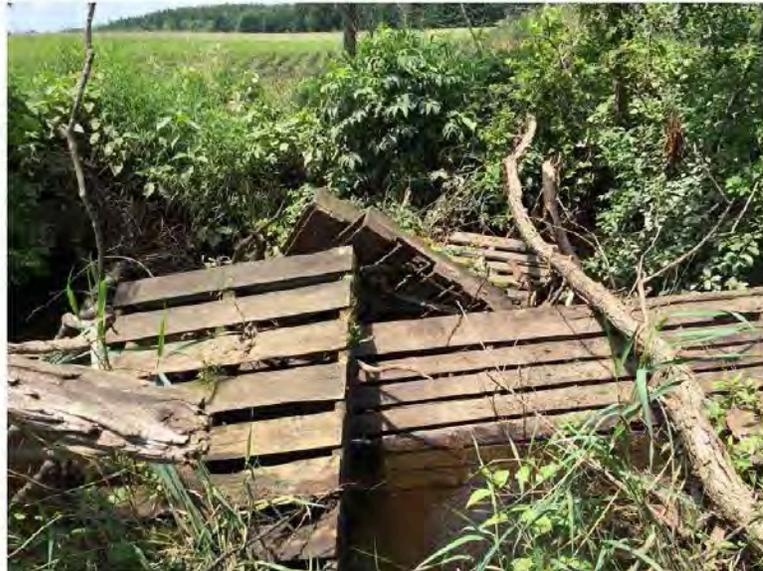
Photo 192. view of wooden pallets on site #123

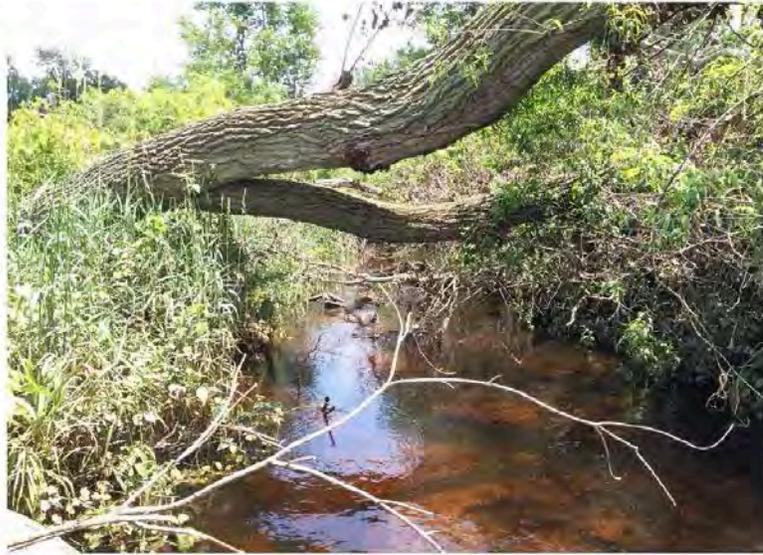
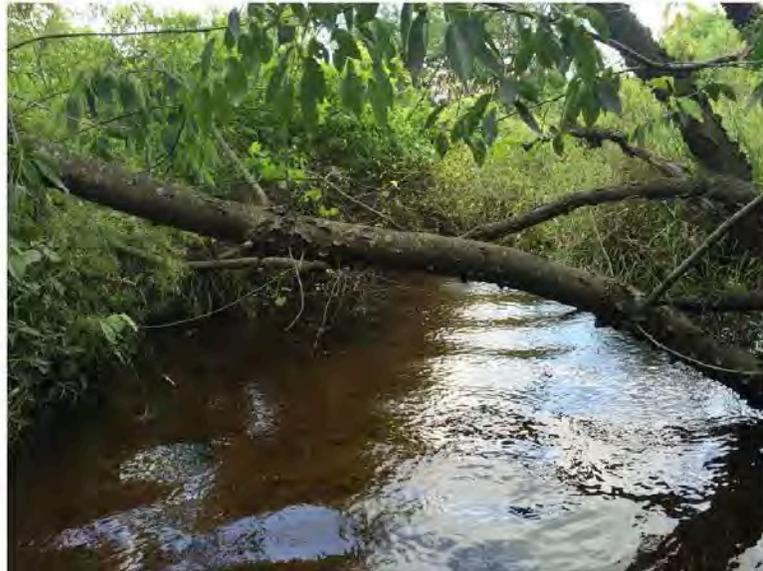
Photo 193. View upstream of site #124

Photo 194. View upstream of site #124

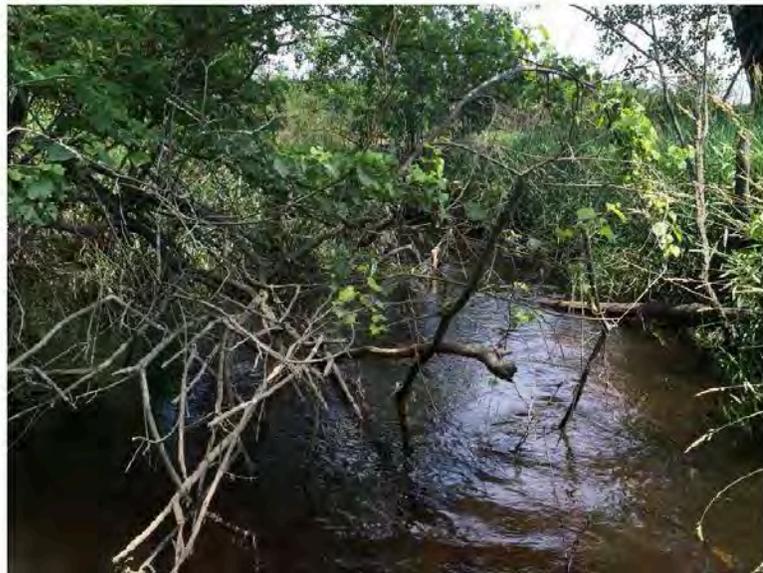
Photo 202. View upstream of site #128

Site No. #	Bank or Channel	Description	Cubic Yards	Recommendations	Priority	Field Photographs
128	LDB RDB MC	Large woody debris, consisting of submerged branches, obstructing natural flow	1 to 2	Relocate to LDB/RDB	H	205 - View u/s 206 - View d/s
Photograph Pointe V	Photograph Point V - Open reach of drain dominated by reed canary grass; mid channel contains overhanging shrubs; no action recommended					207 - View d/s 208 - View u/s
129	LDB RDB MC	Large woody debris, consisting of overhanging shrubs, obstructing natural flow	5	Remove to upland	H	209 - View u/s
130	LDB RDB MC	Large woody debris obstructing natural flow	5	Remove and cut back vegetation from mid channel	H	210 - View d/s
131	LDB RDB MC	Large woody debris, consisting of overhanging shrubs, obstructing natural flow		Remove and cut back vegetation from mid channel	M	211 - View u/s
132	LDB RDB	Large woody debris, consisting of overhanging shrubs, obstructing natural flow		Remove and cut back vegetation from mid channel	H	212 - View u/s 213 - View d/s

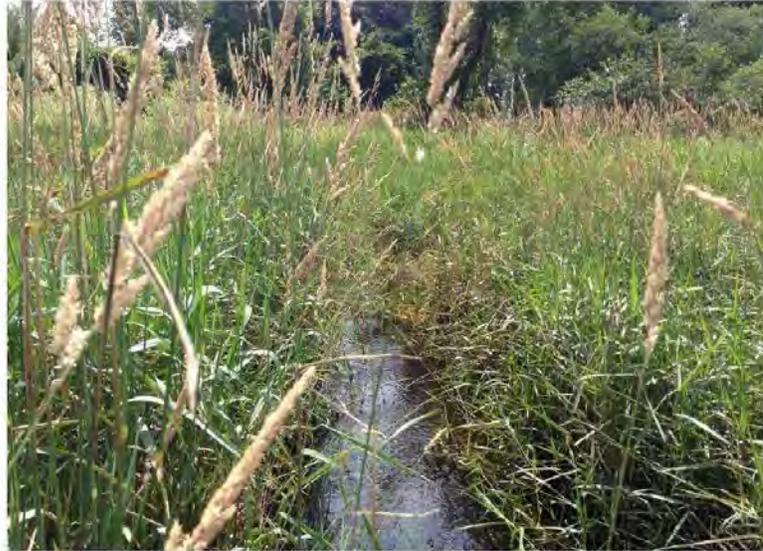
Photo 211. View upstream of Photograph Point W

Photograph Pointe W	Photograph Point W - Open reach of drain showing no apparent signs of obstruction to flow or erosion; 3' stream width; mid channel approximately 32" deep; 12" soft deposition; banks dominated by reed canary grass; no action recommended					214 - View d/s 215 - View u/s
Photograph Pointe X	Photograph Point X - Open reach of drain dominated by reed canary grass; 2.5' stream width; mid channel approximately 36" deep; no apparent signs of obstruction to flow or erosion; no action recommended					216 - View d/s
133	LDB MC	Large woody debris, consisting of overhanging shrubs, obstructing natural flow		Remove and cut back vegetation from mid channel	L	217 - View d/s 218 - View u/s
134	MC	Farm Road Crossing - 48" width		No action recommended	NA	219 - View d/s 220 - View u/s
135	LDB	Deposition of sand and gravel from unnamed tributary along the LDB immediately downstream of its S Drive N crossing; ~40 linear feet of sand deposits; 45' long; 40 wide; >12" deep; approximately 45 LF	~65	Remove all sediment deposits from the main channel of the tributary and the over bank area	H	221 - View South 222 - View South

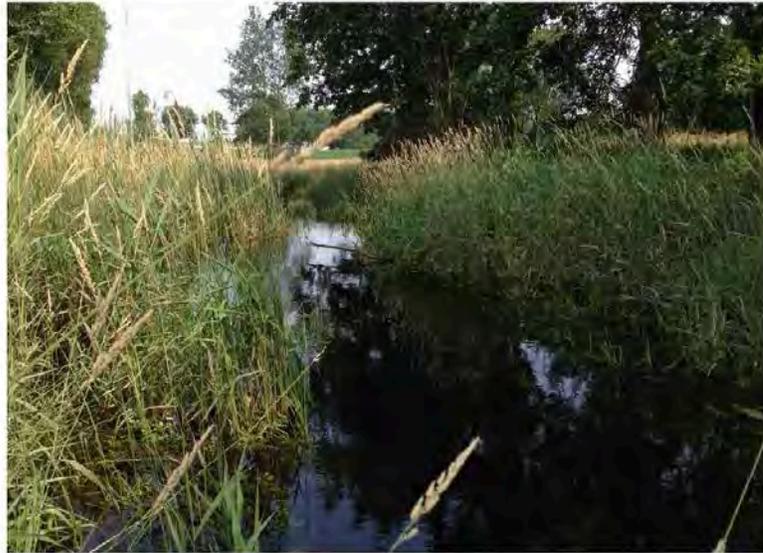
Photo 219. View downstream of Photograph Point Y

Photograph Pointe Y	Photograph Point Y - Open reach of drain acting as a depositional area showing no apparent signs of obstruction to flow or erosion; 12' stream width; mid channel approximately 2 ft. deep; center of drain channel is silt; vegetation present within drain channel; banks lined with reed canary grass; no action recommended					223 - View d/s 224 - View u/s
136	LDB RDB MC	16'X3' wood foot bridge		Remove or elevate	M	225 - View d/s
137	LDB RDB MC	Large woody debris obstructing natural flow	1/4	Relocate to LDB/RDB	M	226 - View u/s
138	MC	Farm Road Crossing - 54" CMP; upstream end of culvert: 26" water depth, 8" sediment depth, 20" space between top of culvert and water surface		Check hydraulics of crossing	L	227 - View d/s 228 - View u/s
139	RDB	Large woody debris, consisting of overhanging trees, obstructing natural flow		Remove to upland; Relocate to LDB/RDB	L	NP
140	LDB RDB MC	Large woody debris, consisting of overhanging trees and branches, obstructing natural flow	3	Relocate to upper bank	H	229 - View d/s

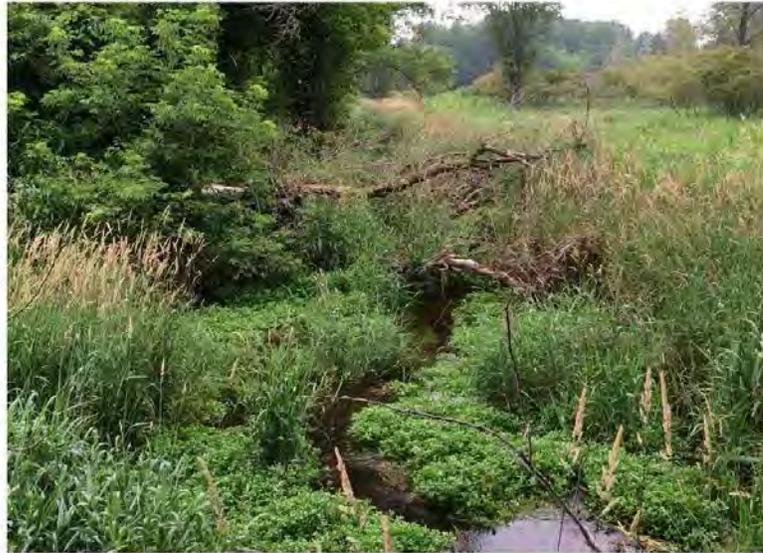
Photo 225. View downstream of site #140

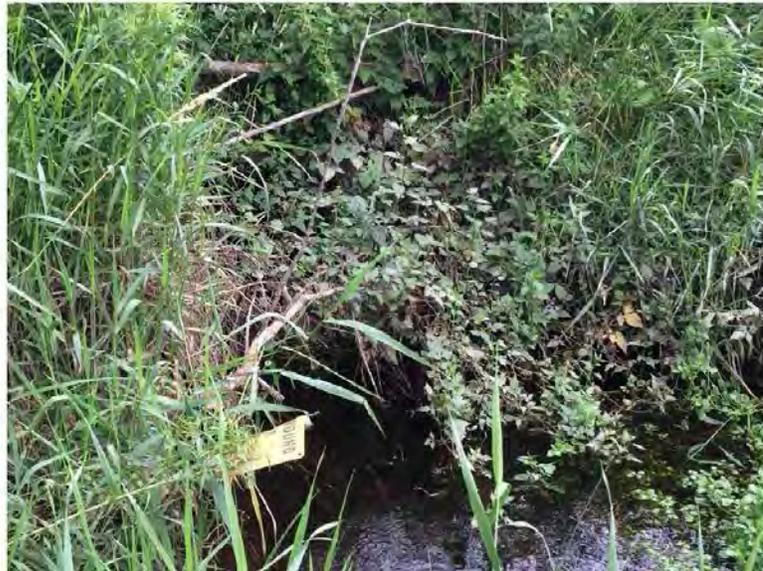
Photo 226. View downstream of site #141

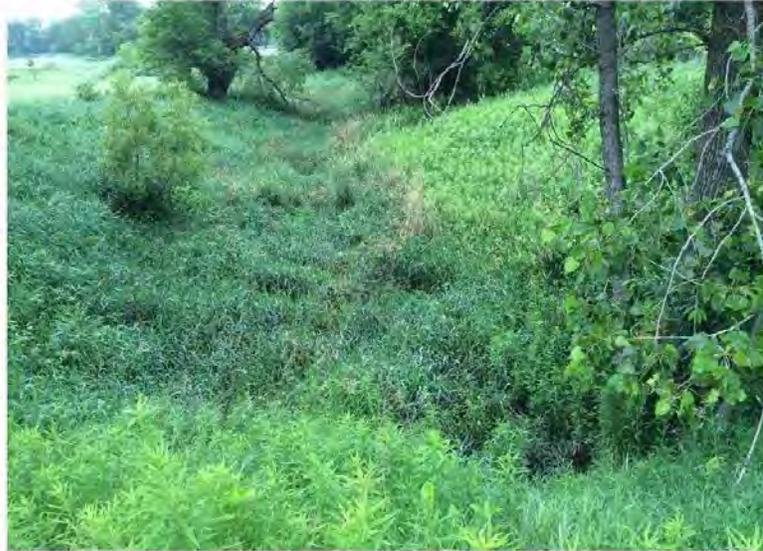
Photo 227. View downstream of site #141

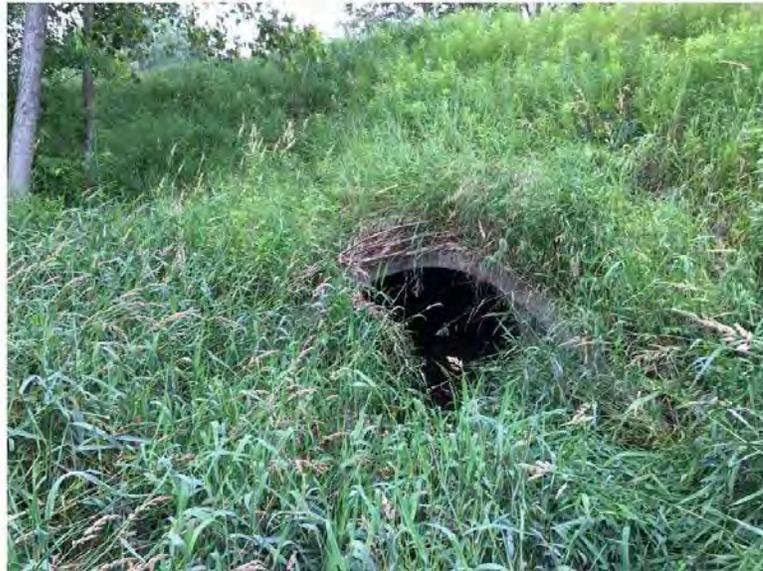
Photo 228. View upstream of site #141

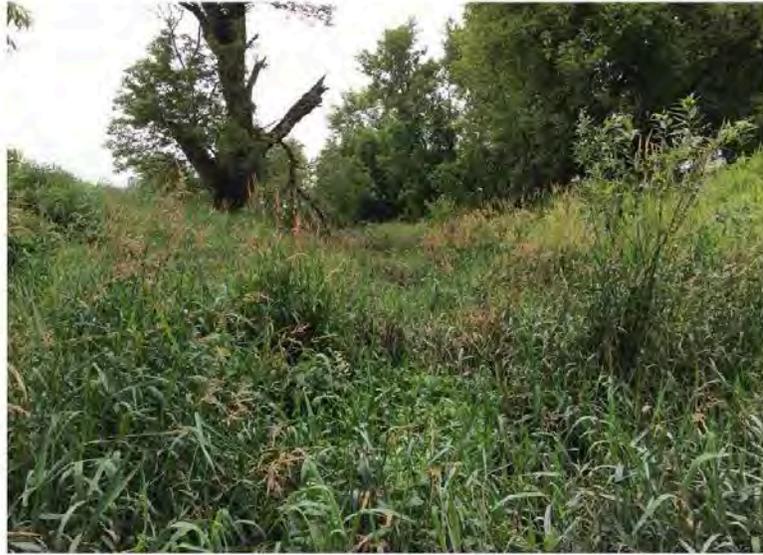
Photo 229. View downstream of Photograph Point Z

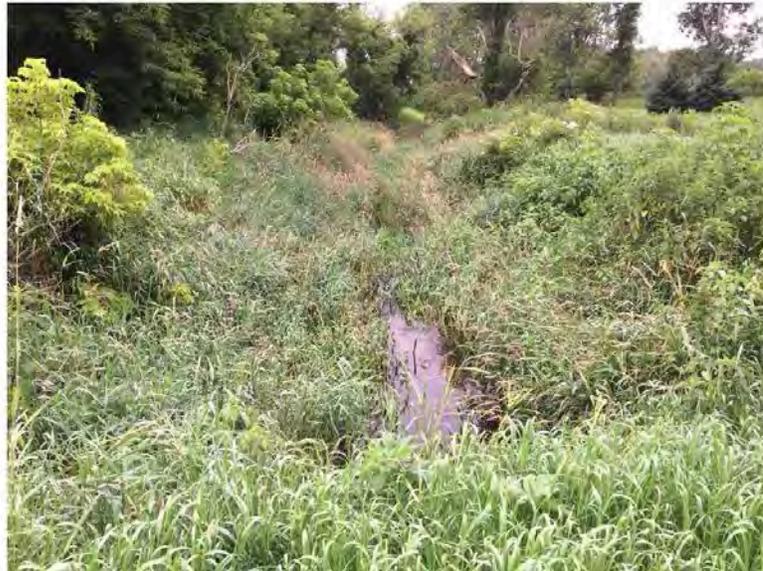
Photo 230. View downstream of site #142

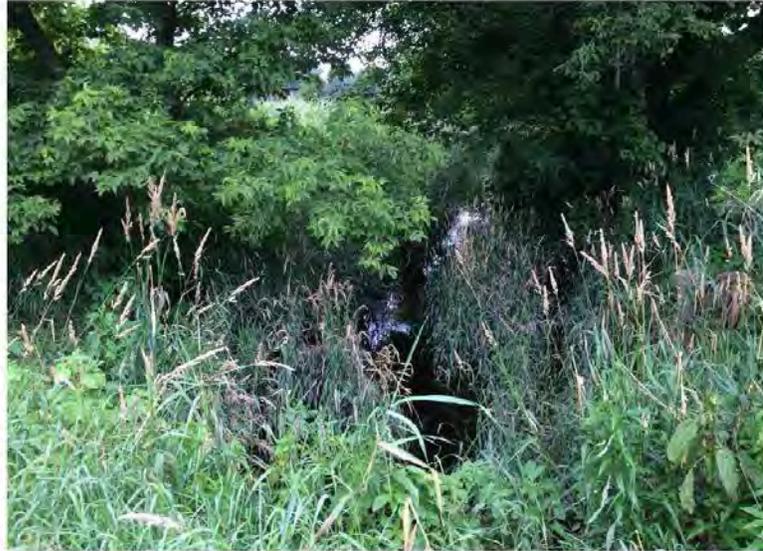
Photo 231. View upstream of site #142

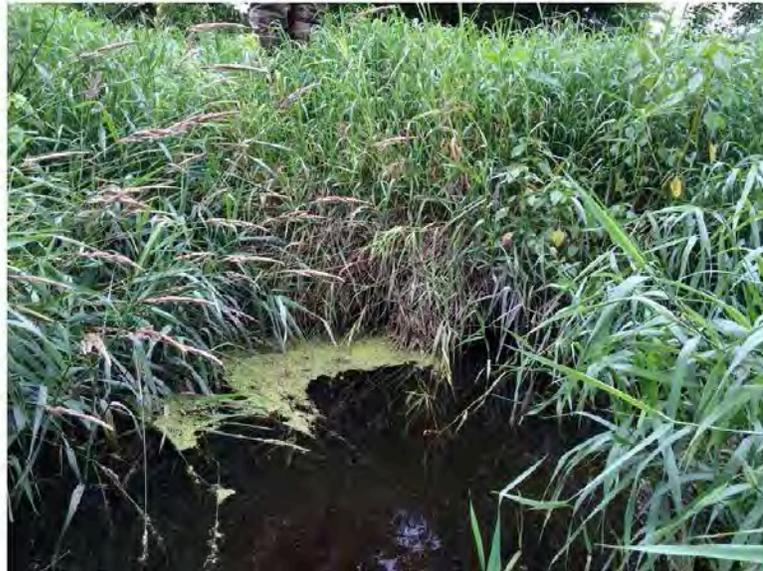
Photo 232. View upstream of site #142

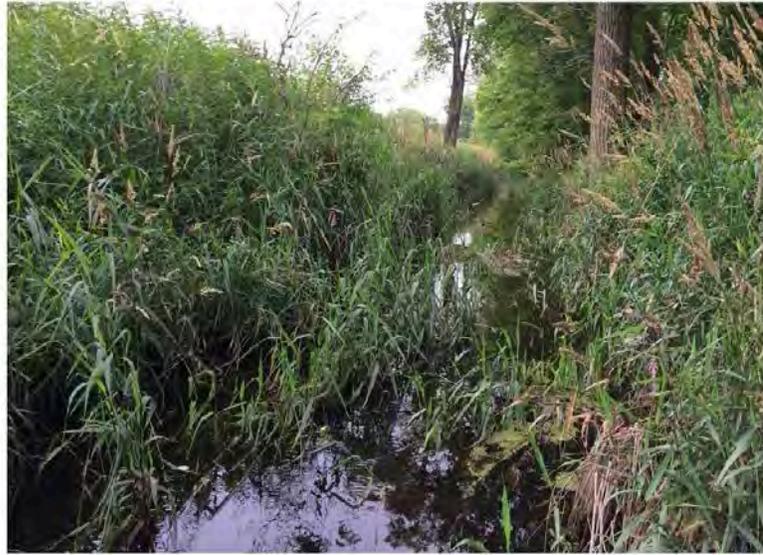
Photo 233. View upstream of Photograph Point ZA

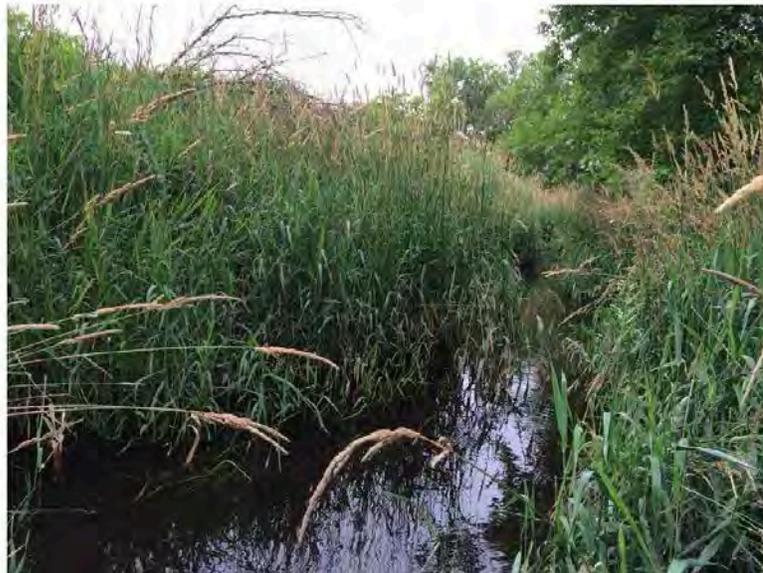
Photo 234. View upstream of Photograph Point ZB

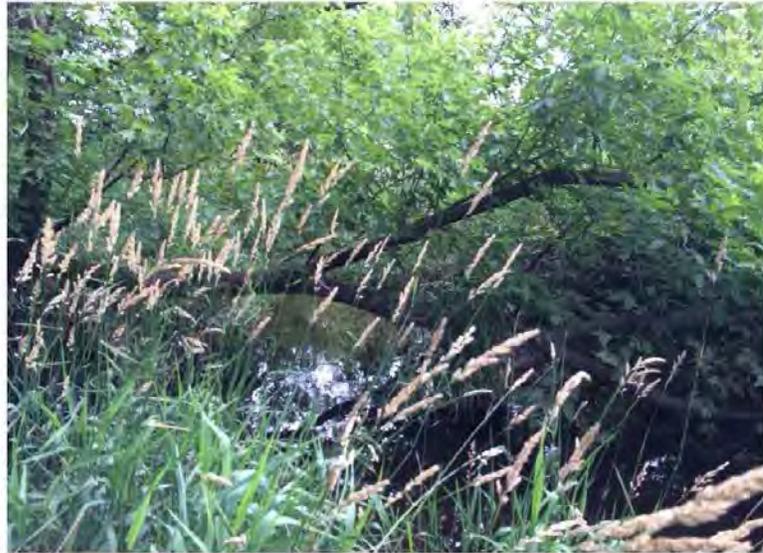
Photo 235. View downstream of site #143

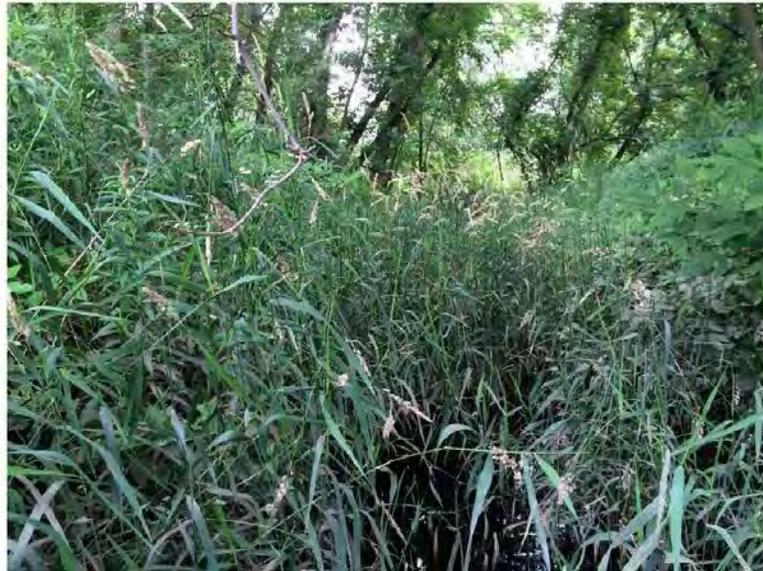
Photo 236. View upstream of site #143

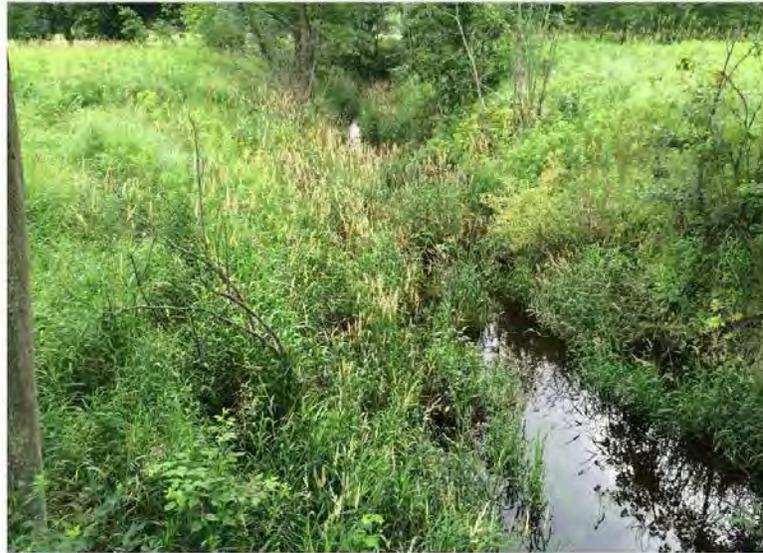
Photo 237. View upstream of site #144

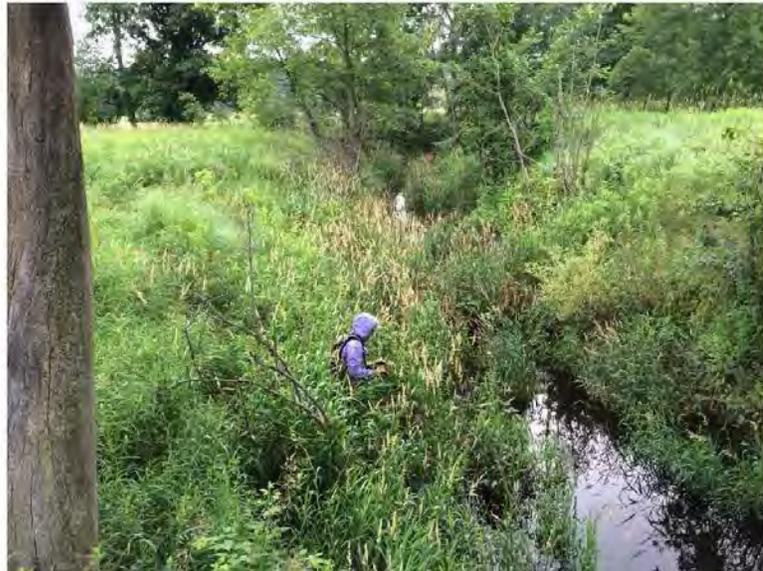
Photo 238. View downstream of site #145

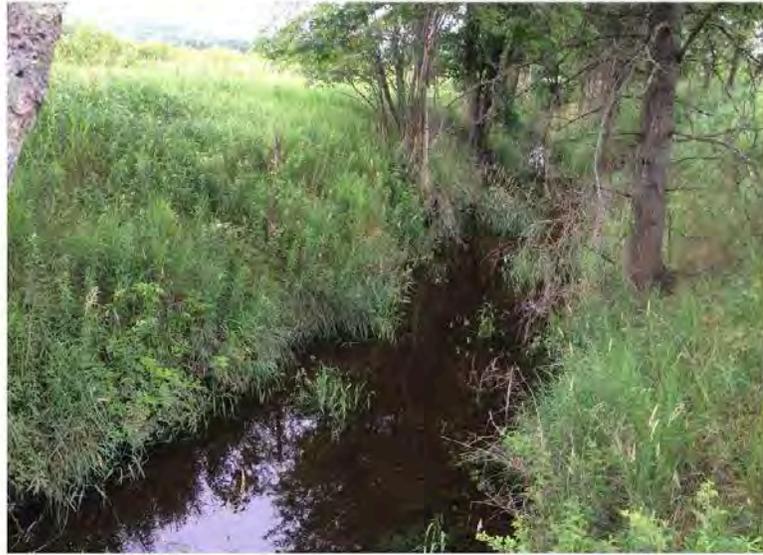
Photo 239. View upstream of Photograph Point ZC

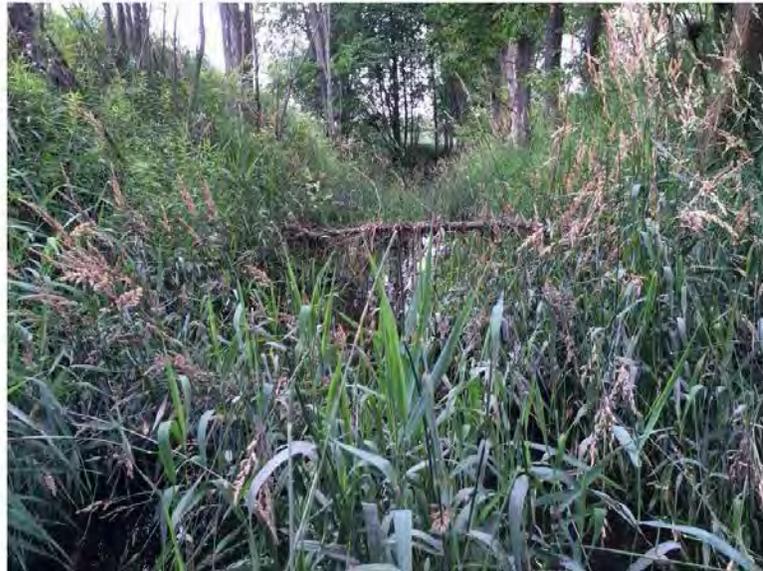
Photo 240. View upstream of site #146

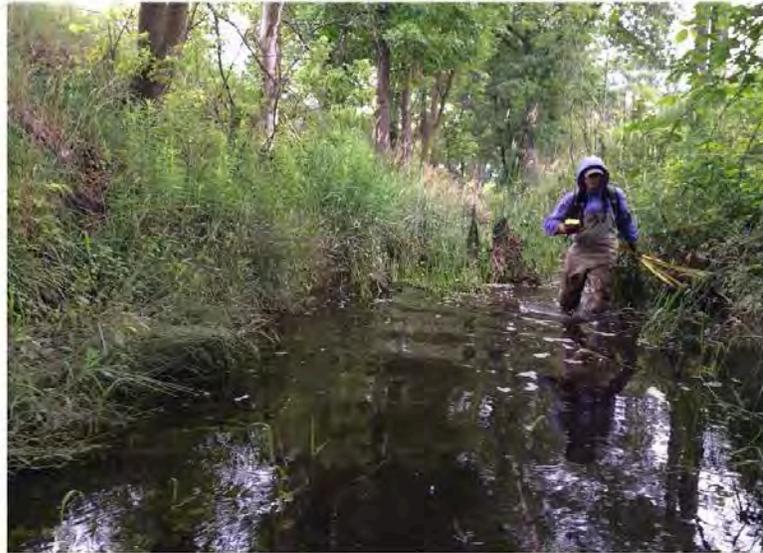
Photo 241. View downstream of site #146

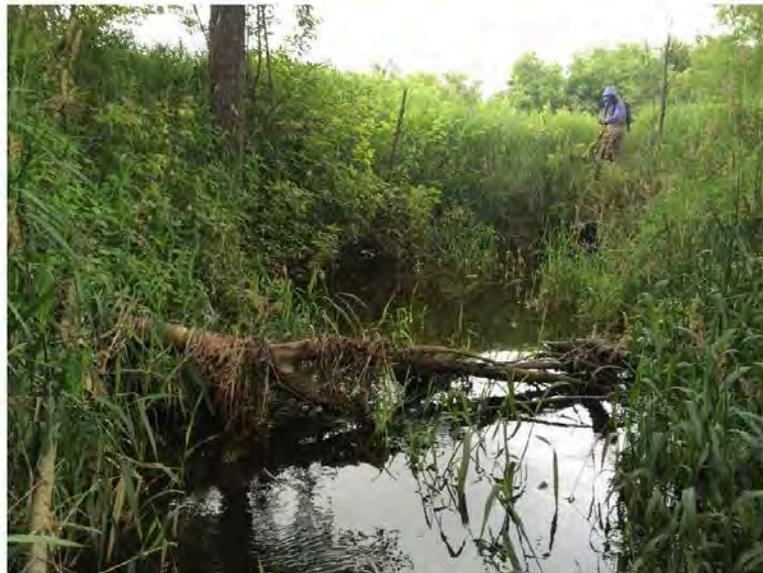
Photo 242. View upstream of site #147

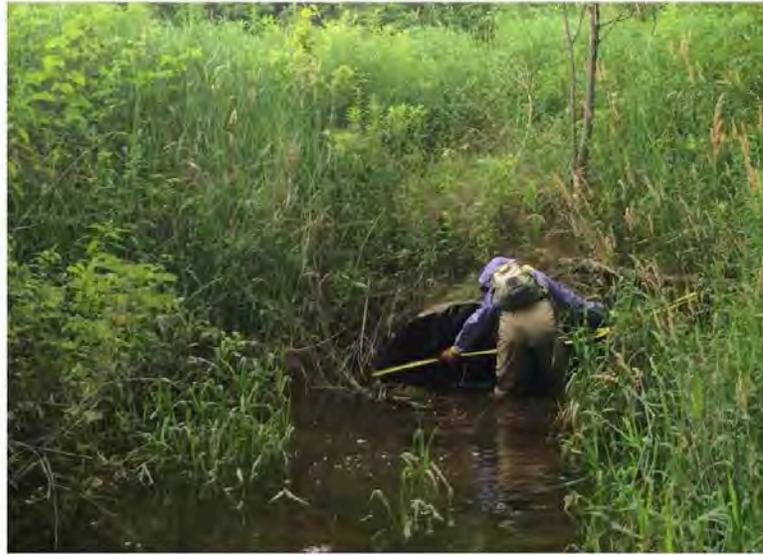
Photo 243. View upstream of site #148

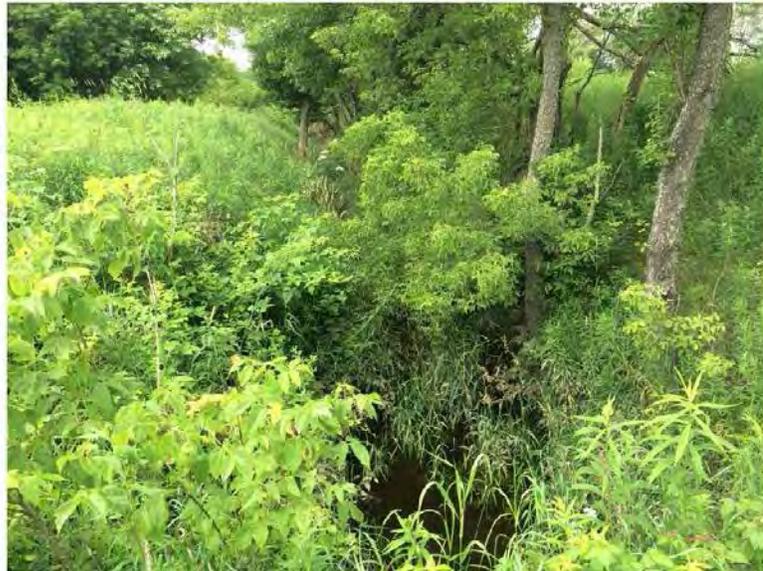
Photo 244. View upstream of site #148

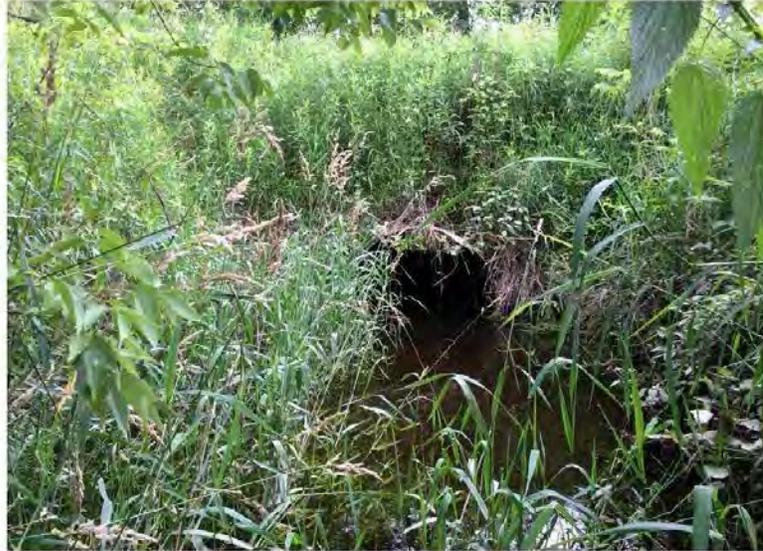
Photo 245. View downstream of site #148

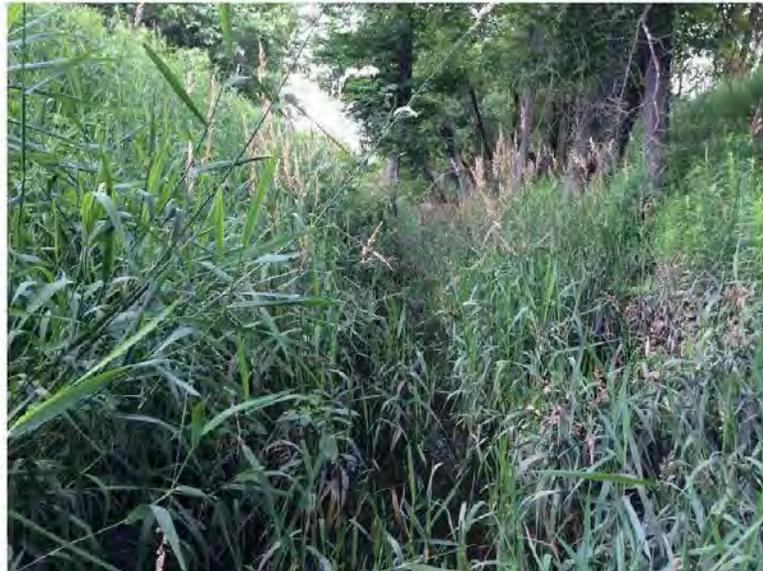
Photo 246. View upstream of site #149

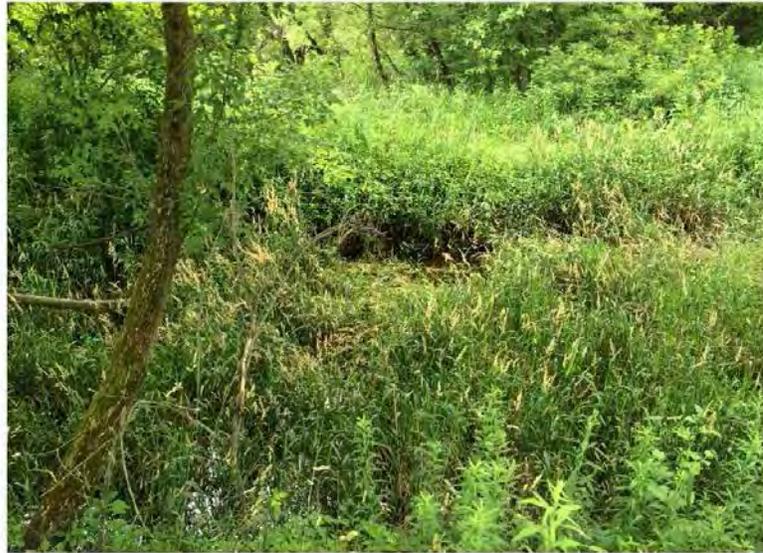
Photo 247. View across channel of site #149

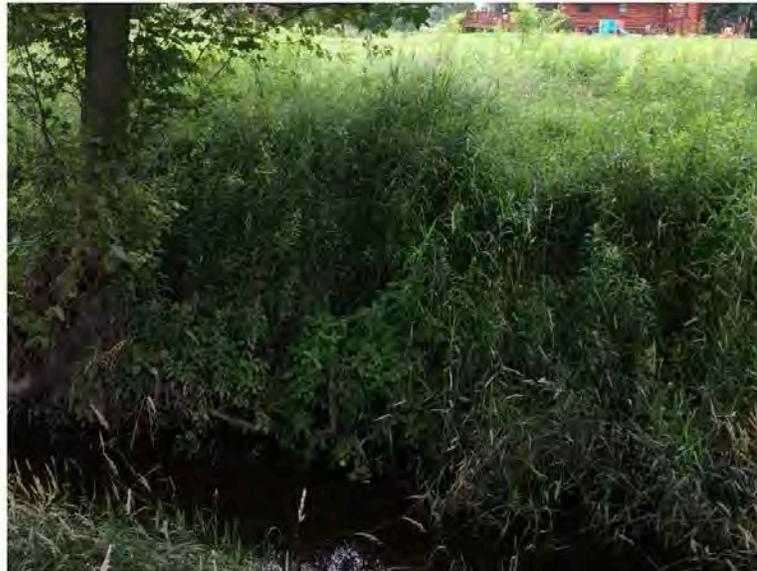
Photo 248. View of long home at site #149

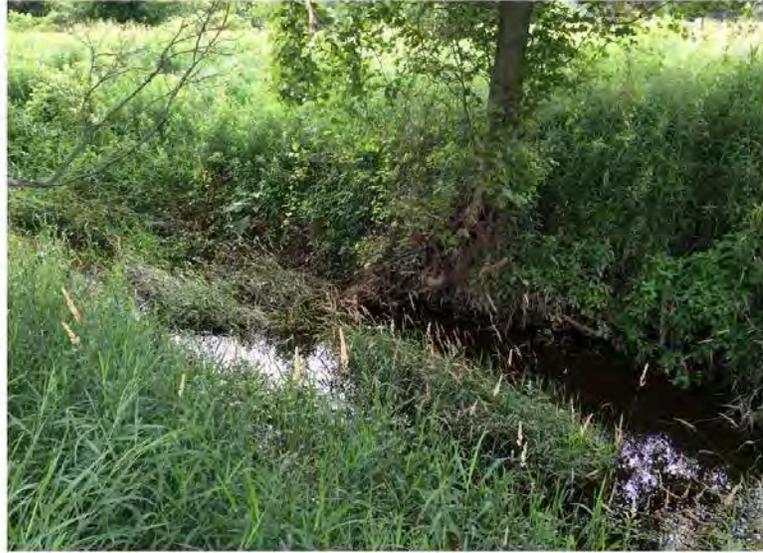
Photo 249. View downstream of site #149

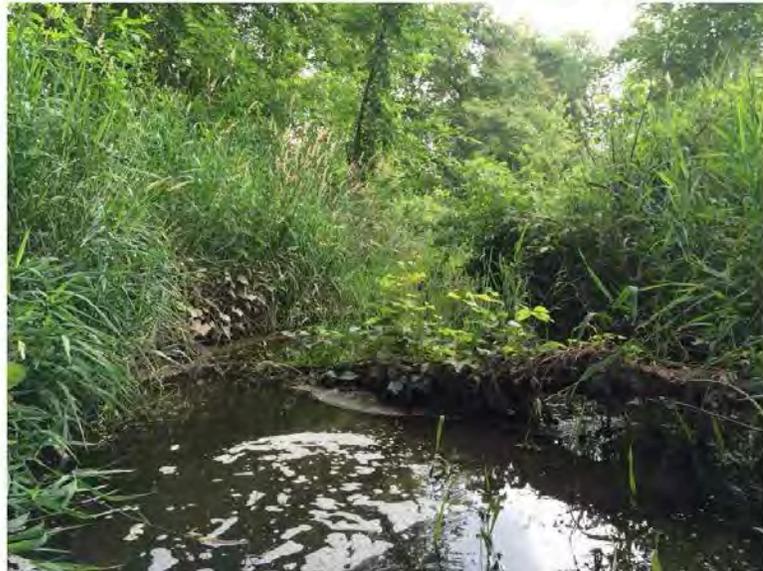
Photo 250. View downstream of site #149

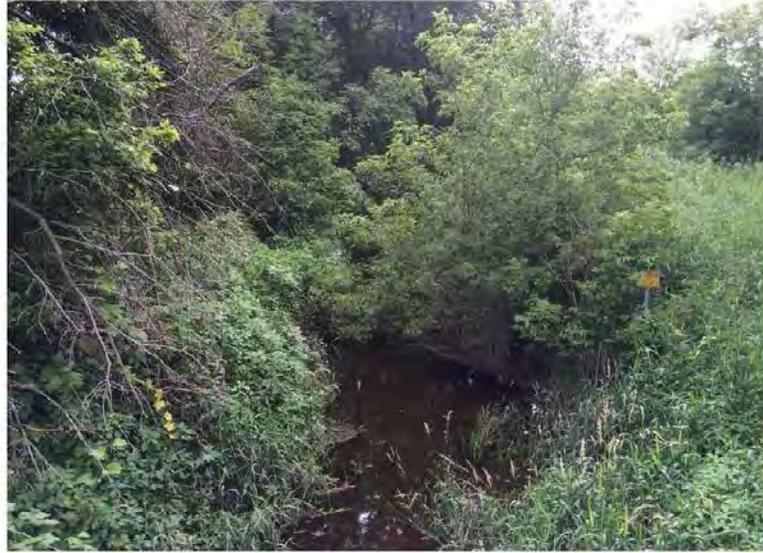
Photo 251. View downstream of site #150

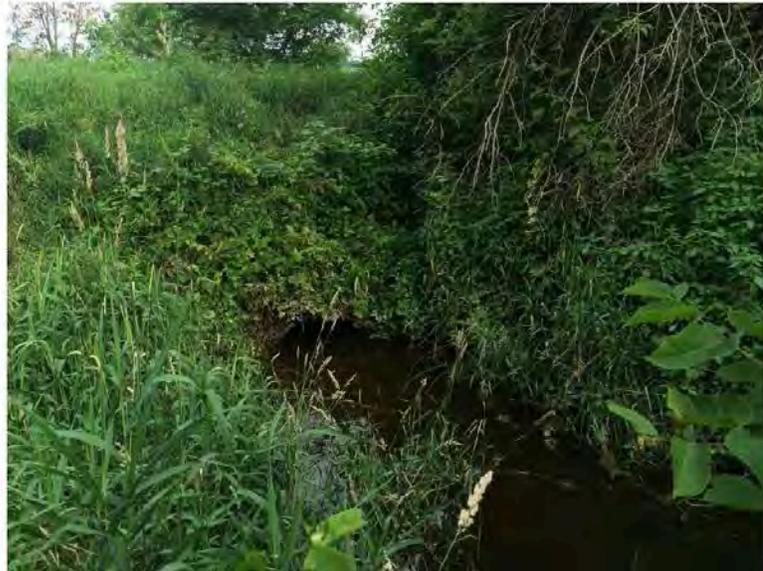
Photo 252. View downstream of site #151
