Gang of Lakes Intercounty Drain Assessment Report

Calhoun and Jackson Counties, Michigan

August 19, 2015

GEI Project No. 1509010

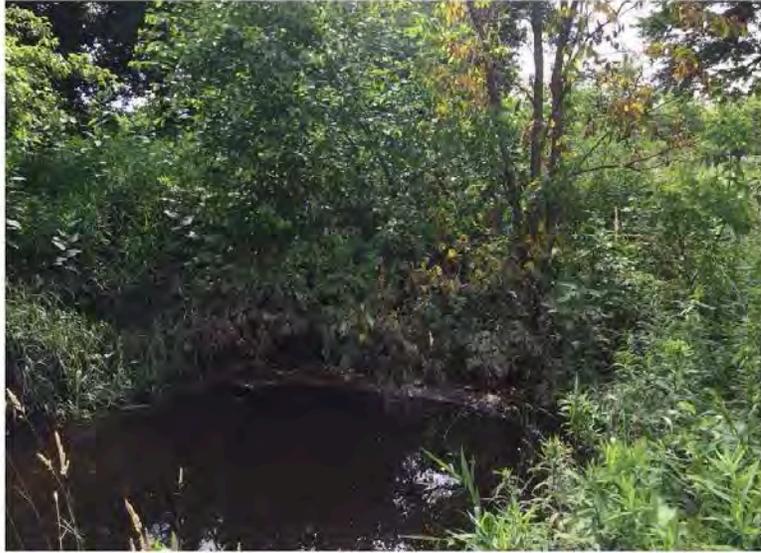
Photo 253. View upstream of site #151

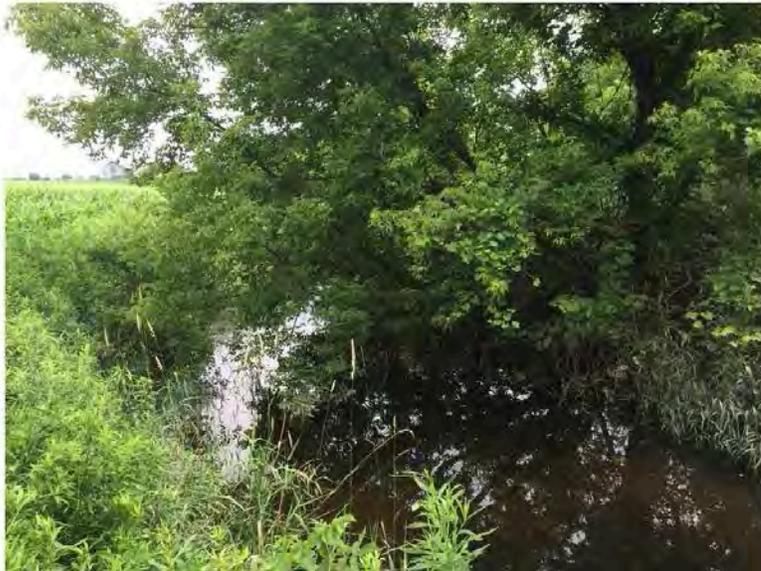
Photo 254. View upstream of site #151

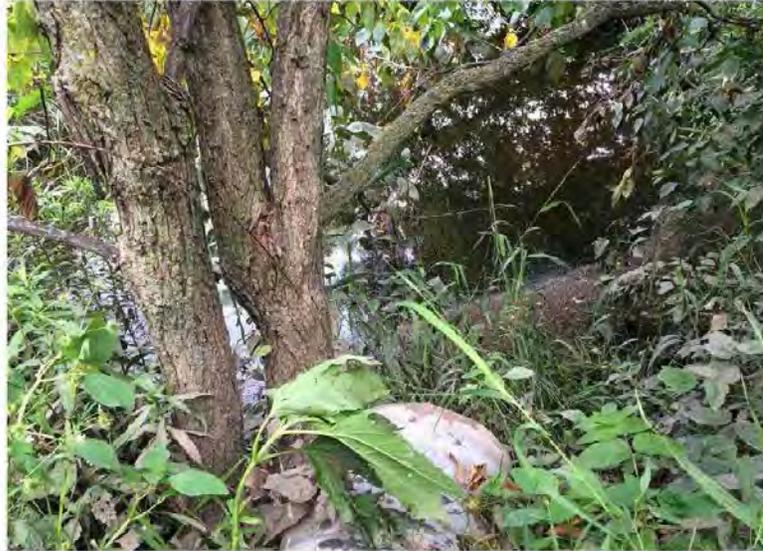
Photo 255. View upstream of site #152

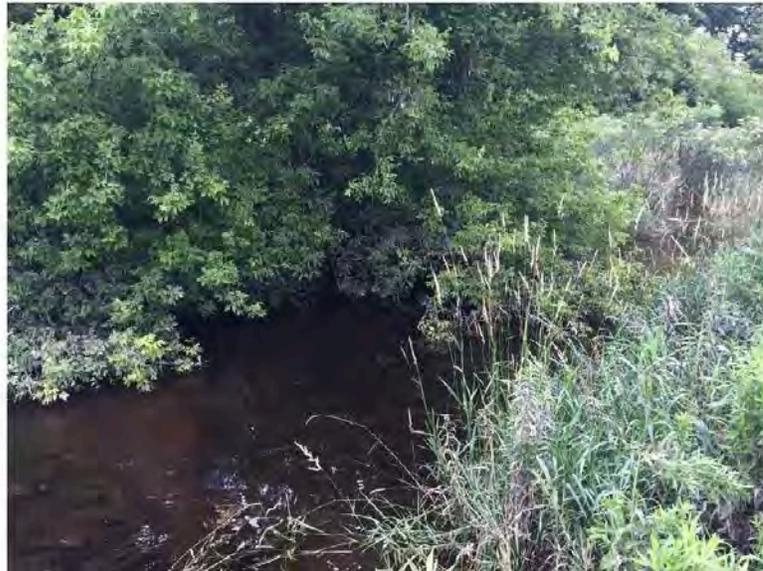
Photo 256. View downstream of site #154

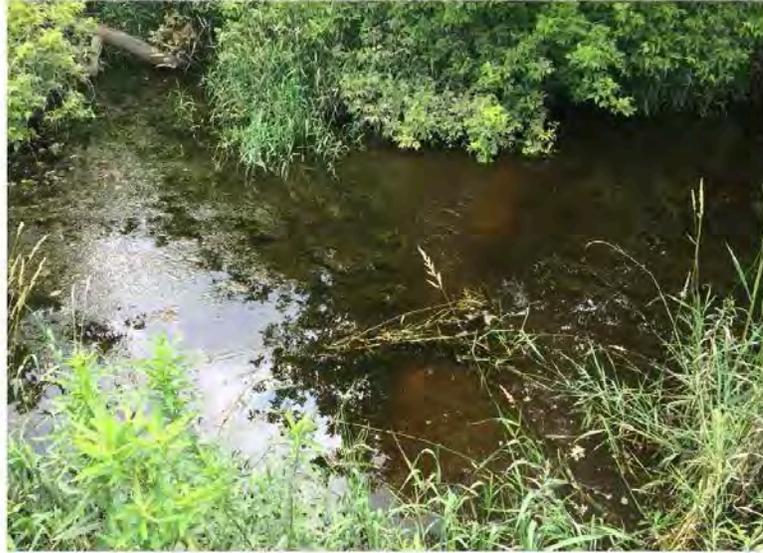
Photo 257. View across to east of site #155

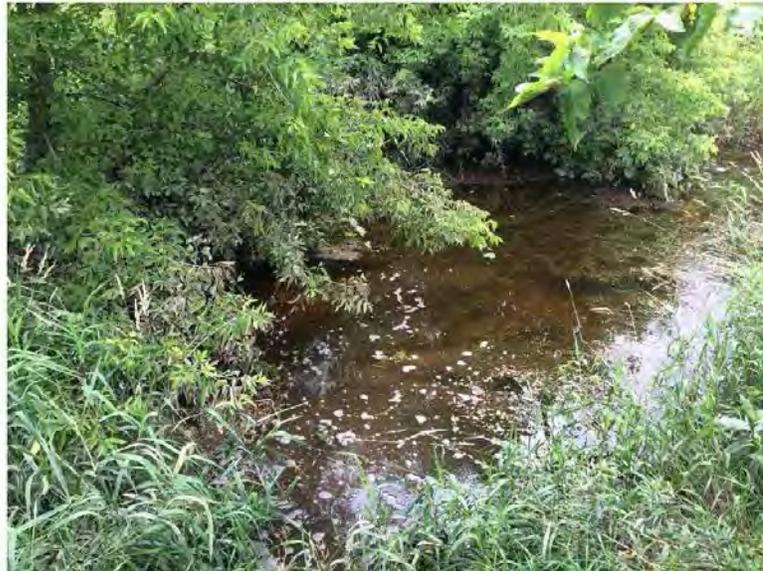
Photo 258. View across to east of site #156

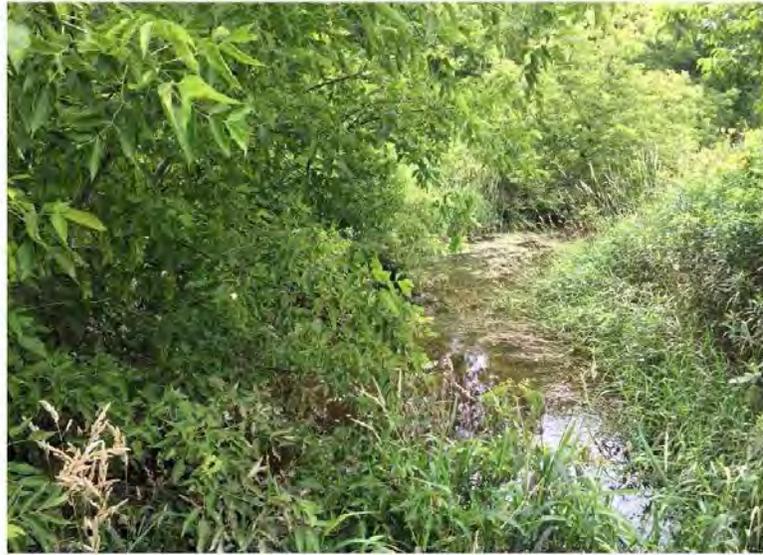
Photo 259. View downstream of site #156
